KELVIN COURT, GREAT WESTERN ROAD,
GLASGOW
CONSERVATION NARRATIVE

April 2019

INSPECTIONS

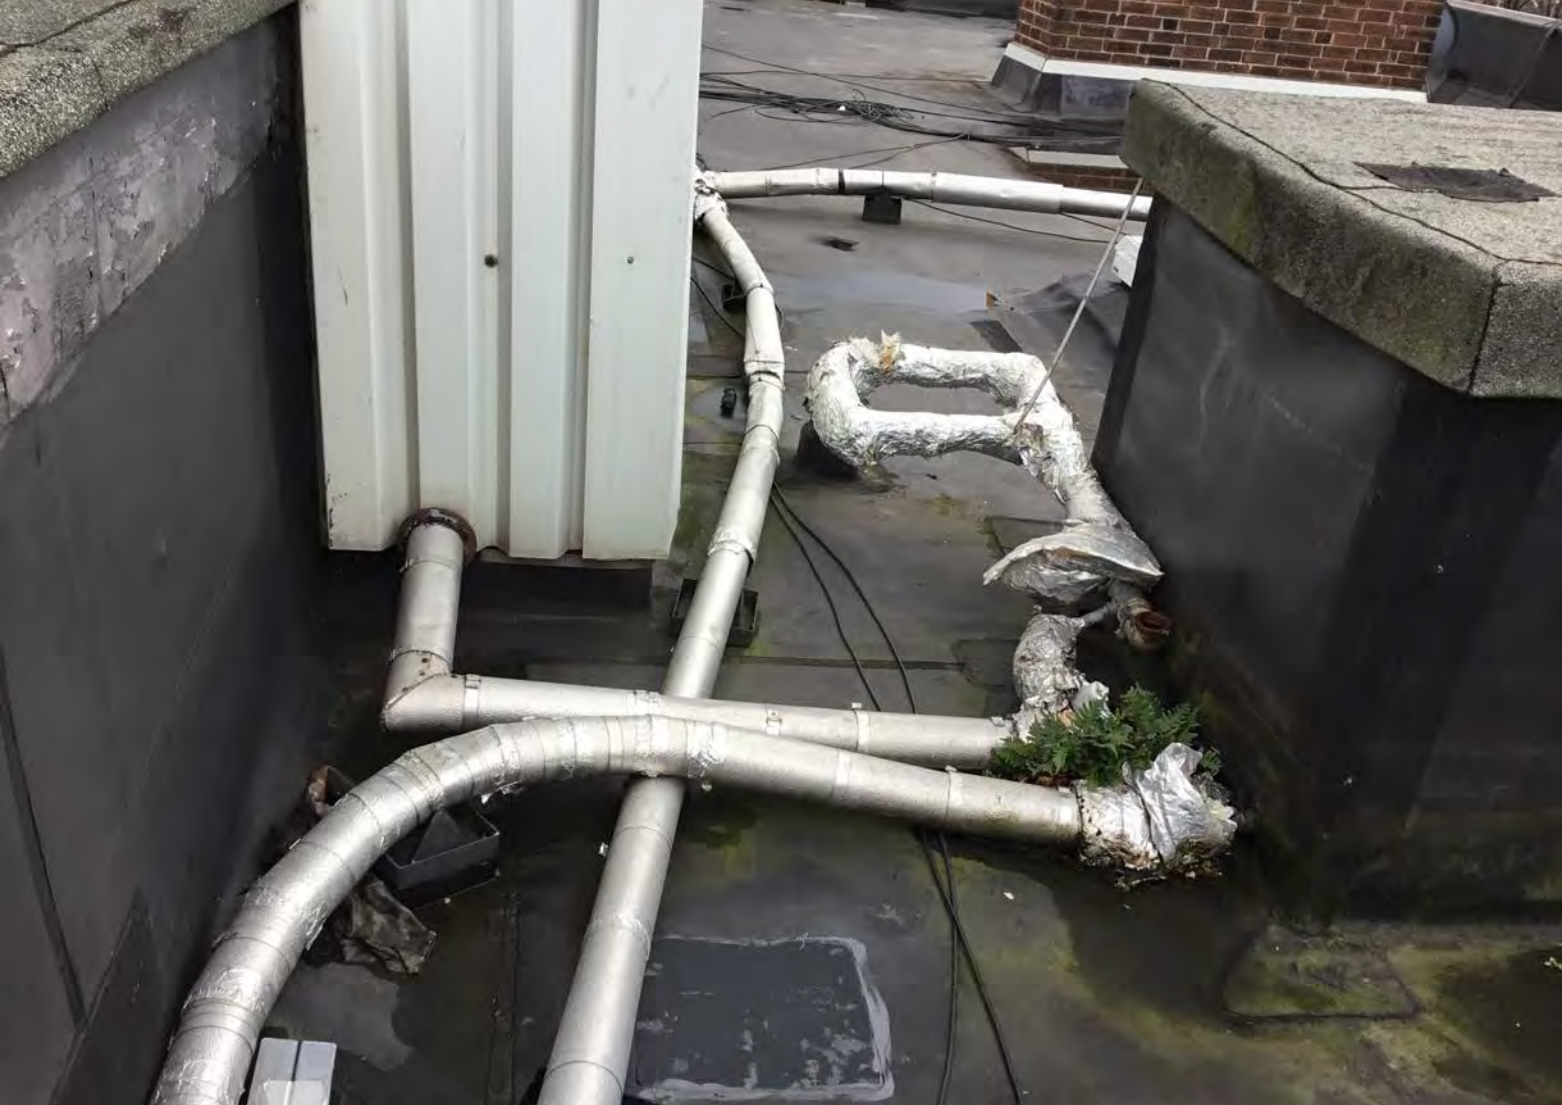
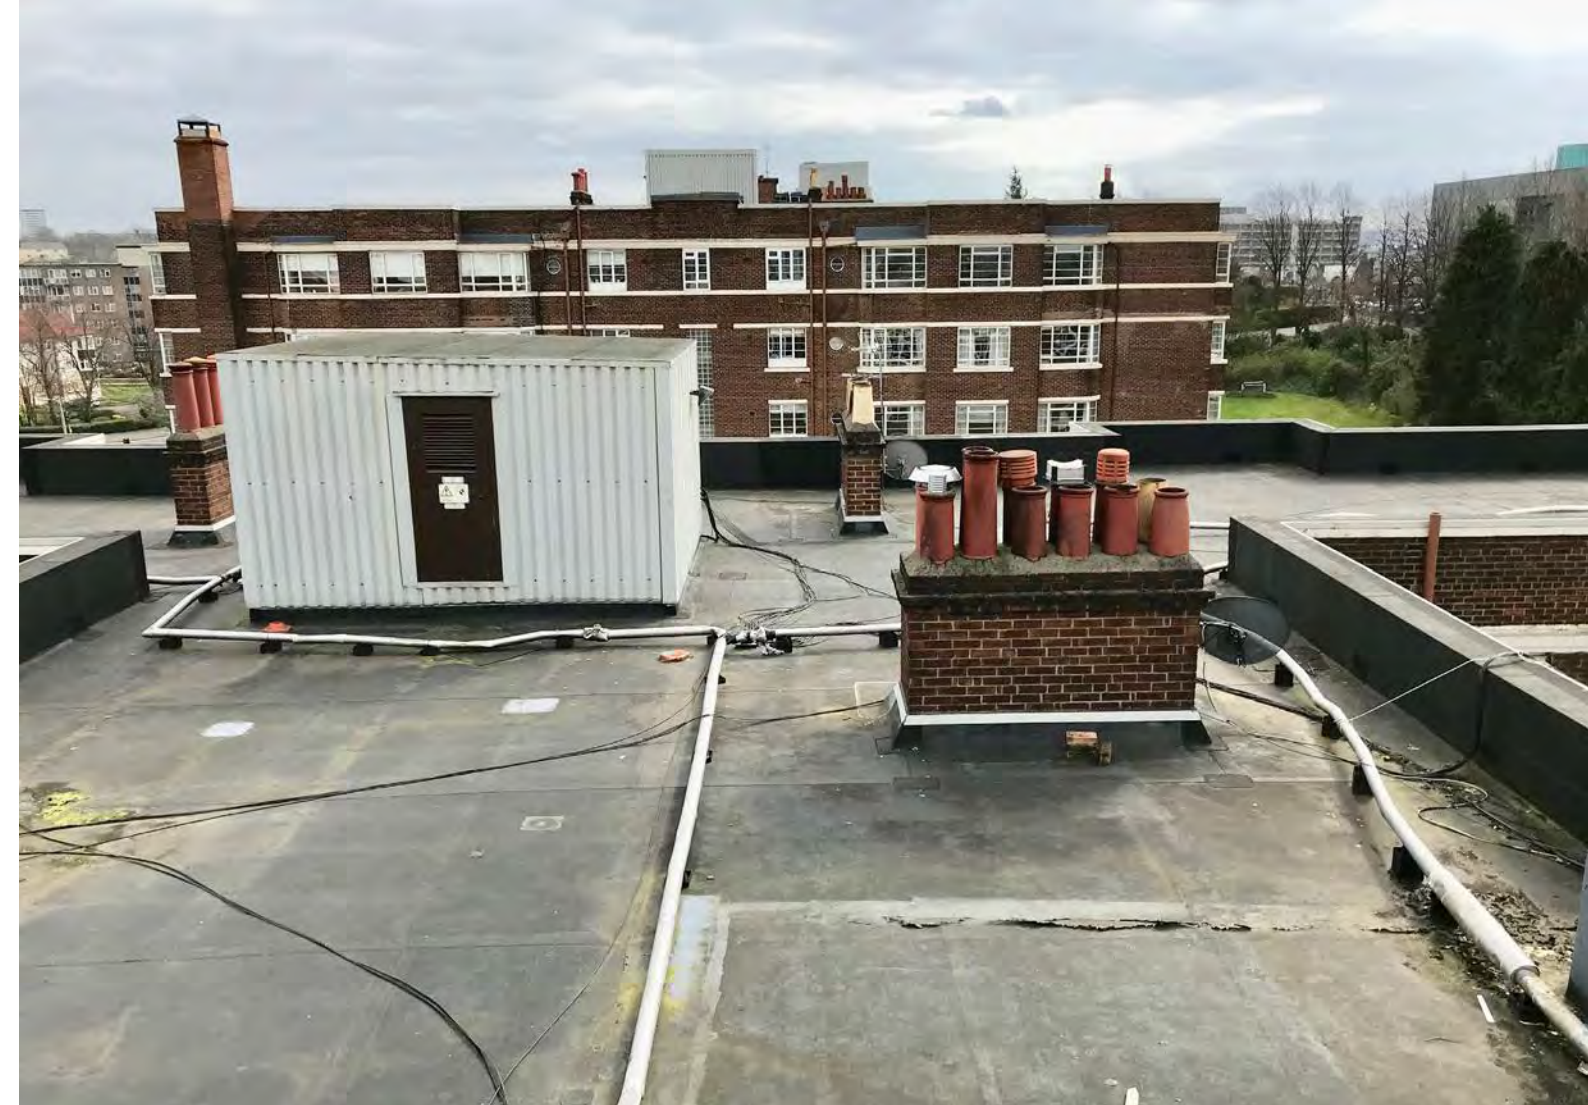
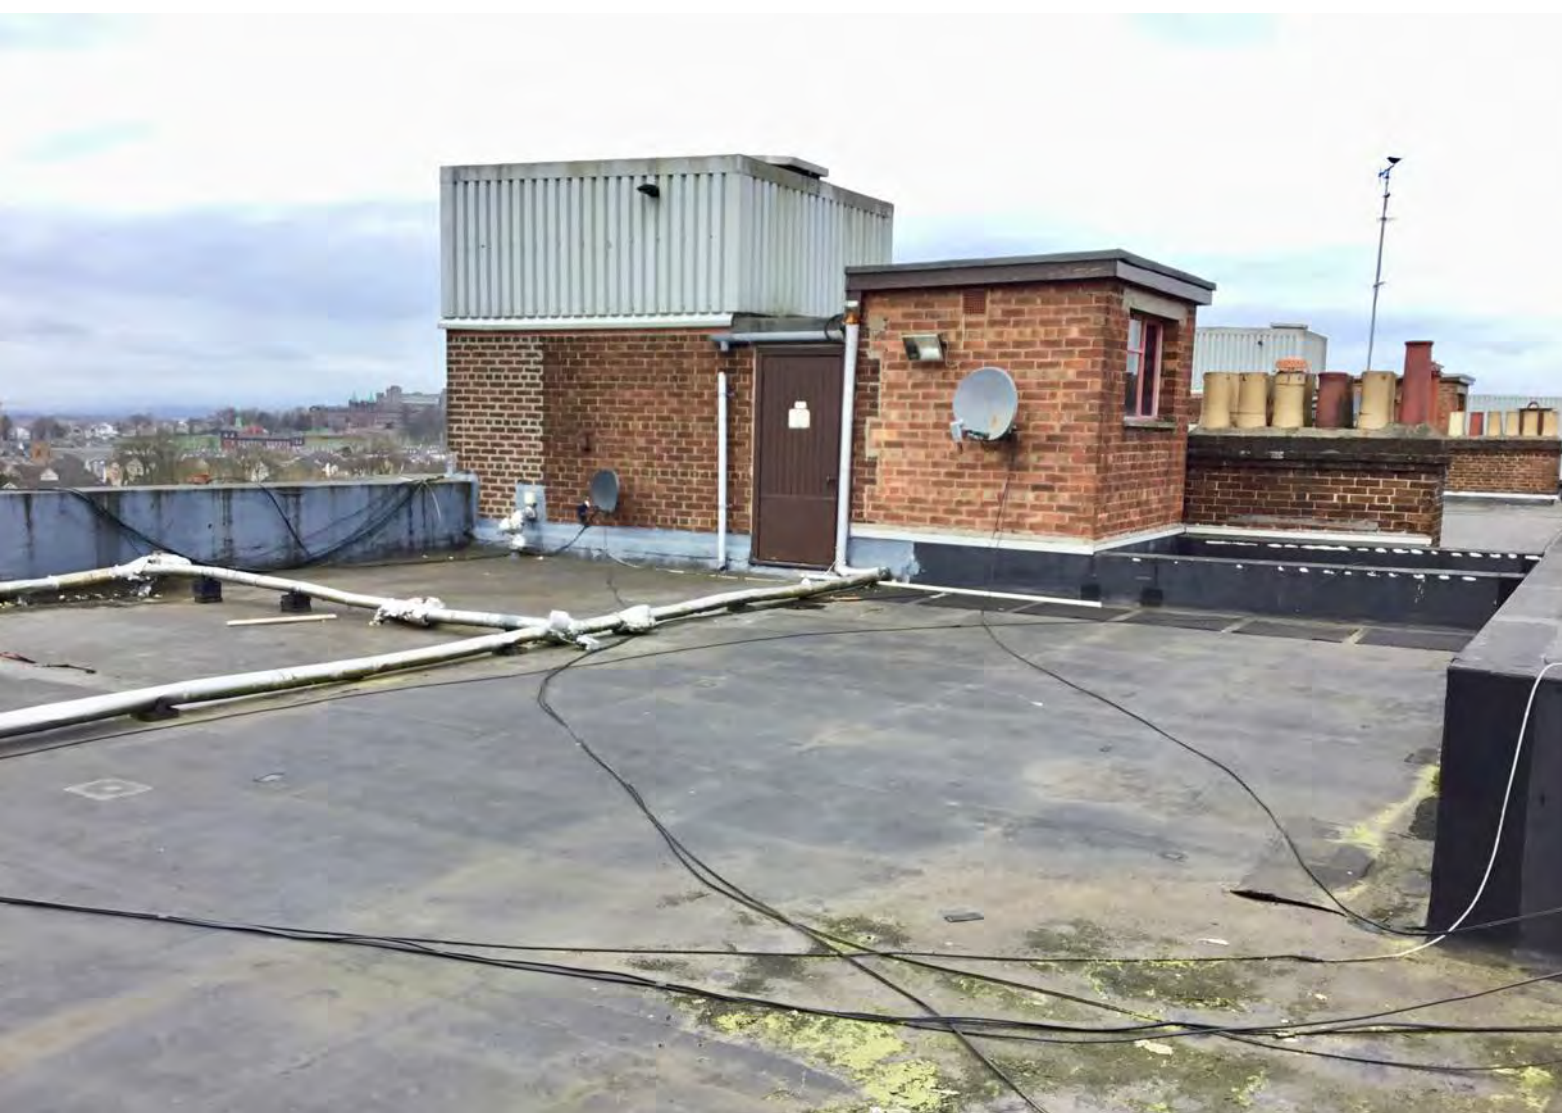
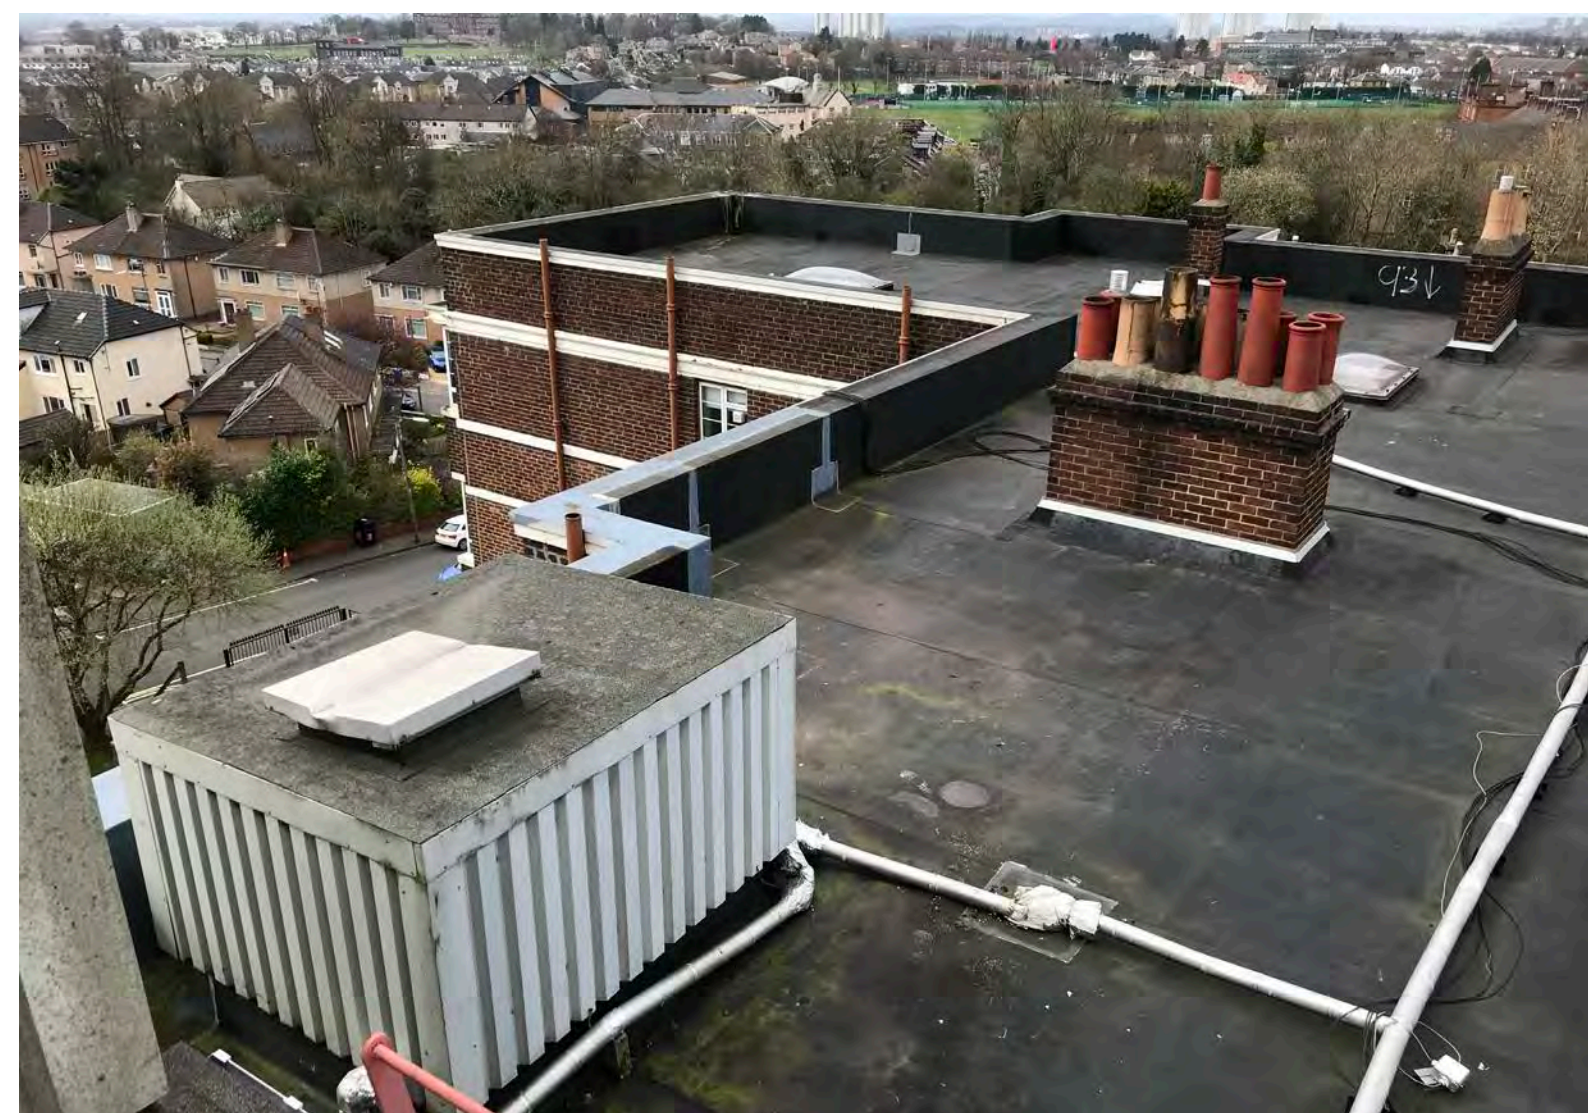
Clockwise from left: Google Maps image of roof showing, in particular, the wayward nature of the cold water pipework (© Google); rubberised membrane, undersized outlet and open pipe left following partial tank removal (© author); most of the component parts on the roof are built of brick - the boxy structure is the lift pulley to the central stair (the TV aerial is especially high) (© author); repairs to the rubberised membrane are typically carried out using liquid waterproofing (© author).

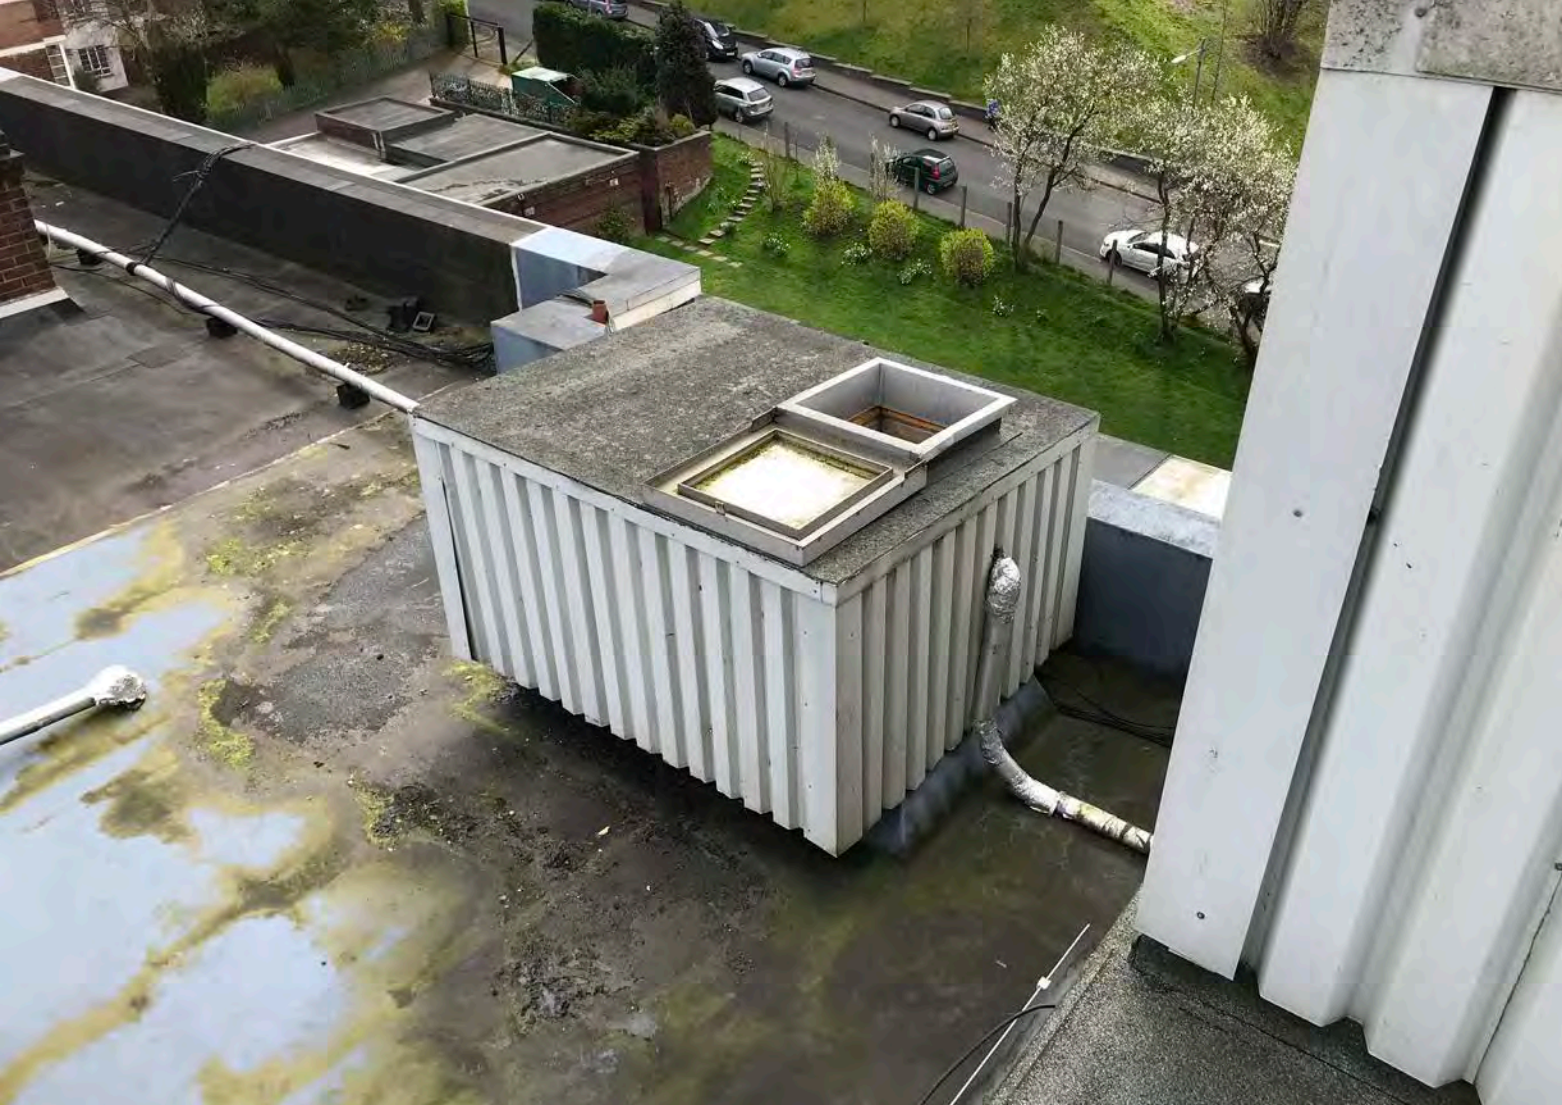
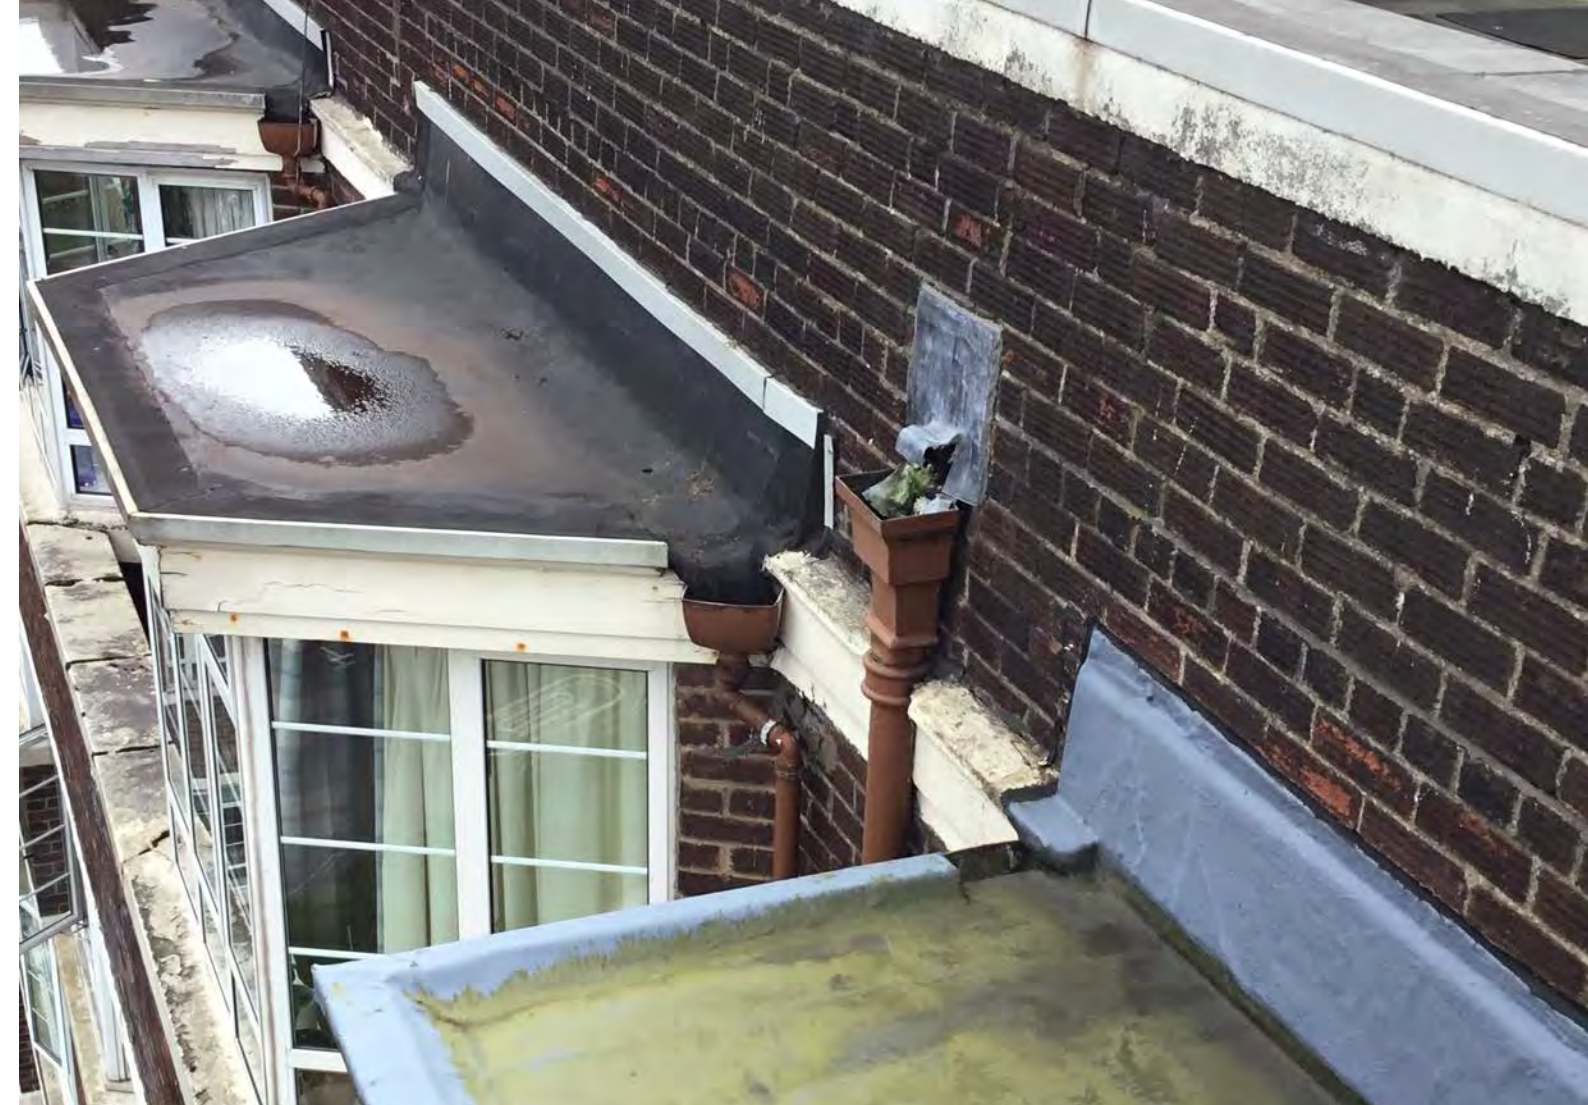
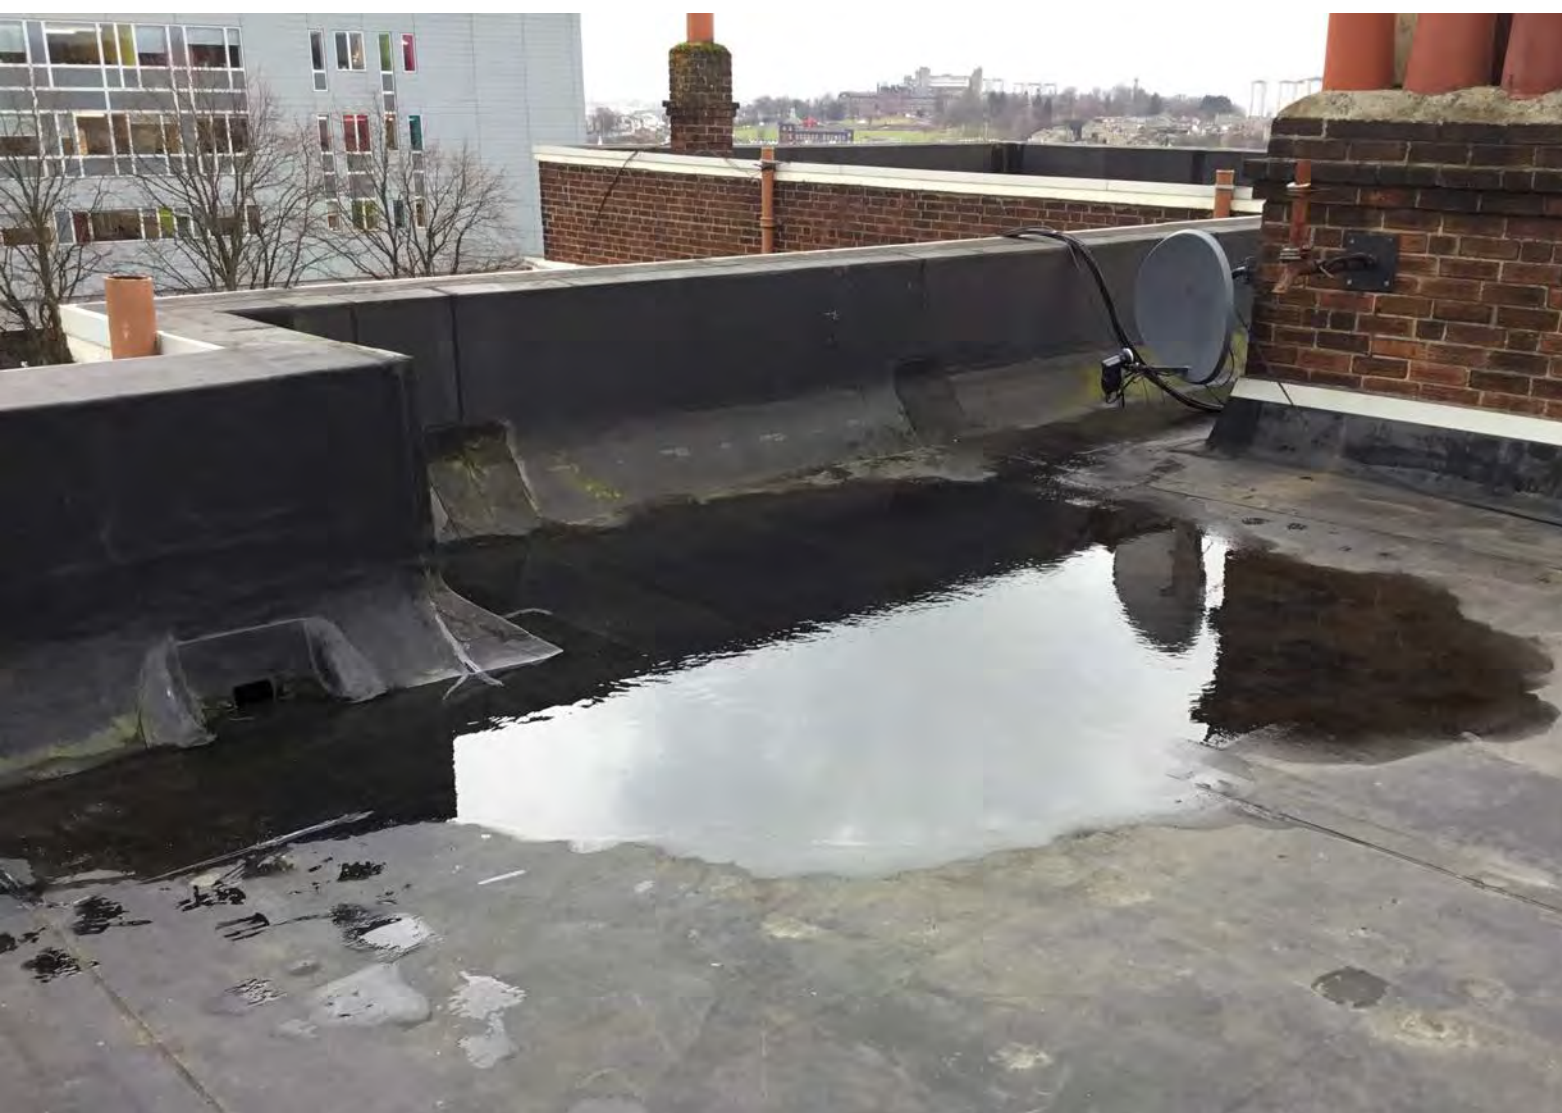
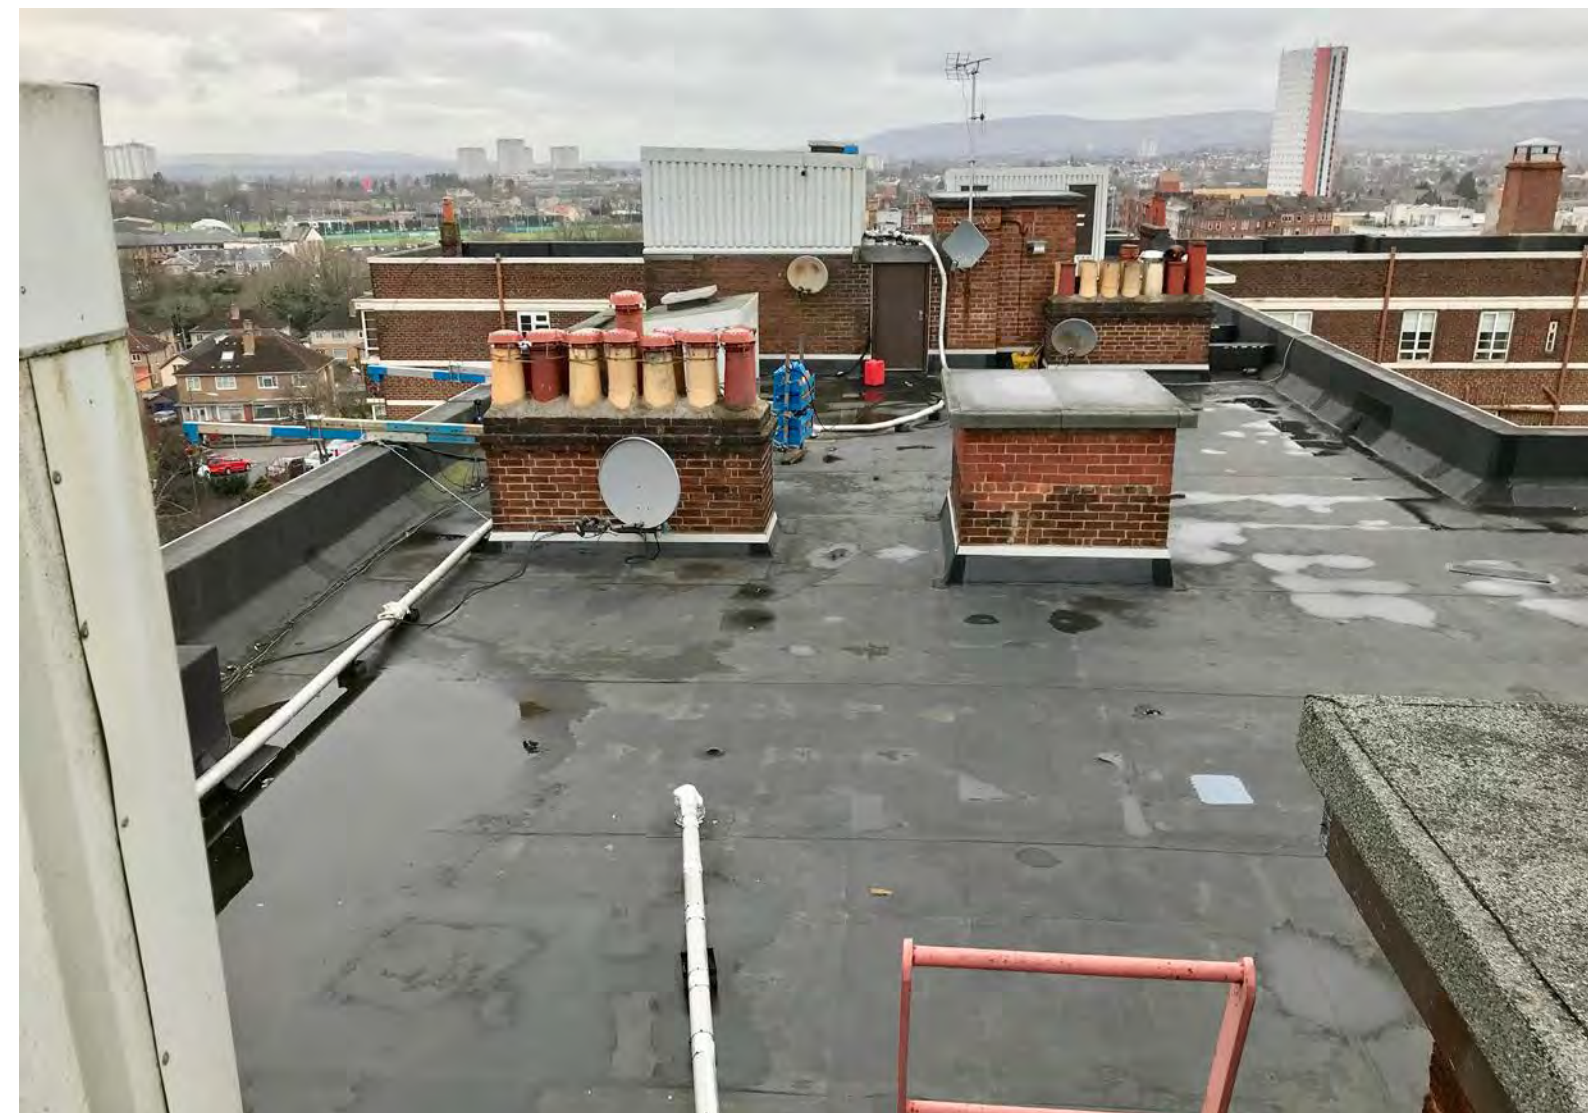
Clockwise from top left: the water distribution pipework is especially contorted and the insulation attractive to seagulls (© author); free-standing lift motor rooms are in fair condition - which is more than can be said for the roof (© author); some water tanks are awkwardly close to the parapet, making waterproofing difficult - one hatch has lain open for months (© author); generally the roofs are a patchwork of repairs and algae (© author).

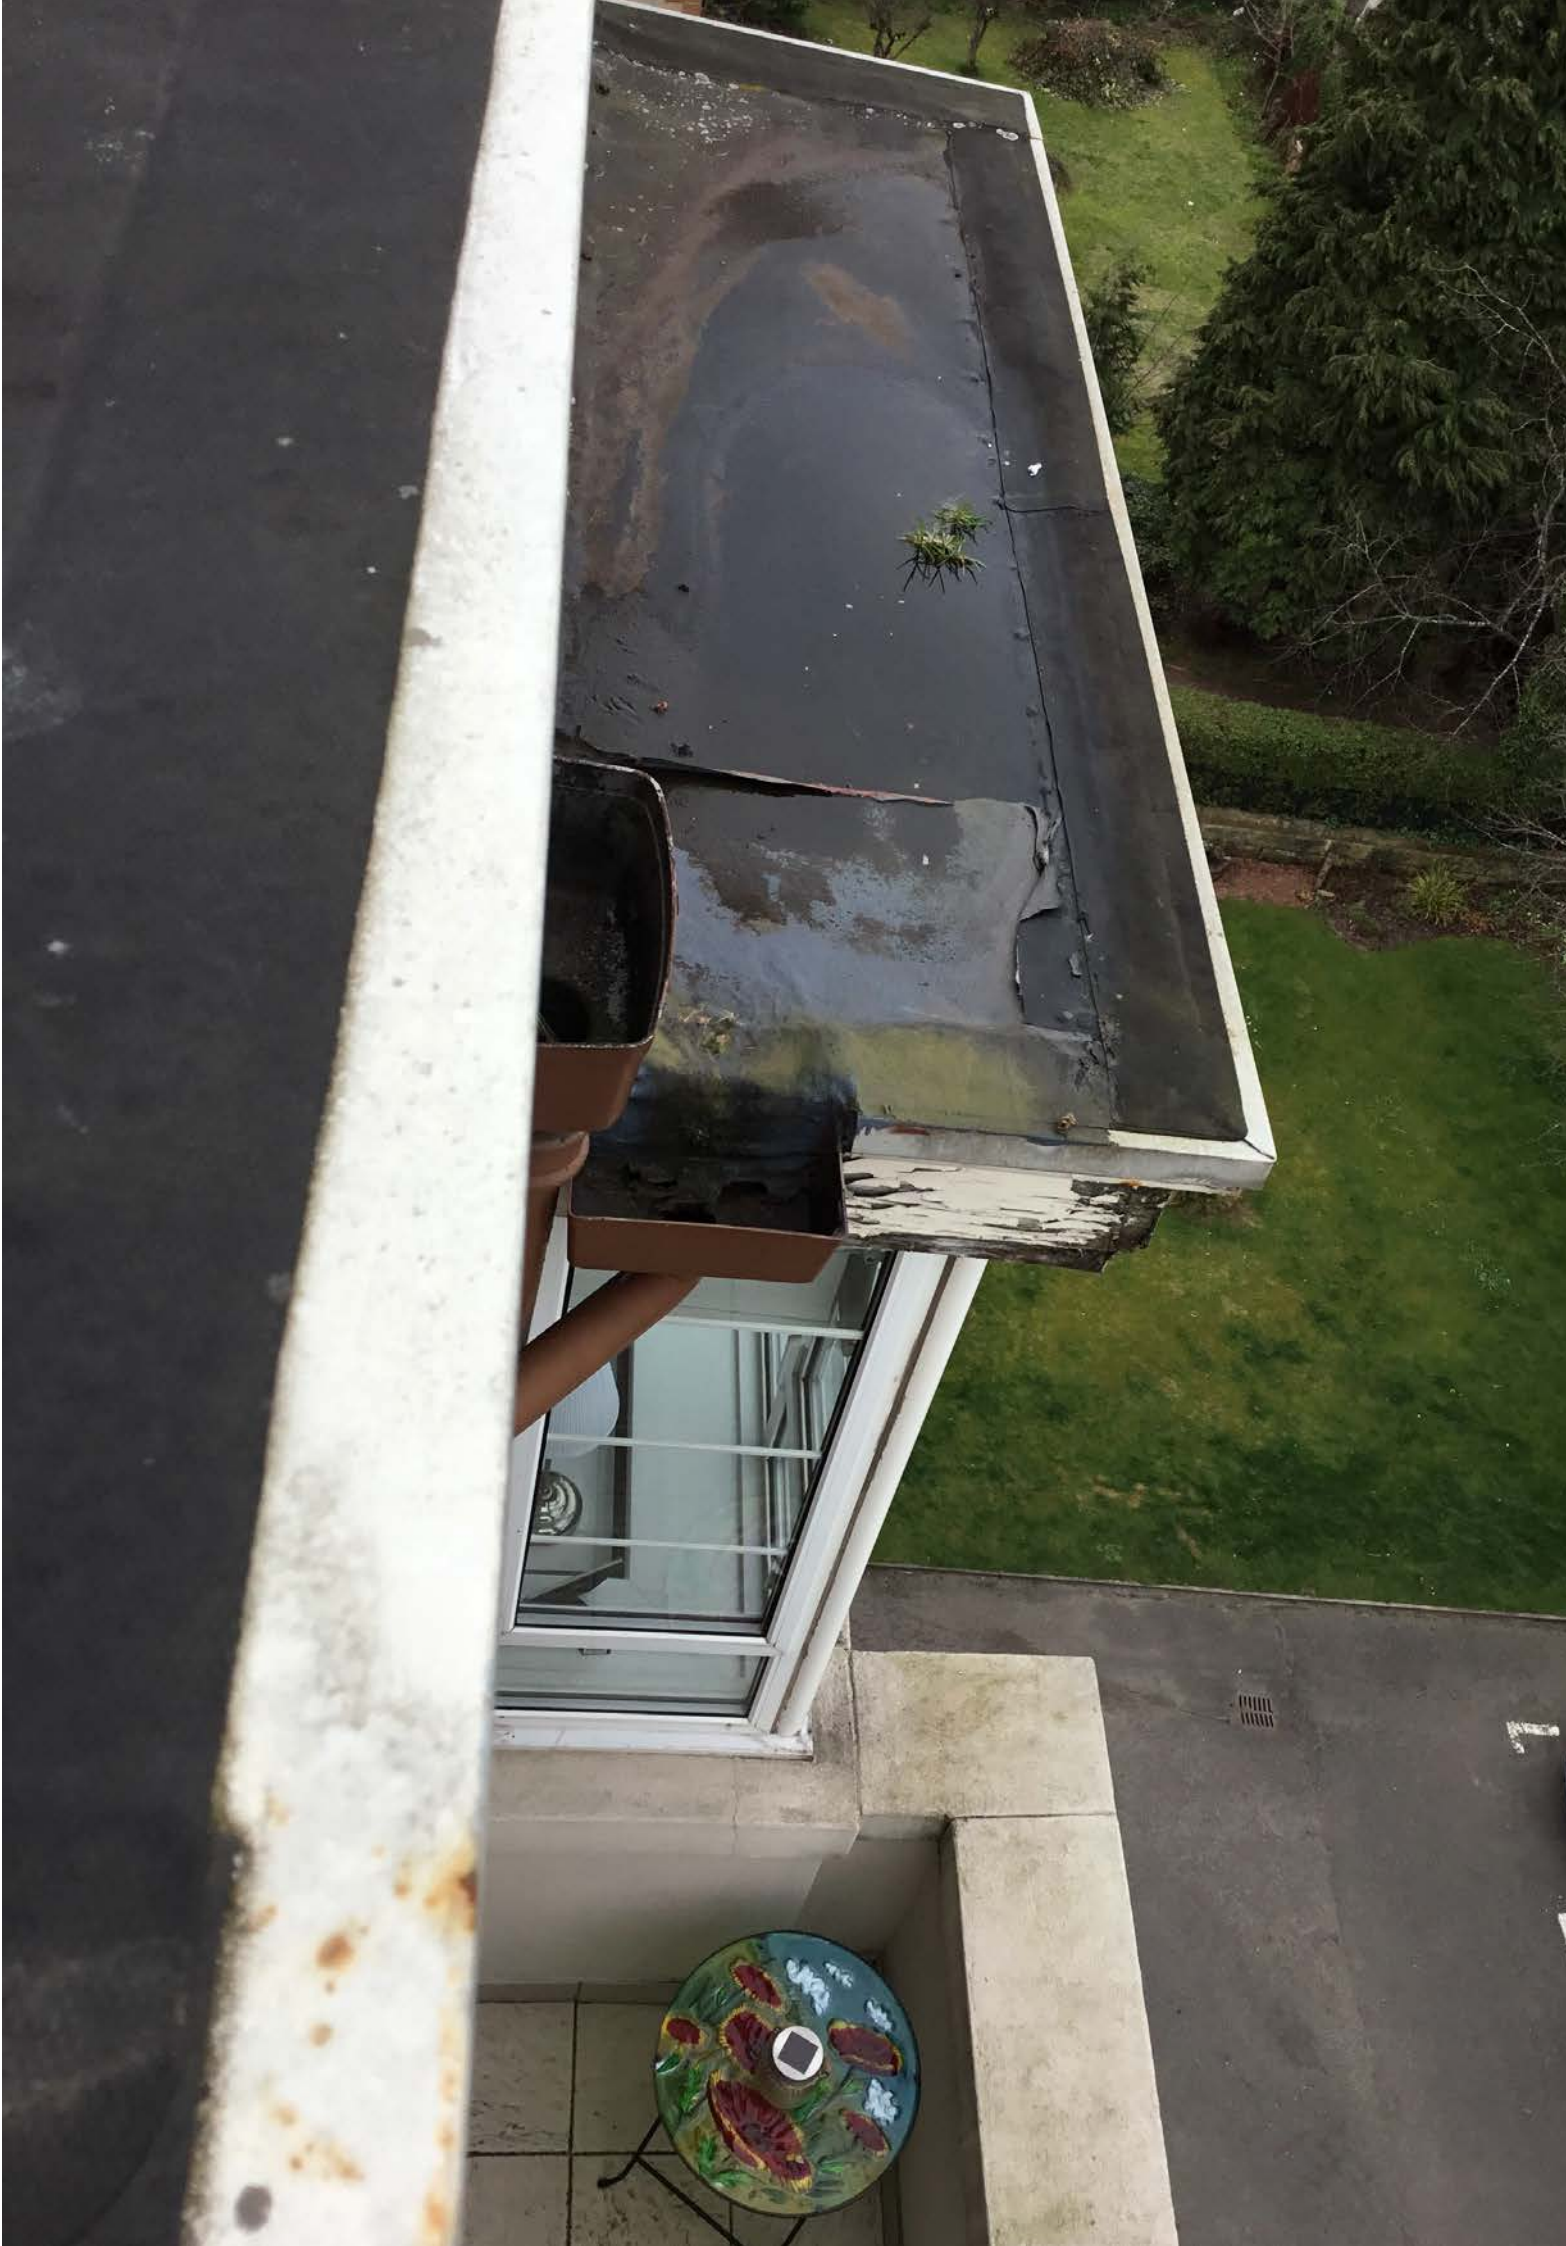
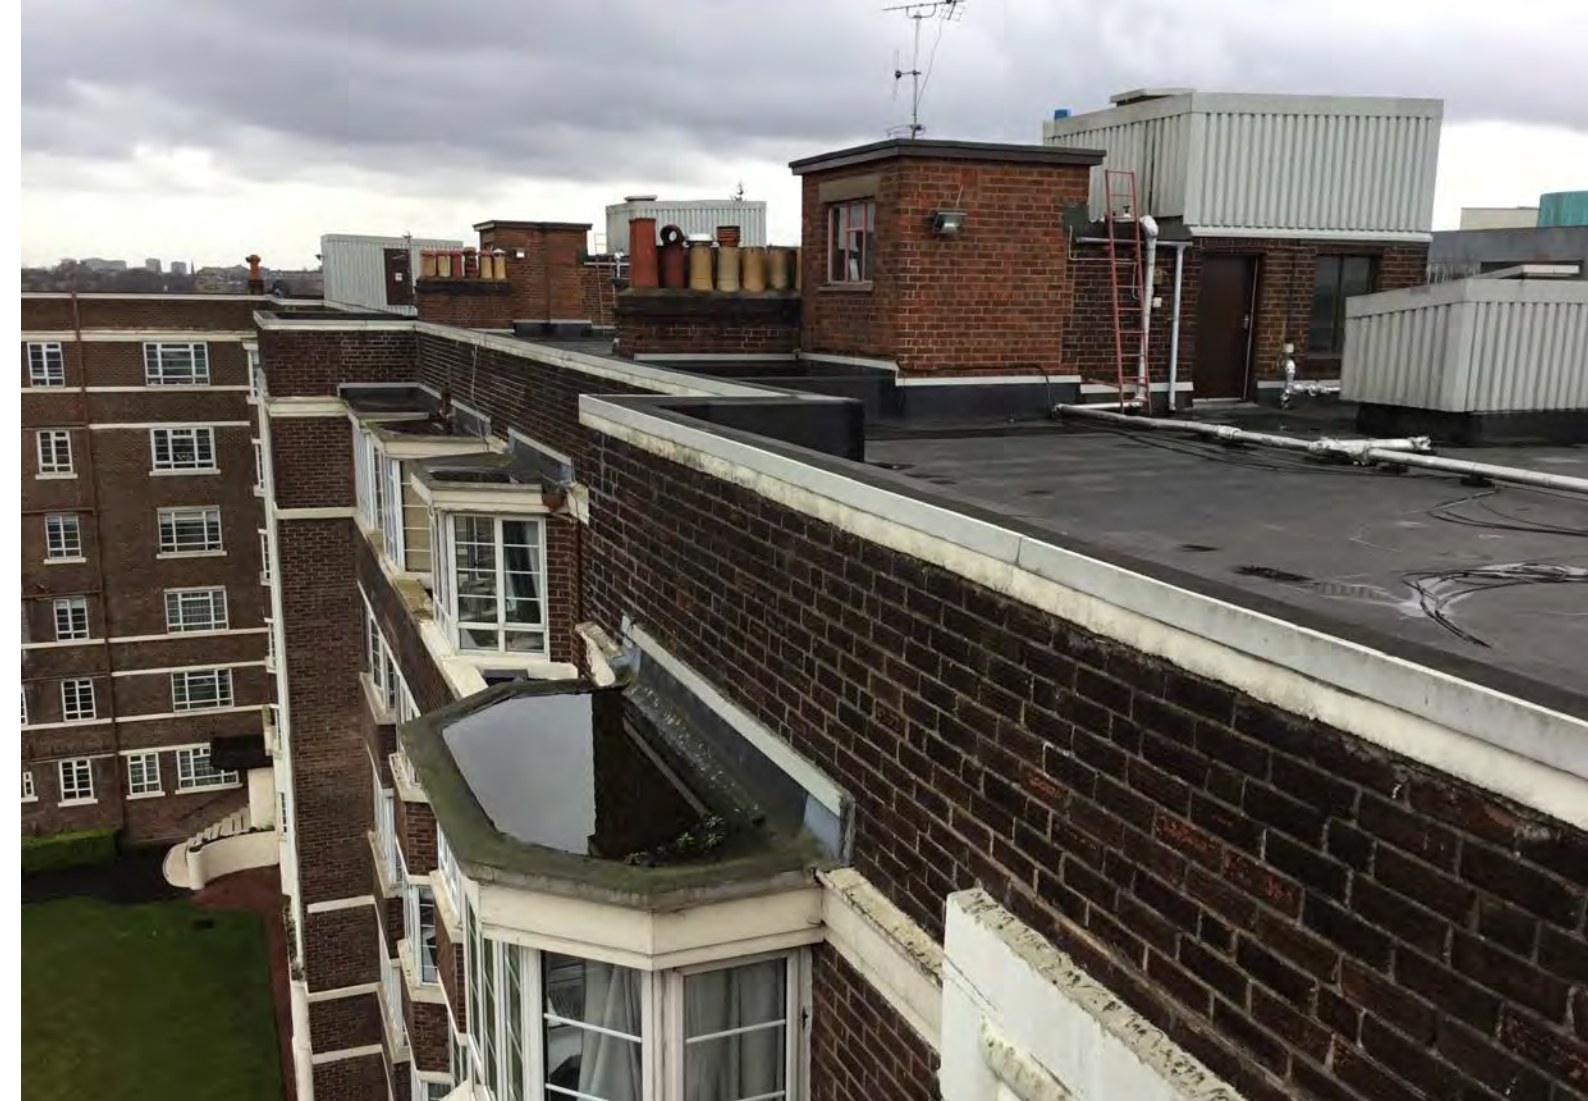
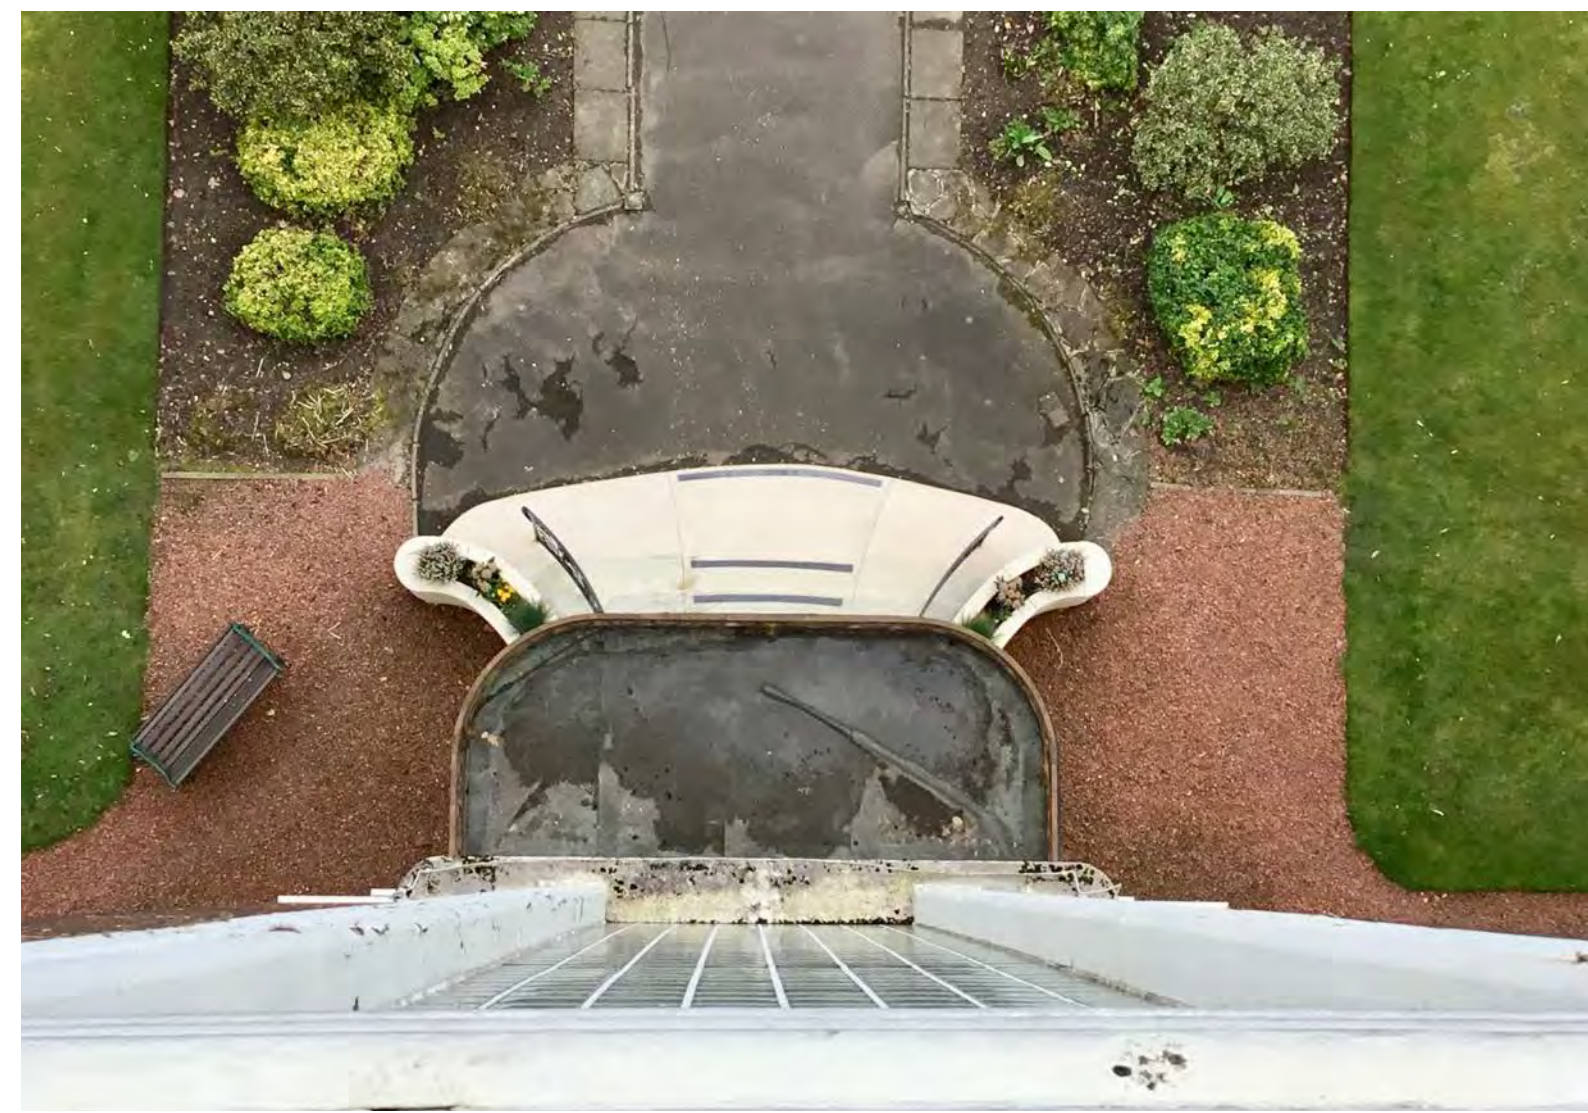
Clockwise from top left: water tank with open hatch, creating possibility of contamination: note algae build-up on roof and patching (© author); under-sized outlet untidily discharging into non-original hopper, also ponding on bay window roof and deteriorating fascia (© author); typical roof arrangement, which becomes especially cluttered in areas of stairwell roofs and lift motor rooms - maintenance of the elevations requires a ballasted hoist system (in blue) (© author); widespread ponding occurs at outlets after rainfall (© author).
