KELVIN COURT, GREAT WESTERN ROAD,
GLASGOW
CONSERVATION NARRATIVE

April 2019

INSPECTIONS

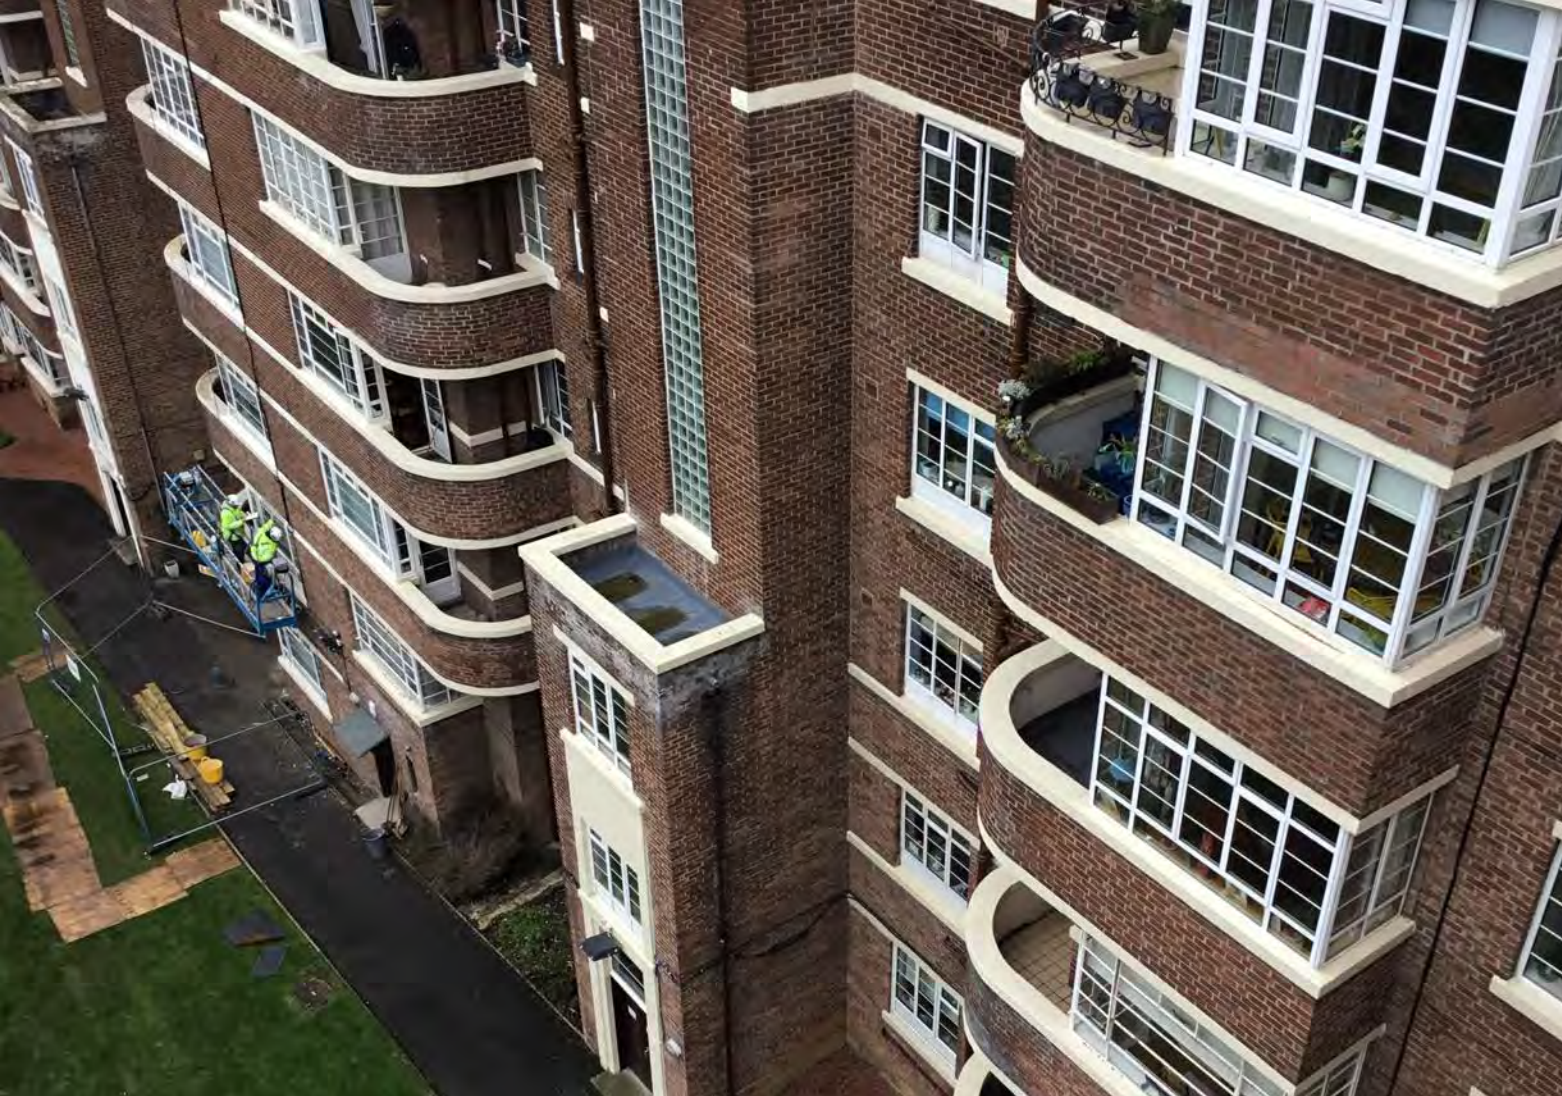
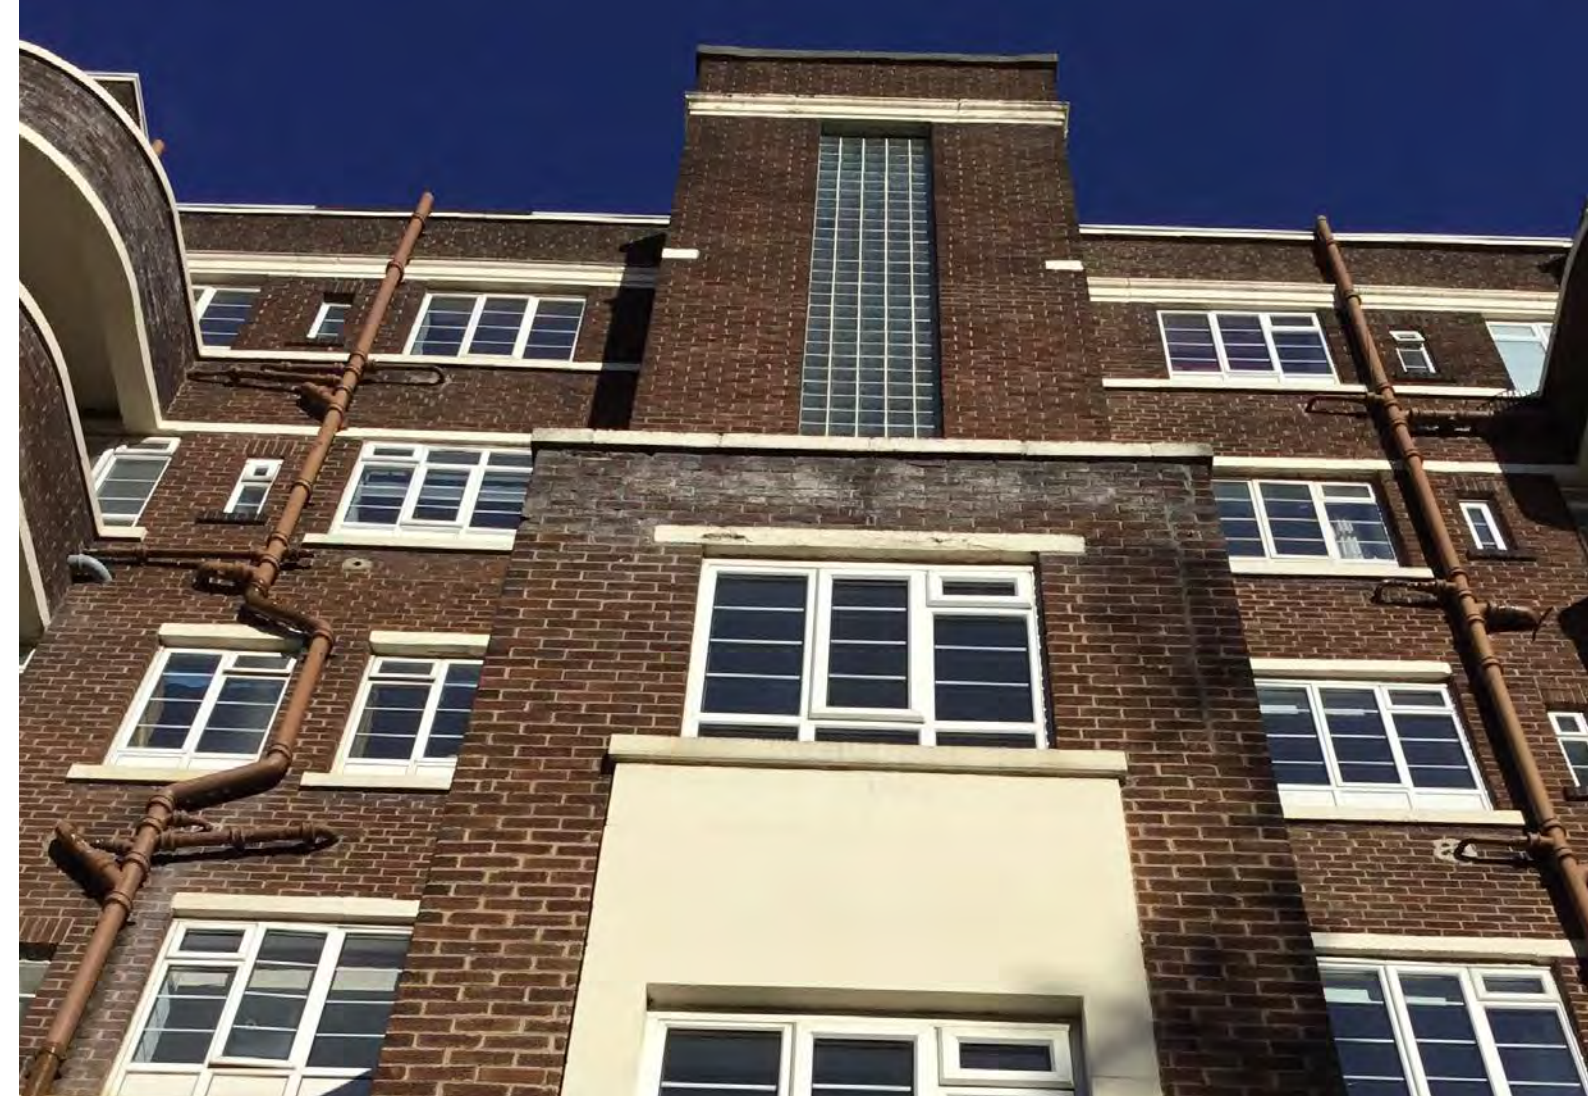
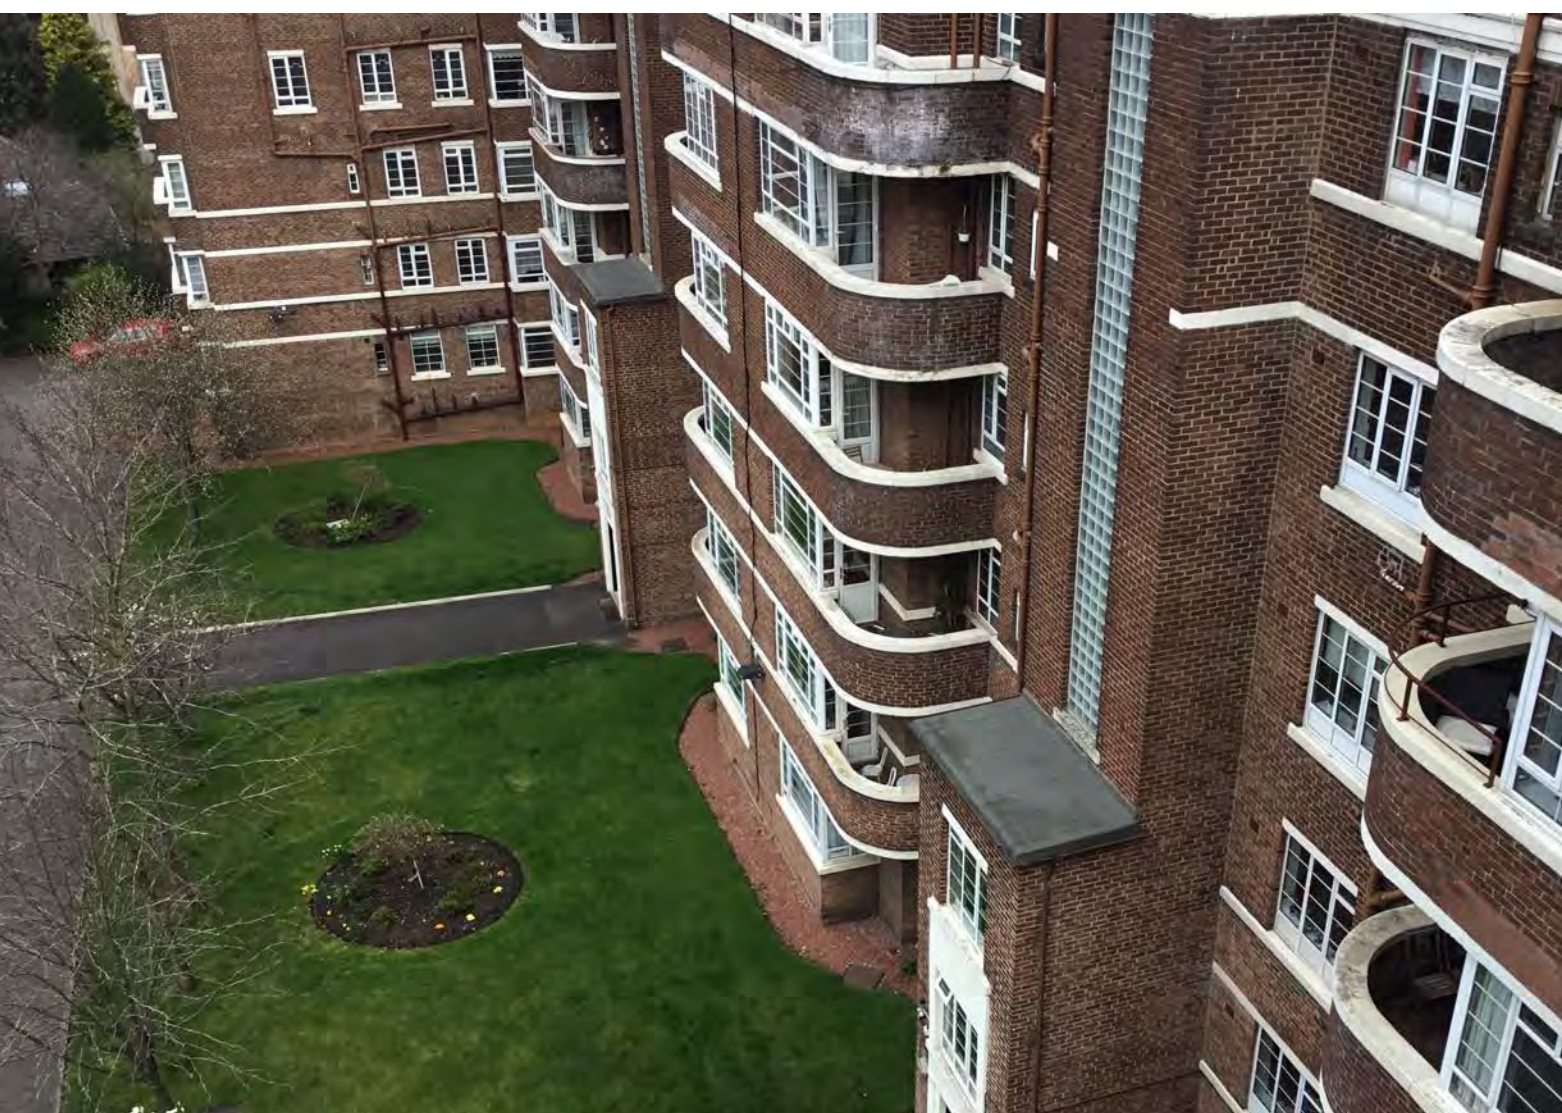
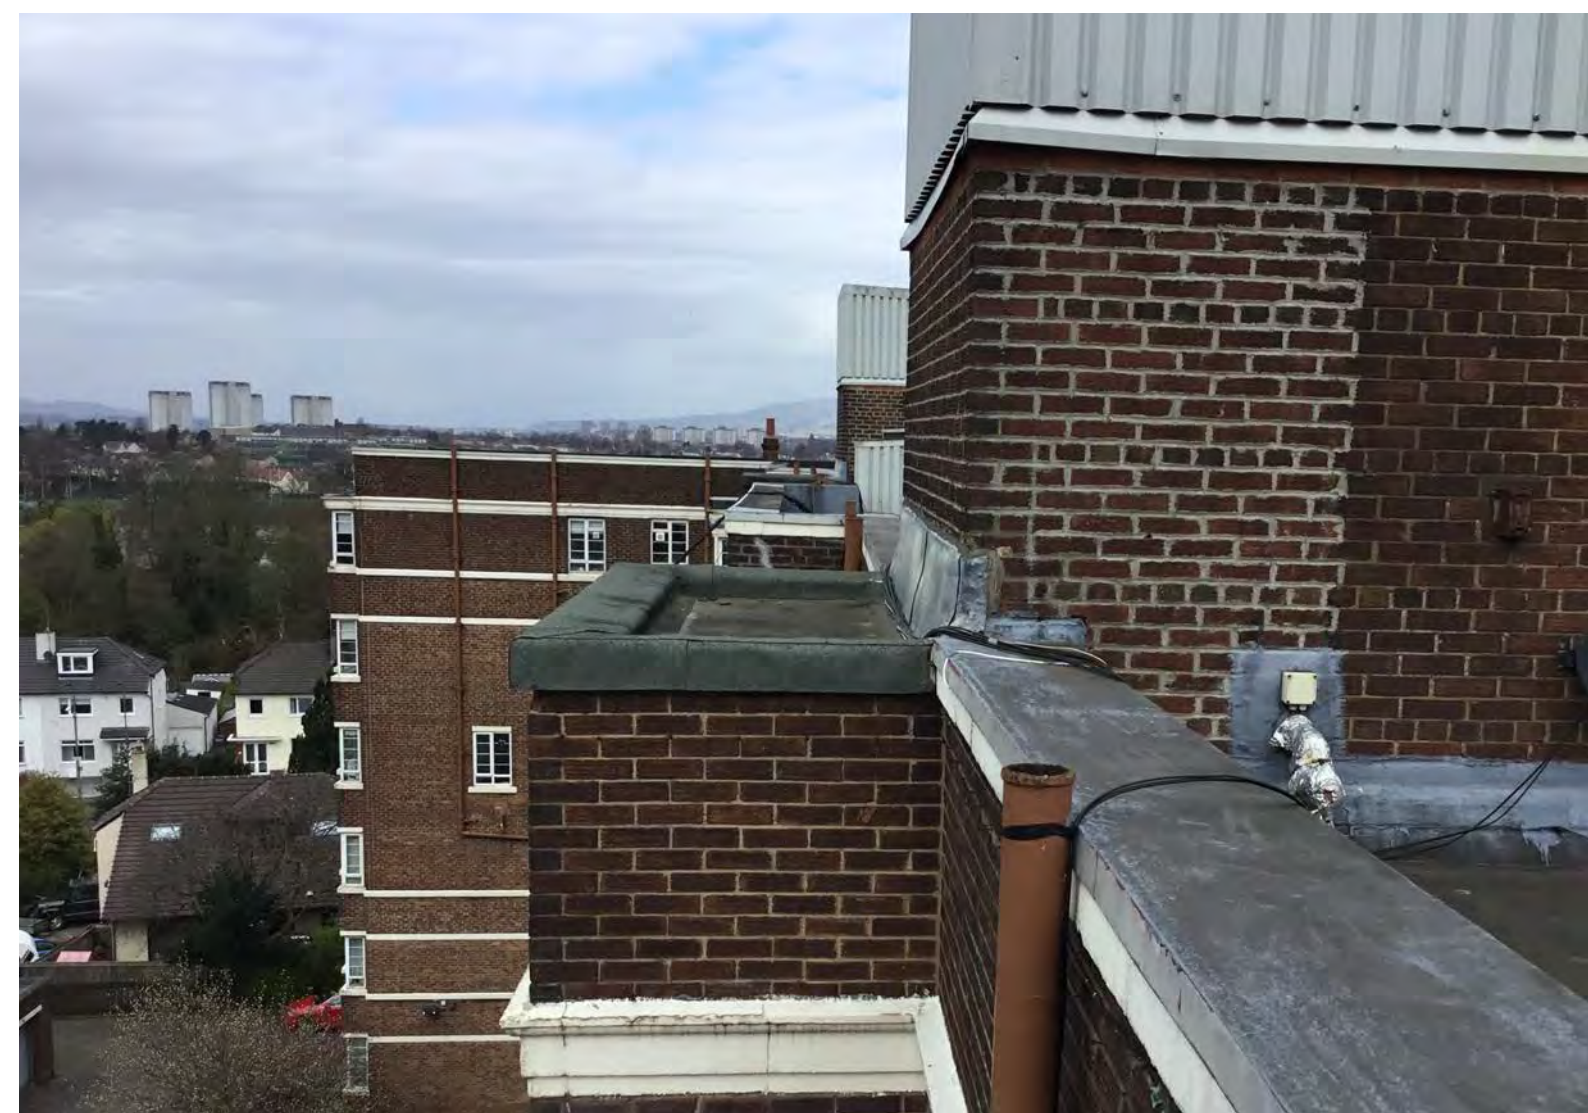
Clockwise from left: bay window roof showing typical deterioration - poor membrane finish and defective fascia, as well as non-original plastic hoppers (© author); ponding on bay window roofs is common (© author); the entrance canopy roofs do not drain well and seem to have old lighting conduit under the roof membrane (© author).

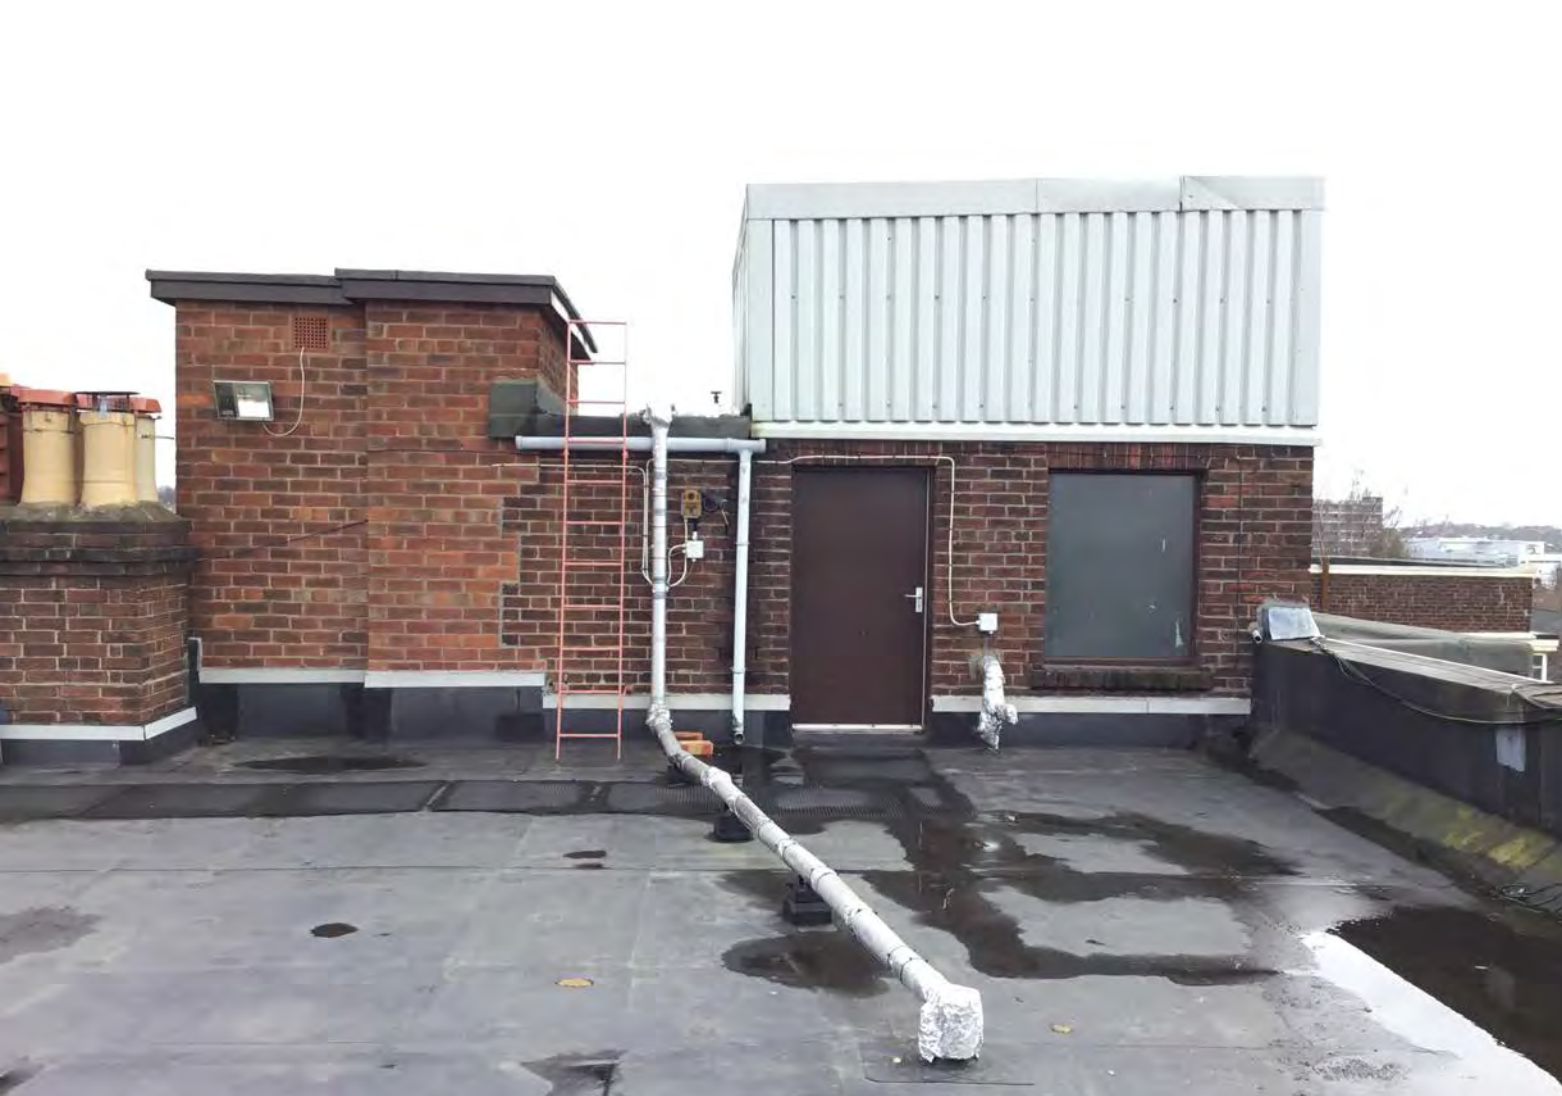
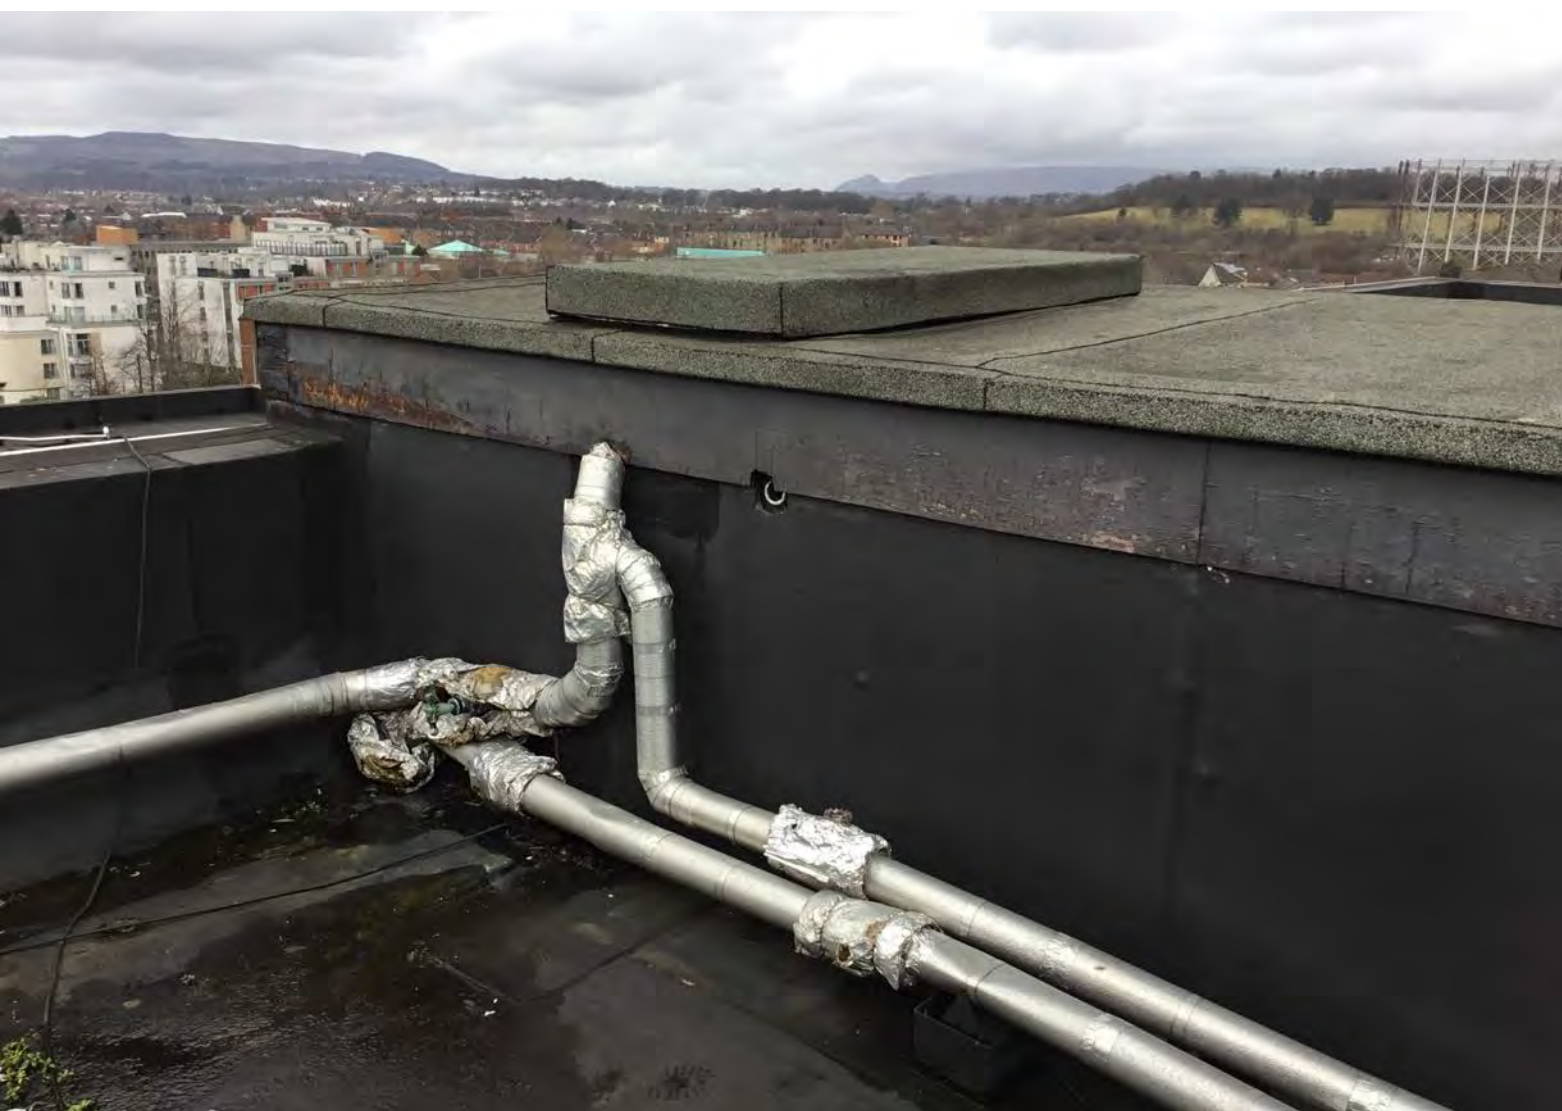
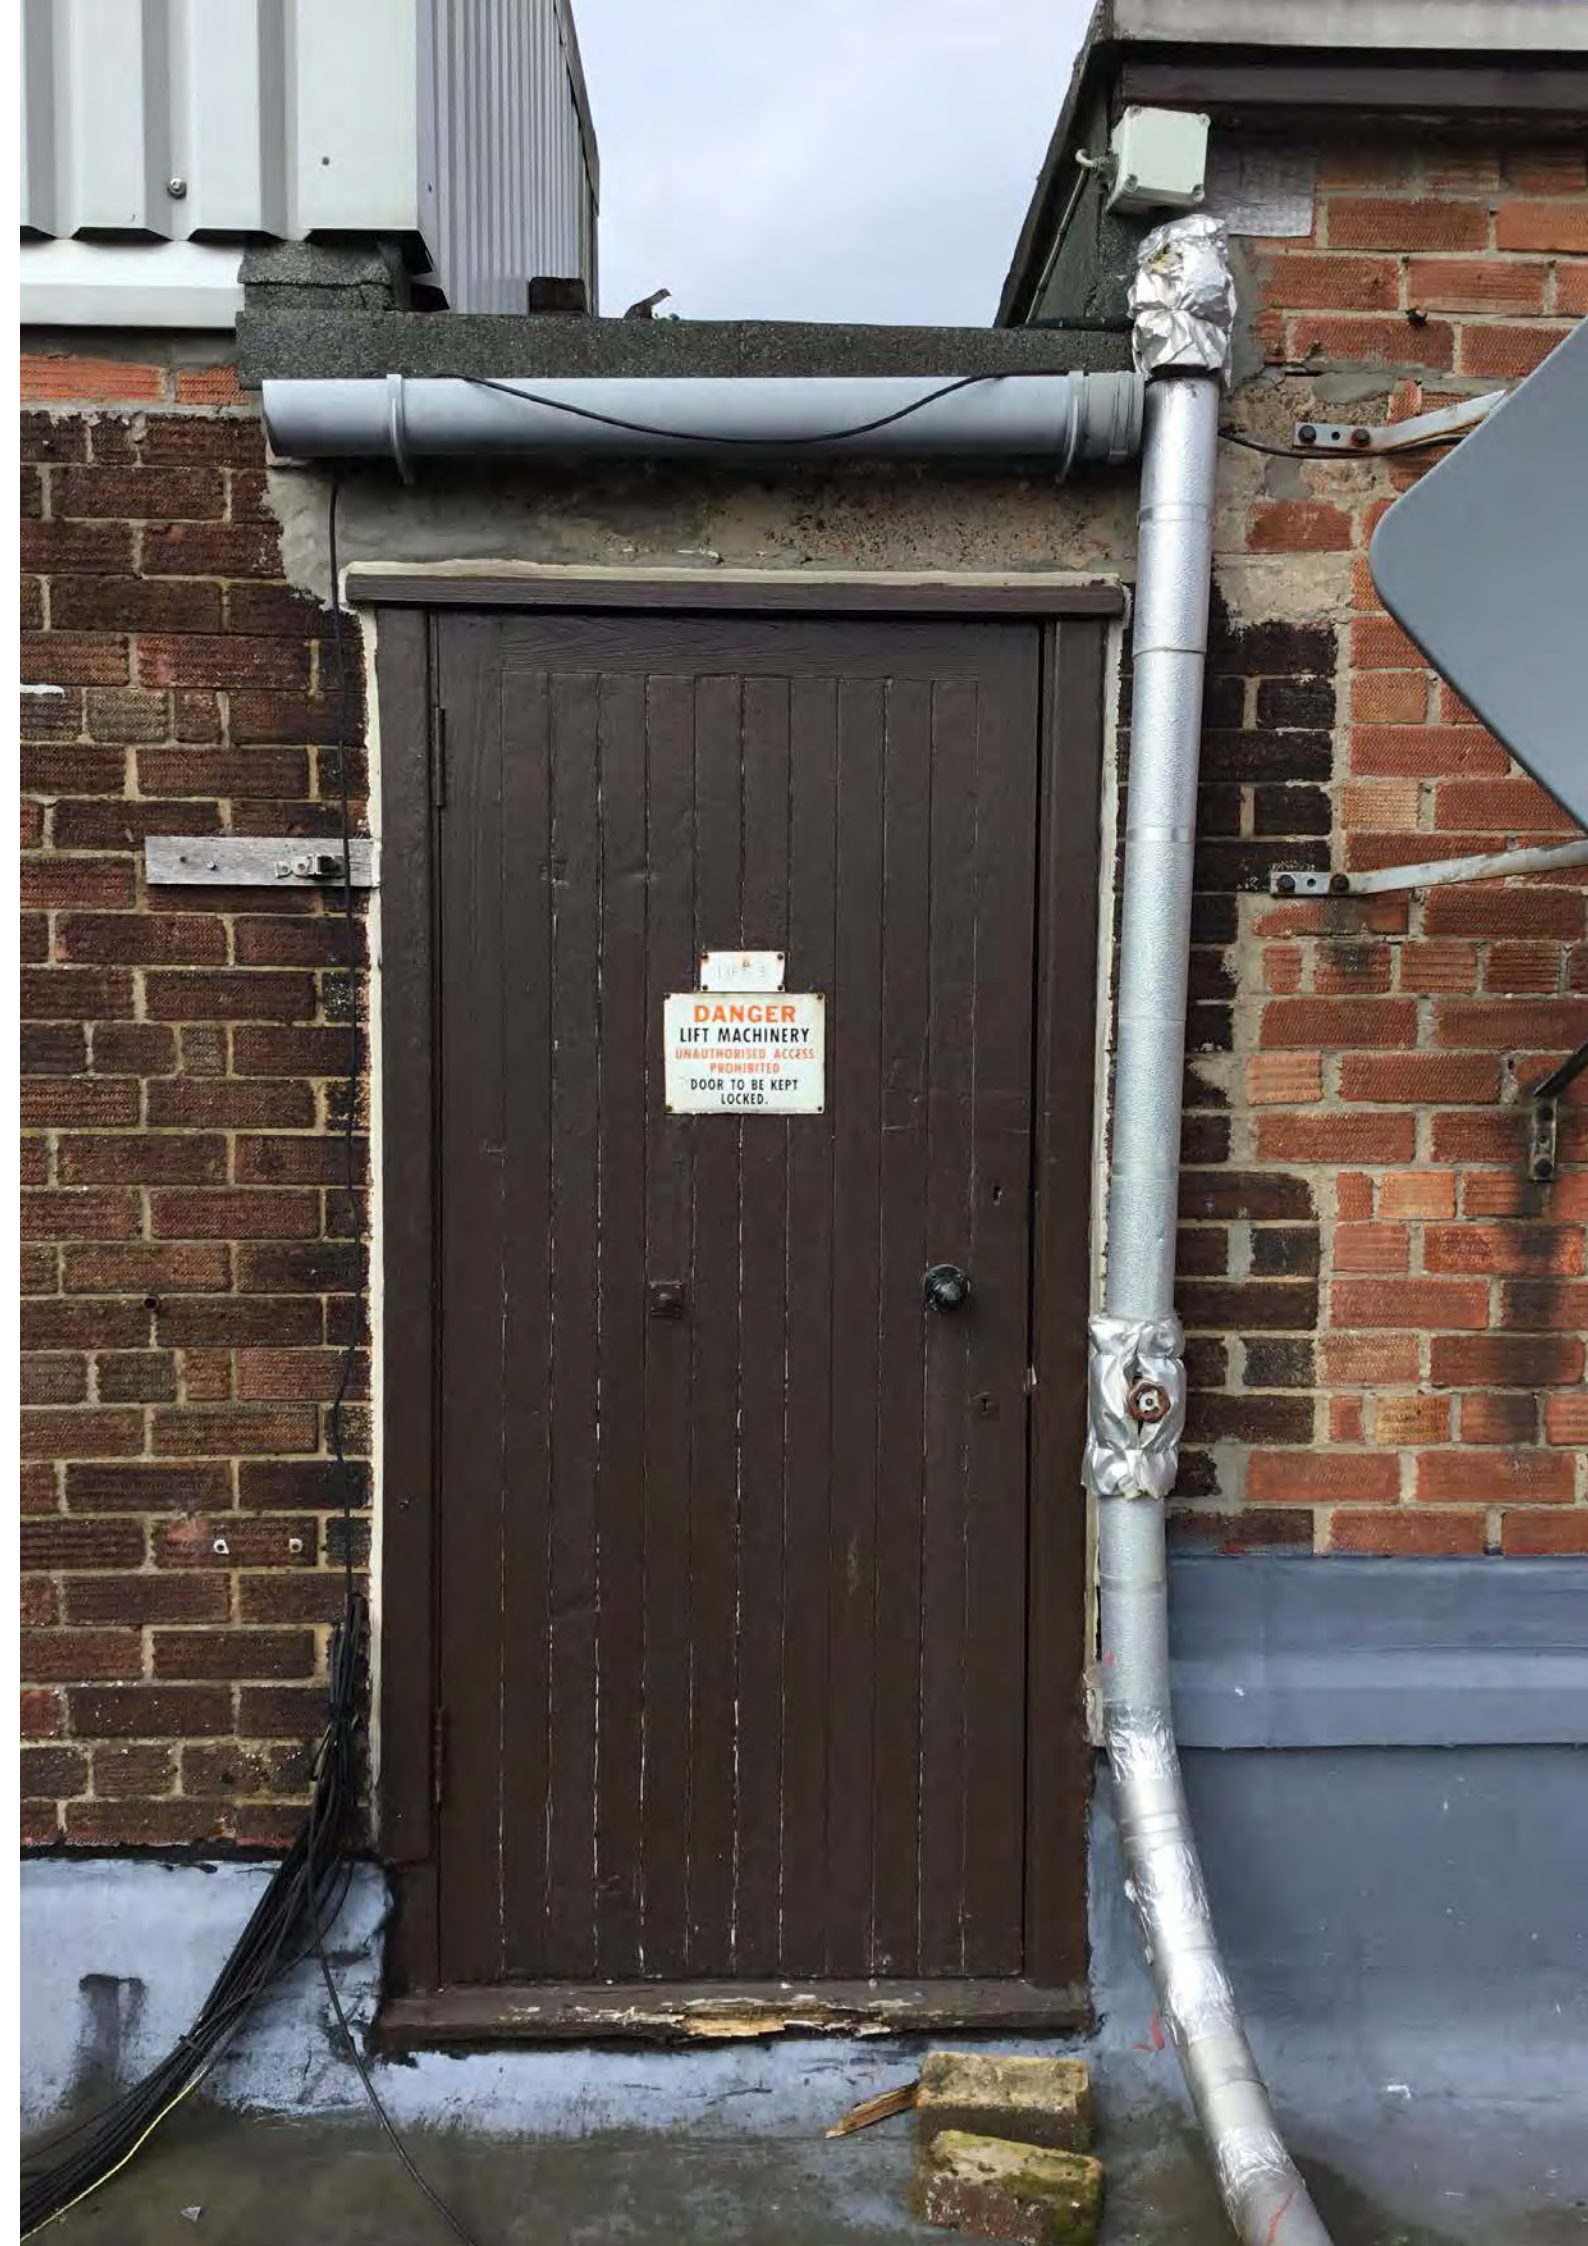
Clockwise from top left: on the east block, the lower rear stairwell roofs have parapets (© author); the parapets may be admitting water - note efflorescence and corroding concrete window lintel (© author); the upper rear stairwell roofs are clumsily covered in felt (and drain badly) (© author); the west block lower rear stairwell roofs have been simplified (although not the side stair roofs) (© author).

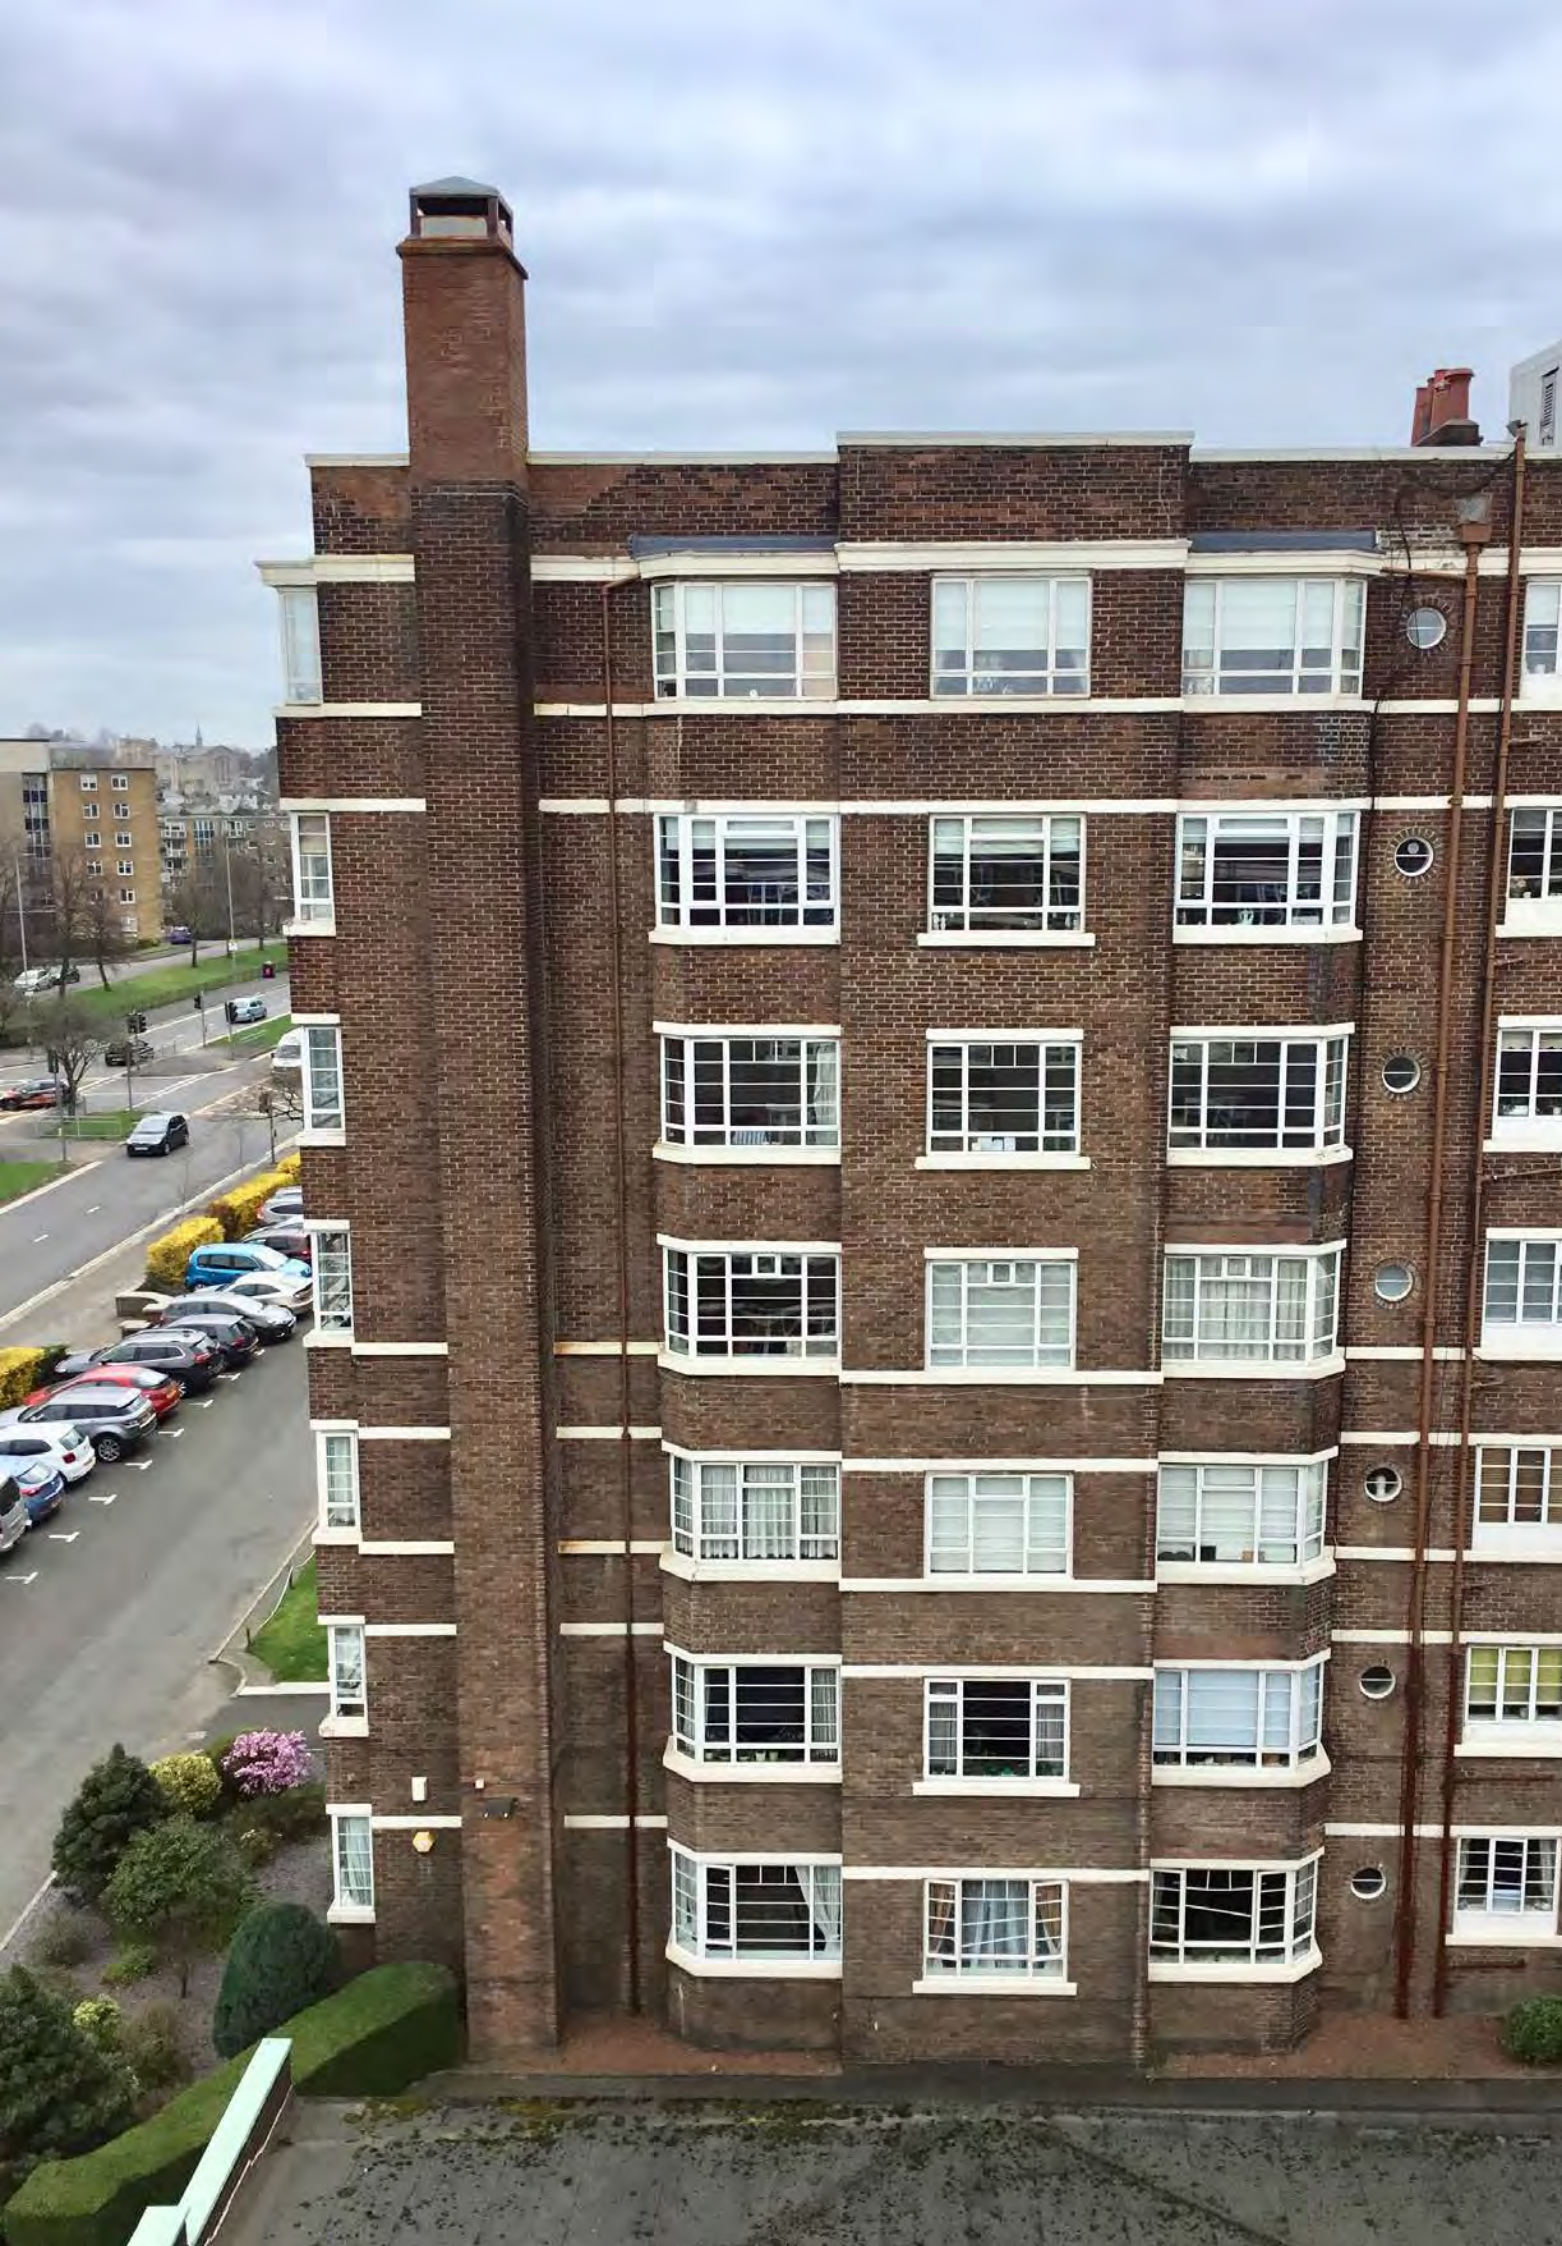
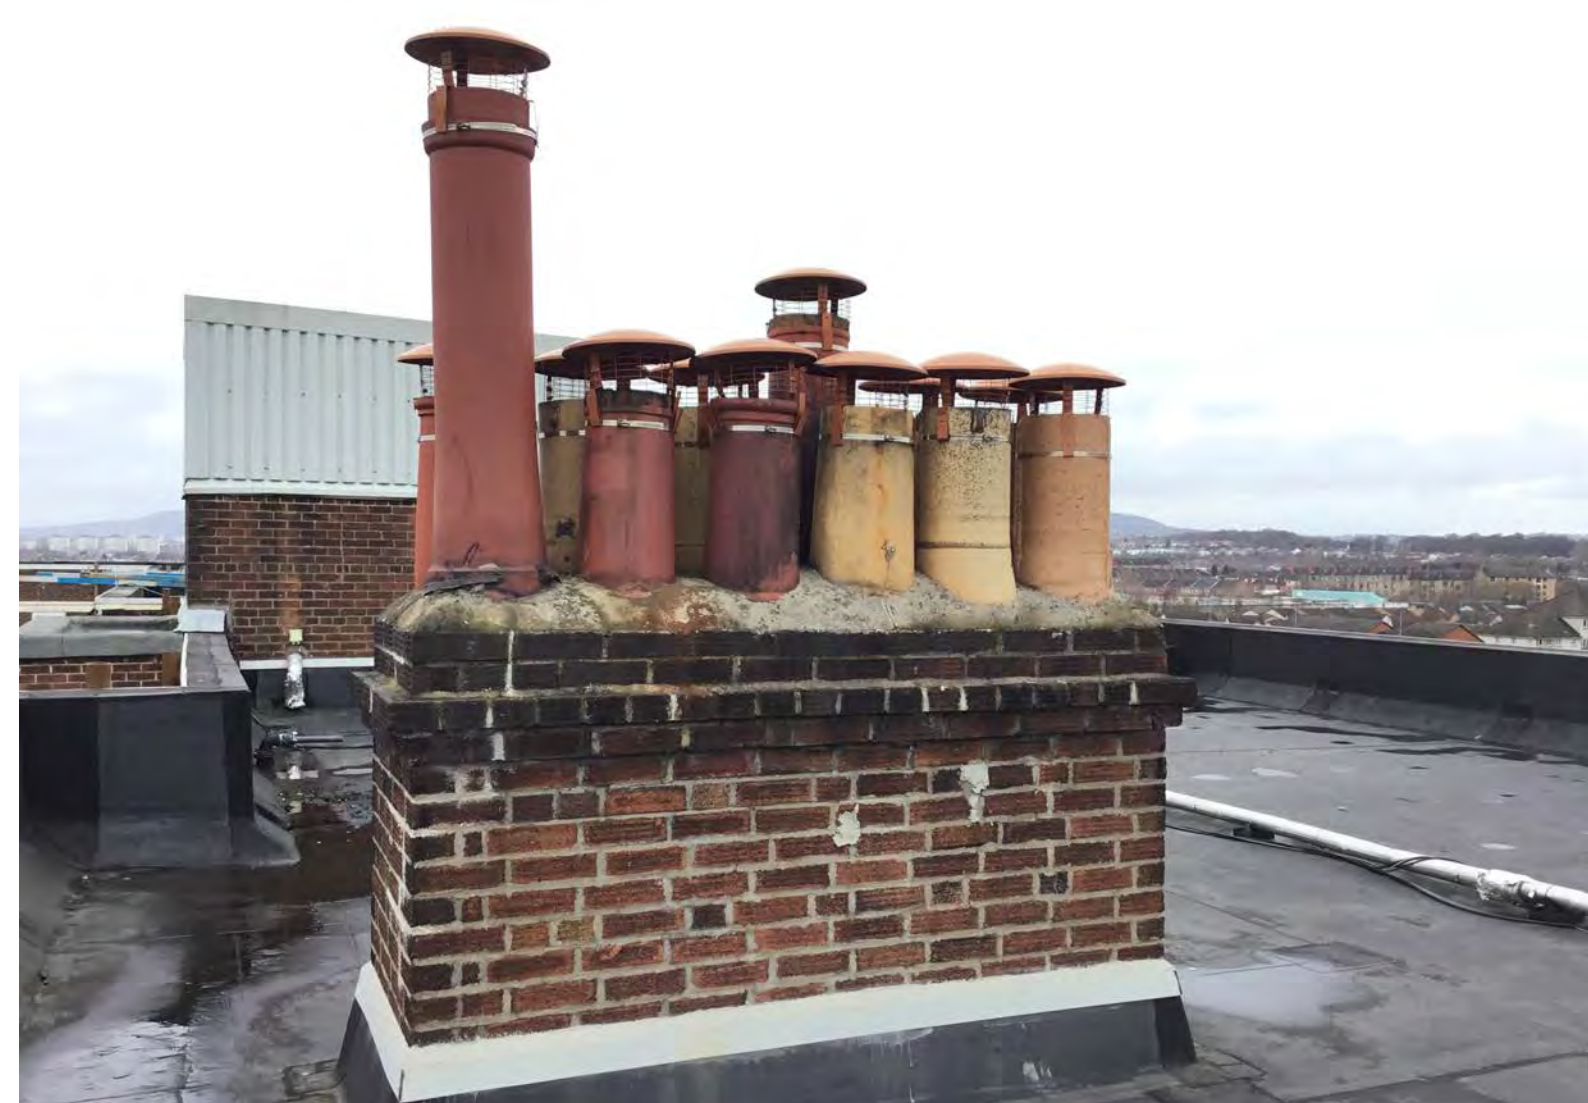
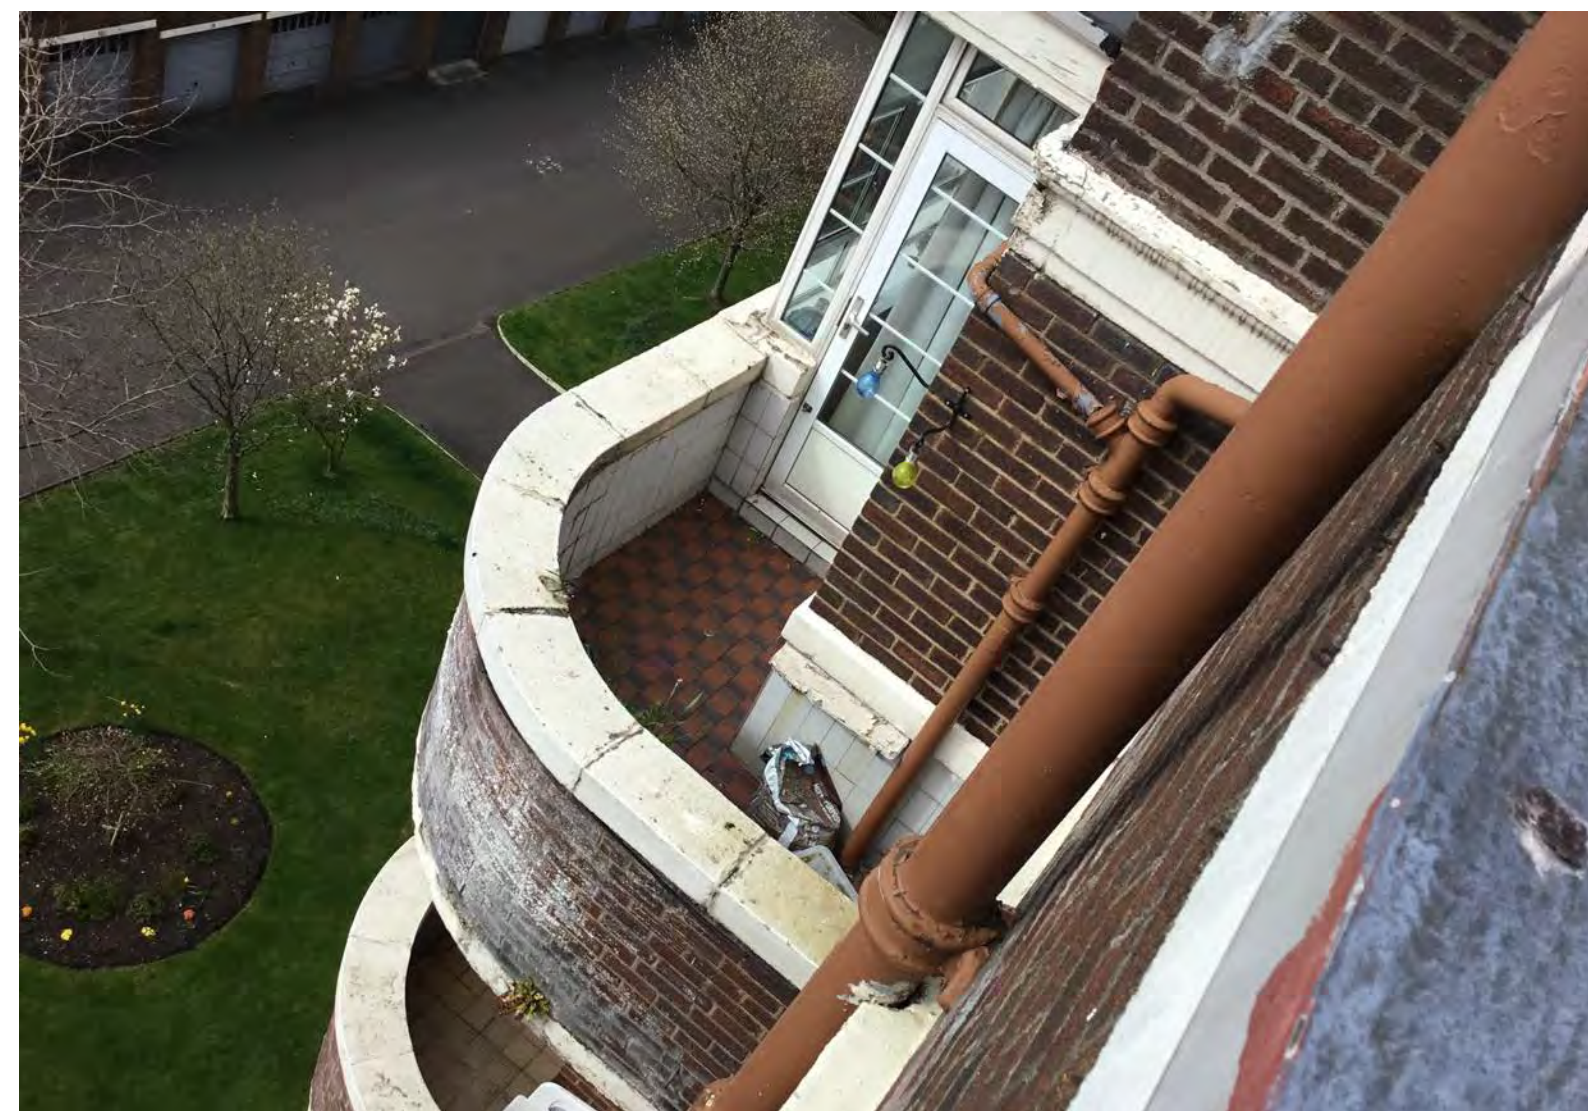
Clockwise from top left: the principal water tanks sit above the rear stairwells (© author); typical rooftop defects include rotting door timbers, cracks in mismatched brick, missing rainwater pipes, rusting satellite dish bolts, untidy pipework and patches to membrane (© author); the tank above the west stair on the east block may feed the boilers - it has a rotting fascia, untidy pipework and an overflow cut too short (© author).
