KELVIN COURT, GREAT WESTERN ROAD,
GLASGOW
CONSERVATION NARRATIVE

April 2019

INSPECTIONS

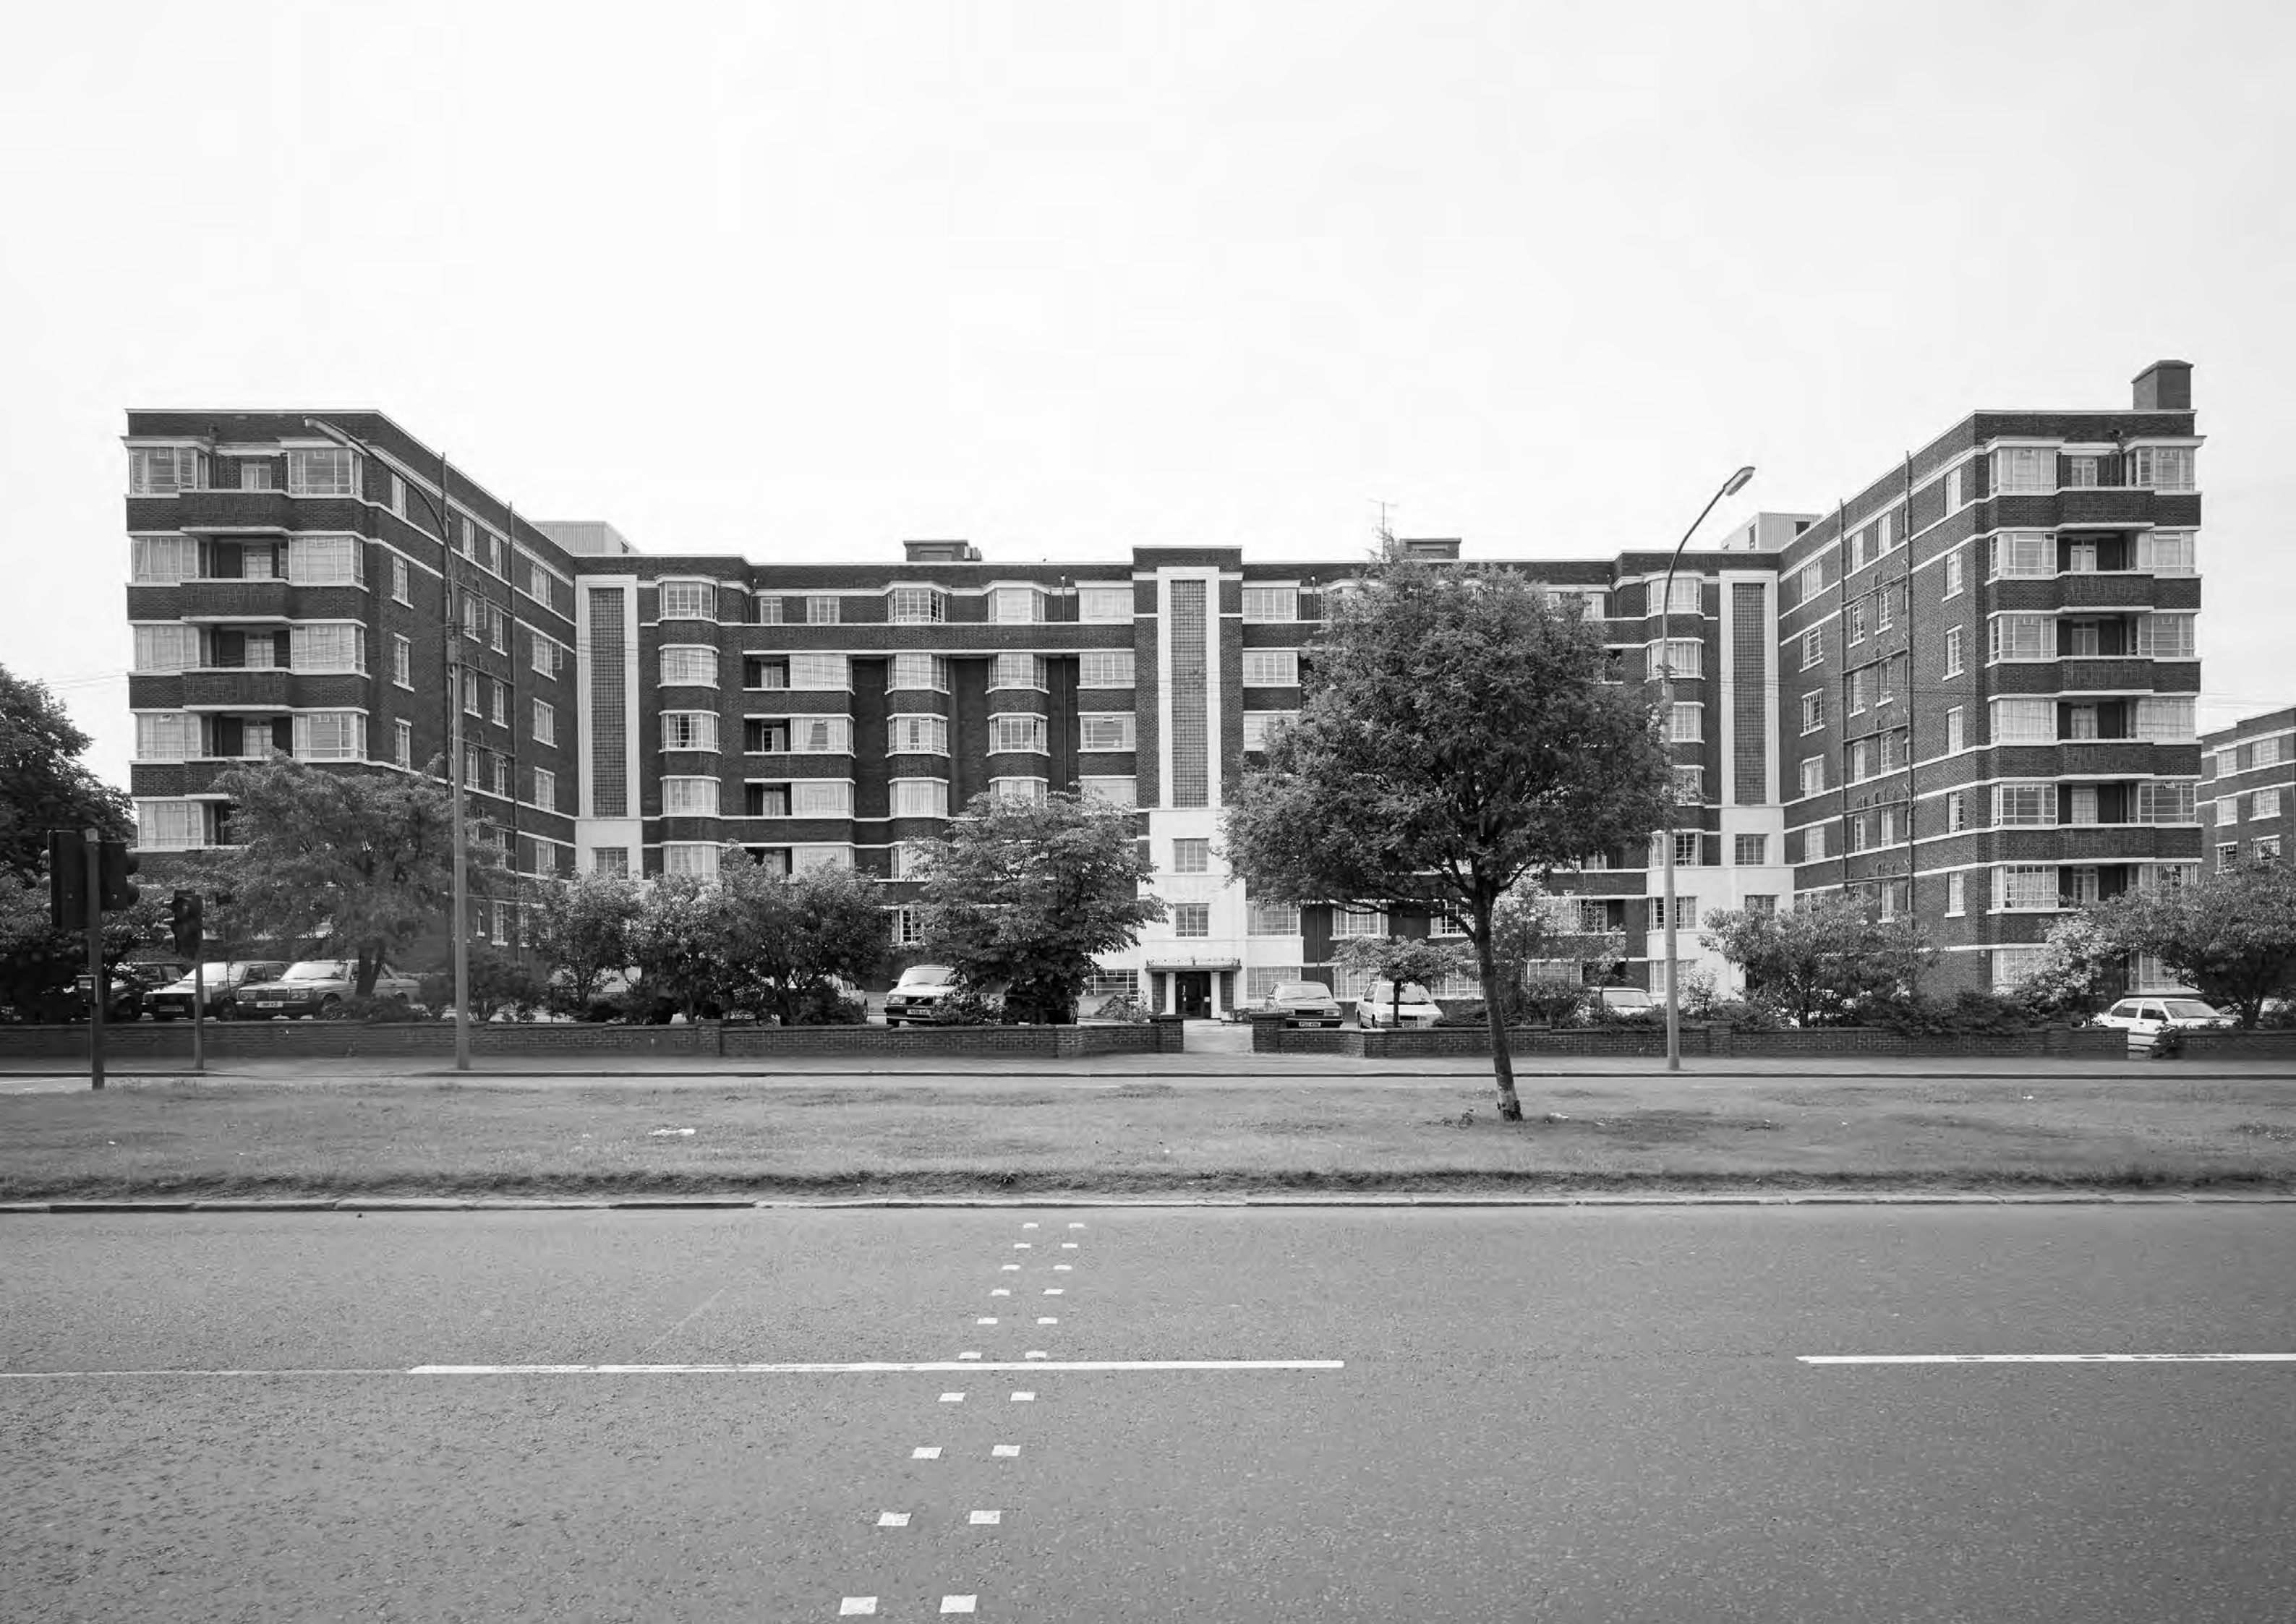
Clockwise from left: there are a number of instances of cavity tray installation that have required the removal of areas of brick - the replacement brick is not quite colour-matched (© author); underside of a balcony showing paint peeling from the concrete (© author); a poorly repaired balcony (or void) lined with a membrane simply turned up at the edges (© author).

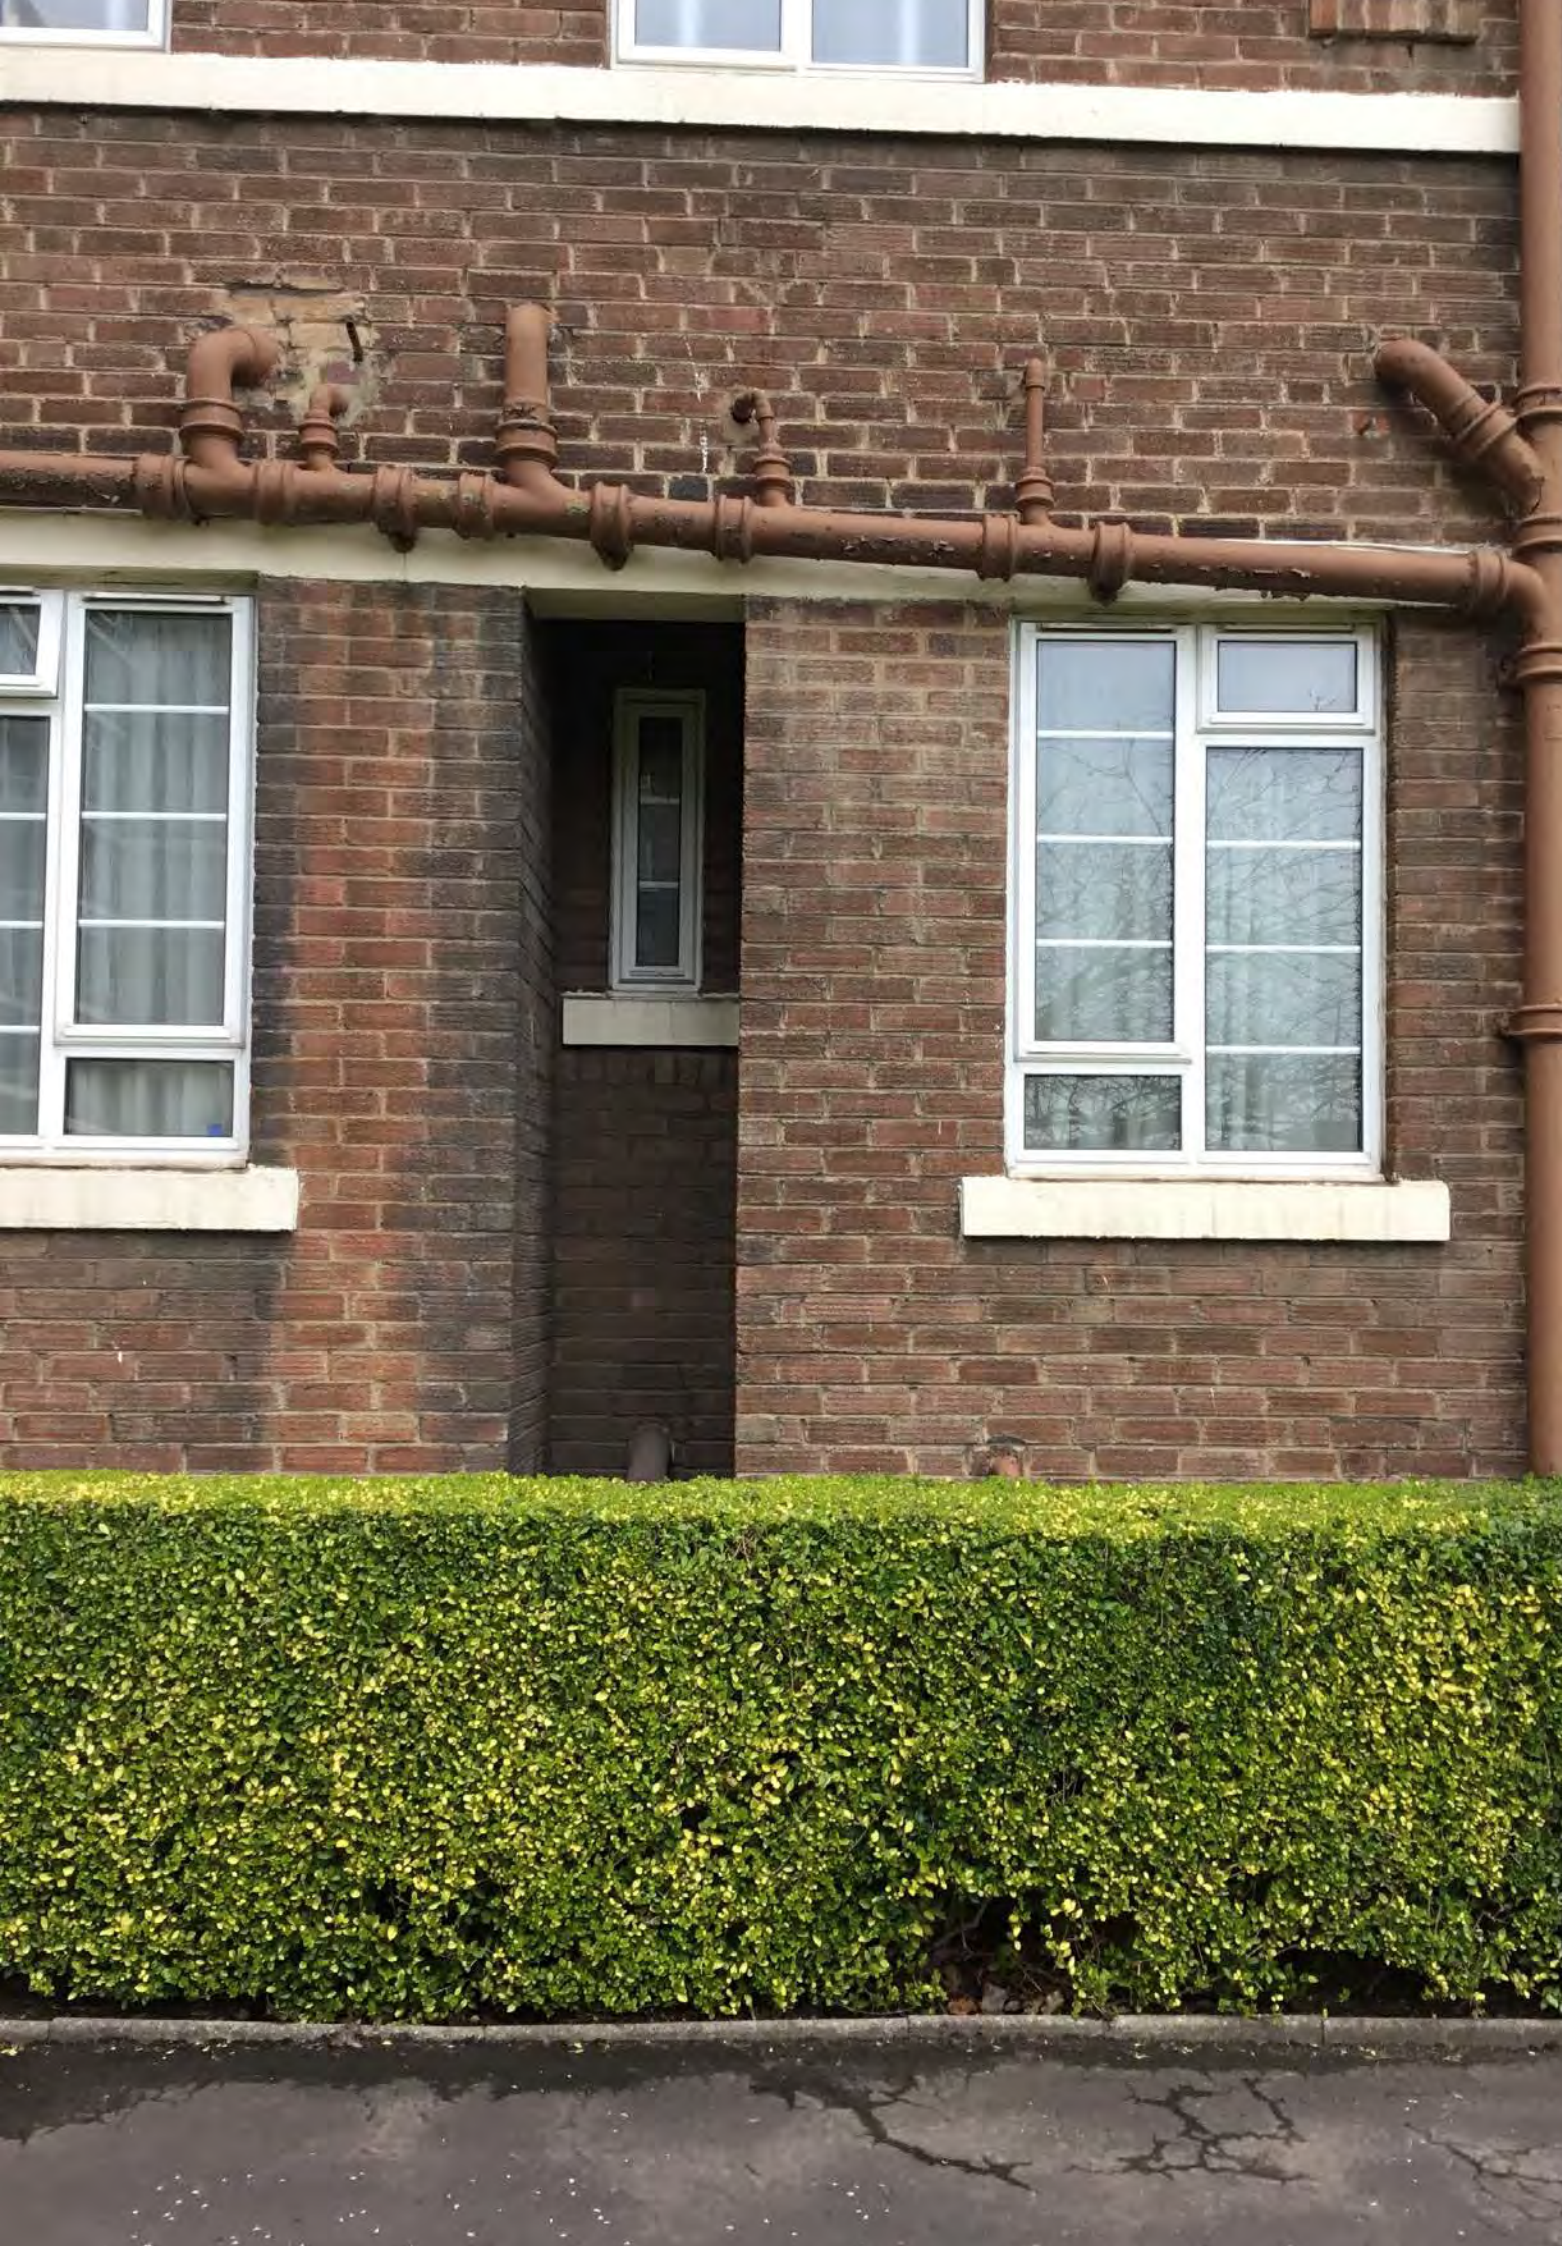
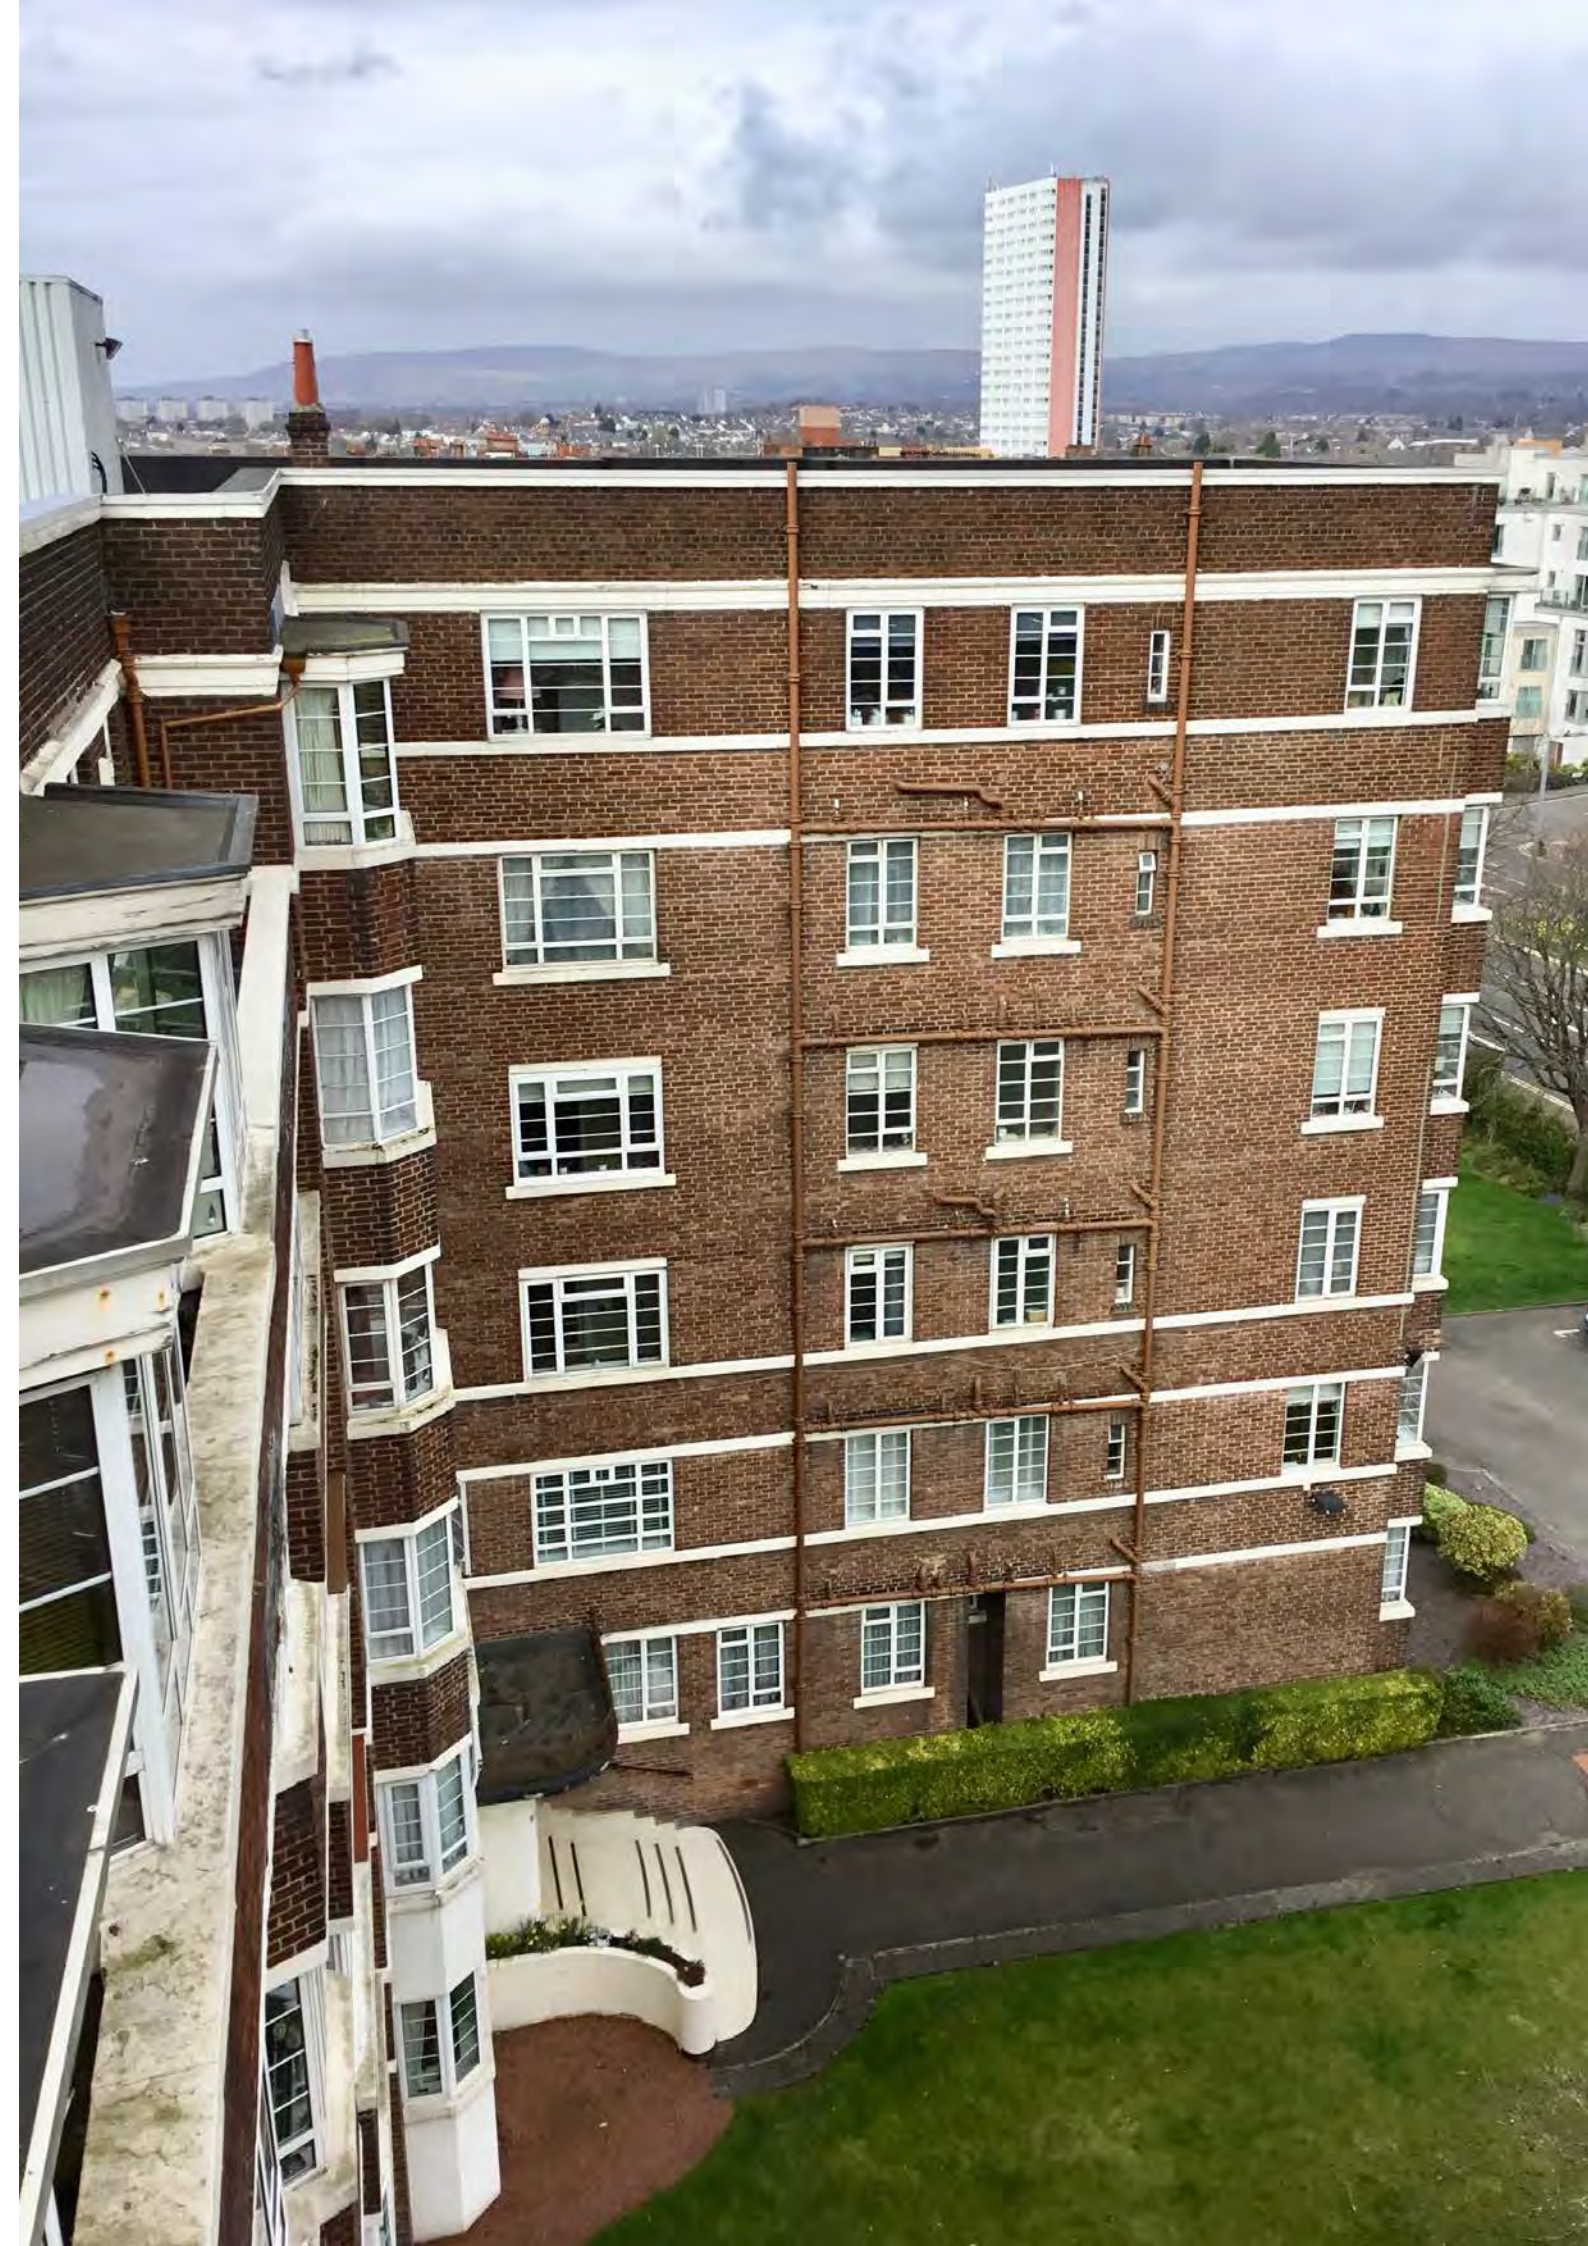
Clockwise from top left: there is a good deal of cracking that has been pointed but possibly without any analysis of cause (© author); cracking occurs in a range of locations: the pointing here is poorly applied (© author); cracking typically occurs at high corners (© author); beautiful porthole windows survive to a handful of apartments (© author); Crittall advertising sign as displayed in Historic Environment Scotland’s Engine Shed (© author).

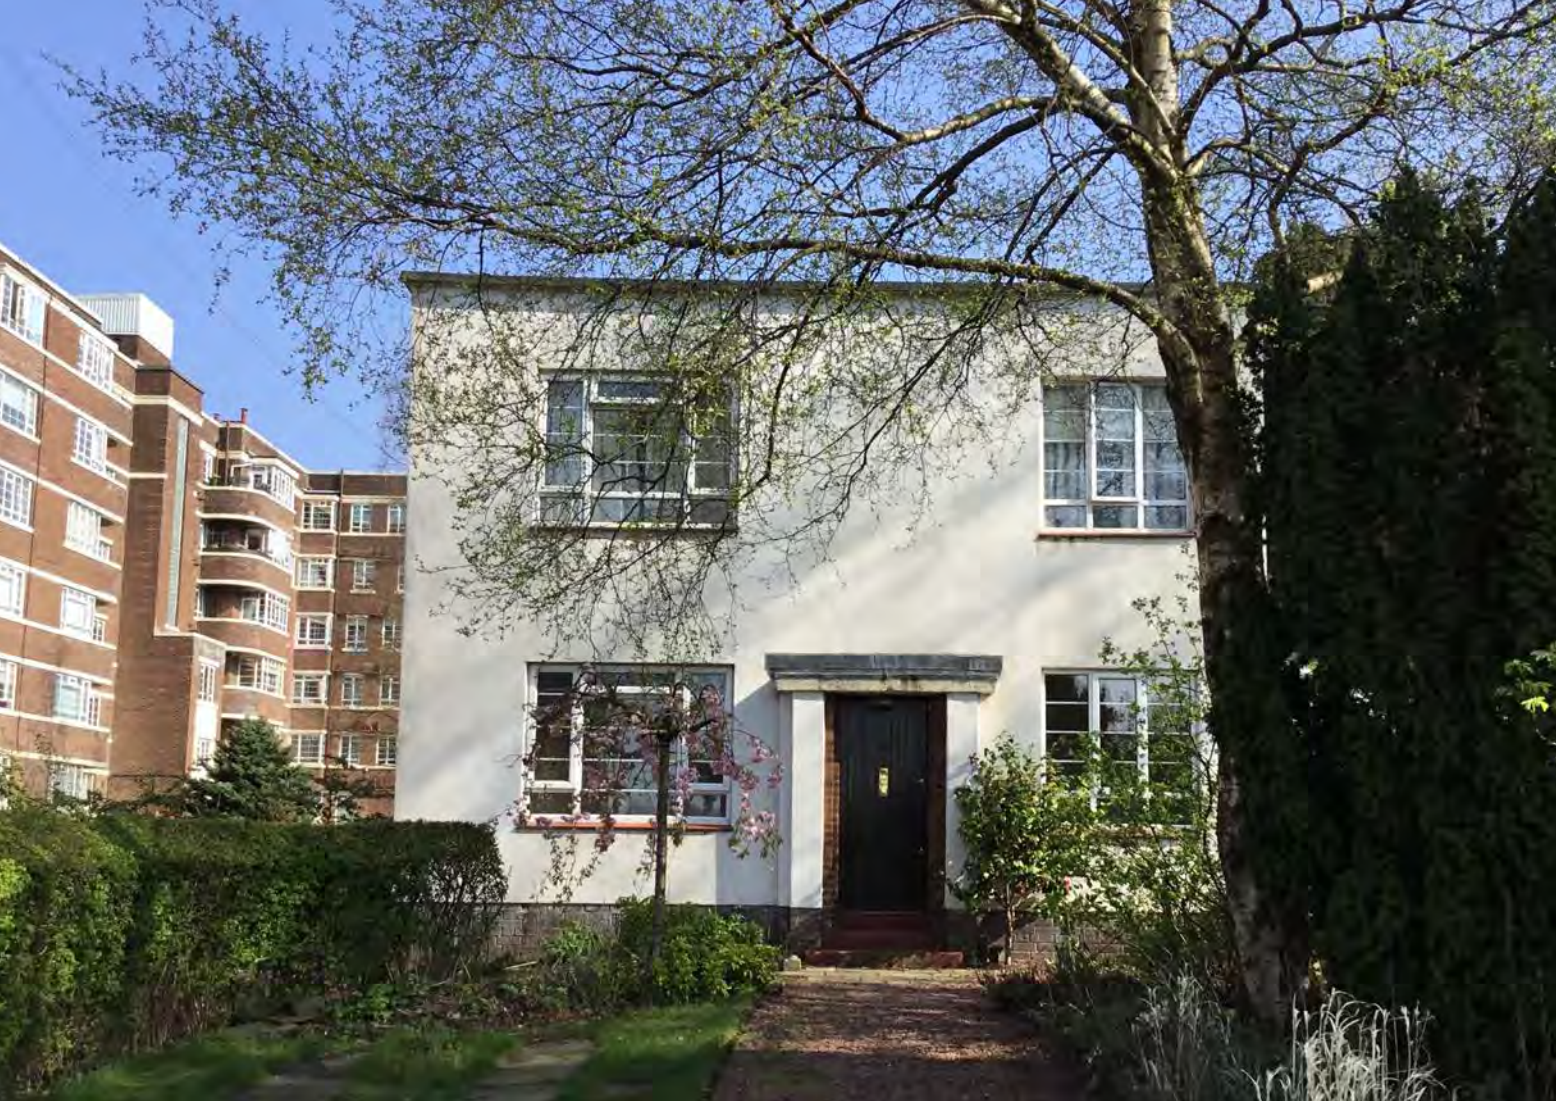
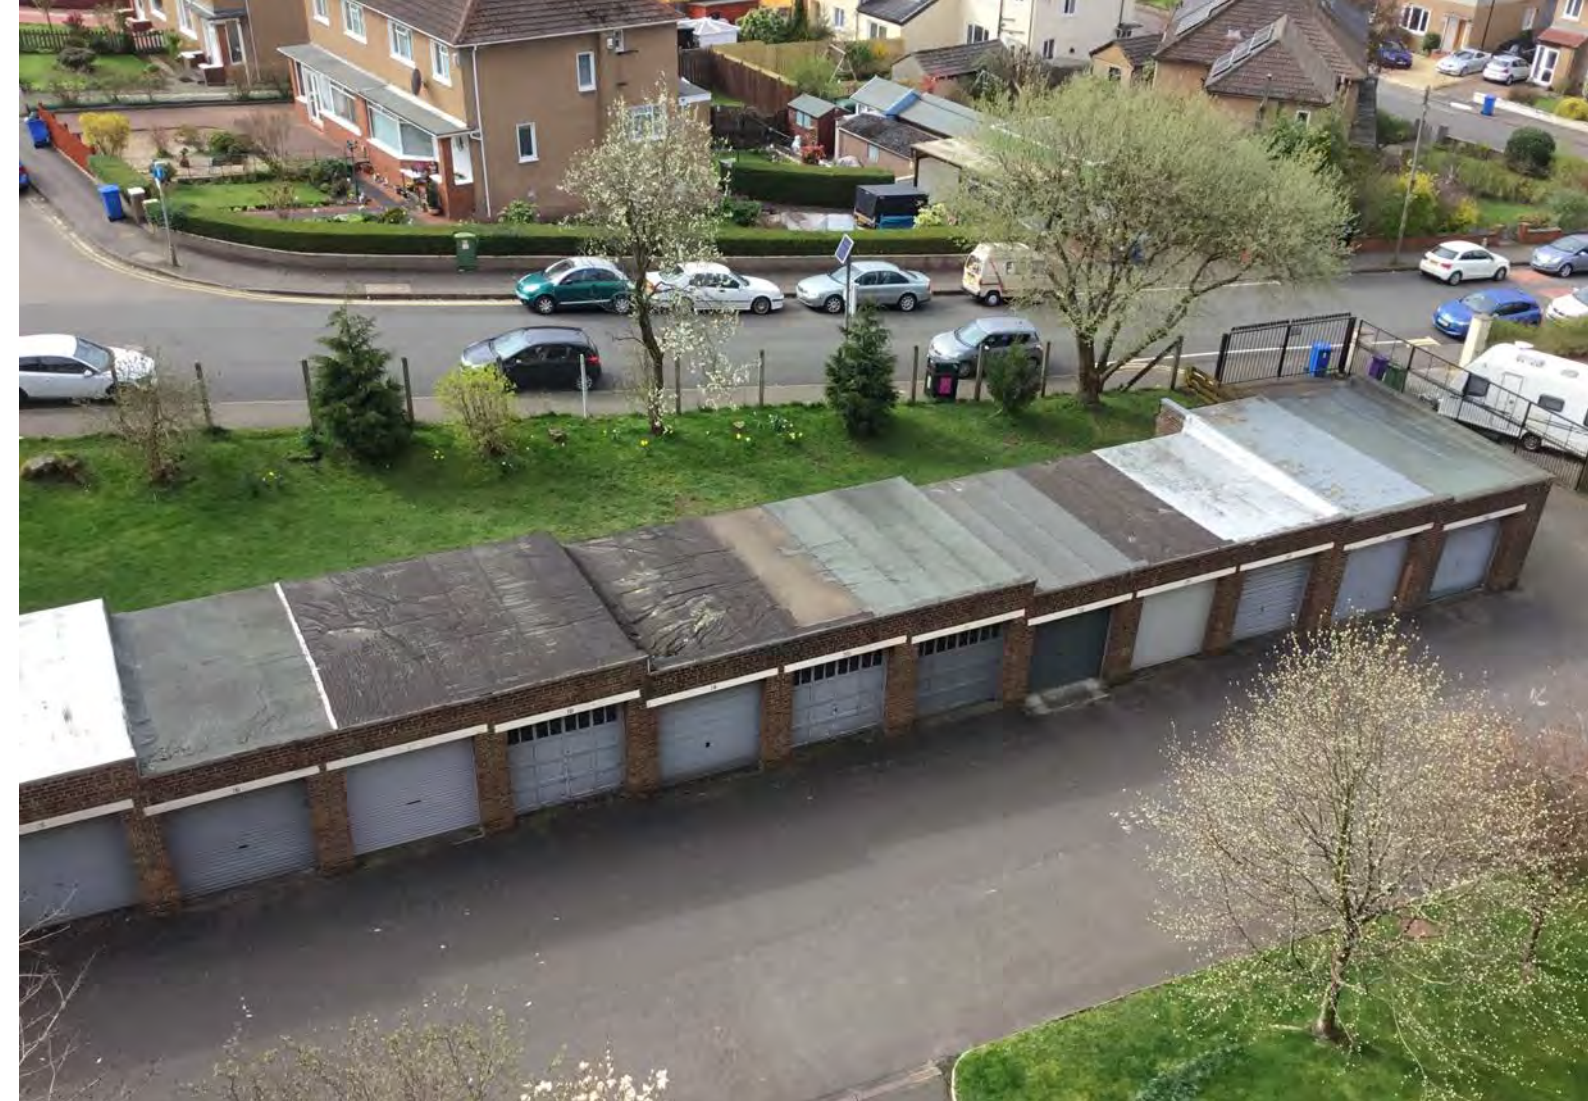
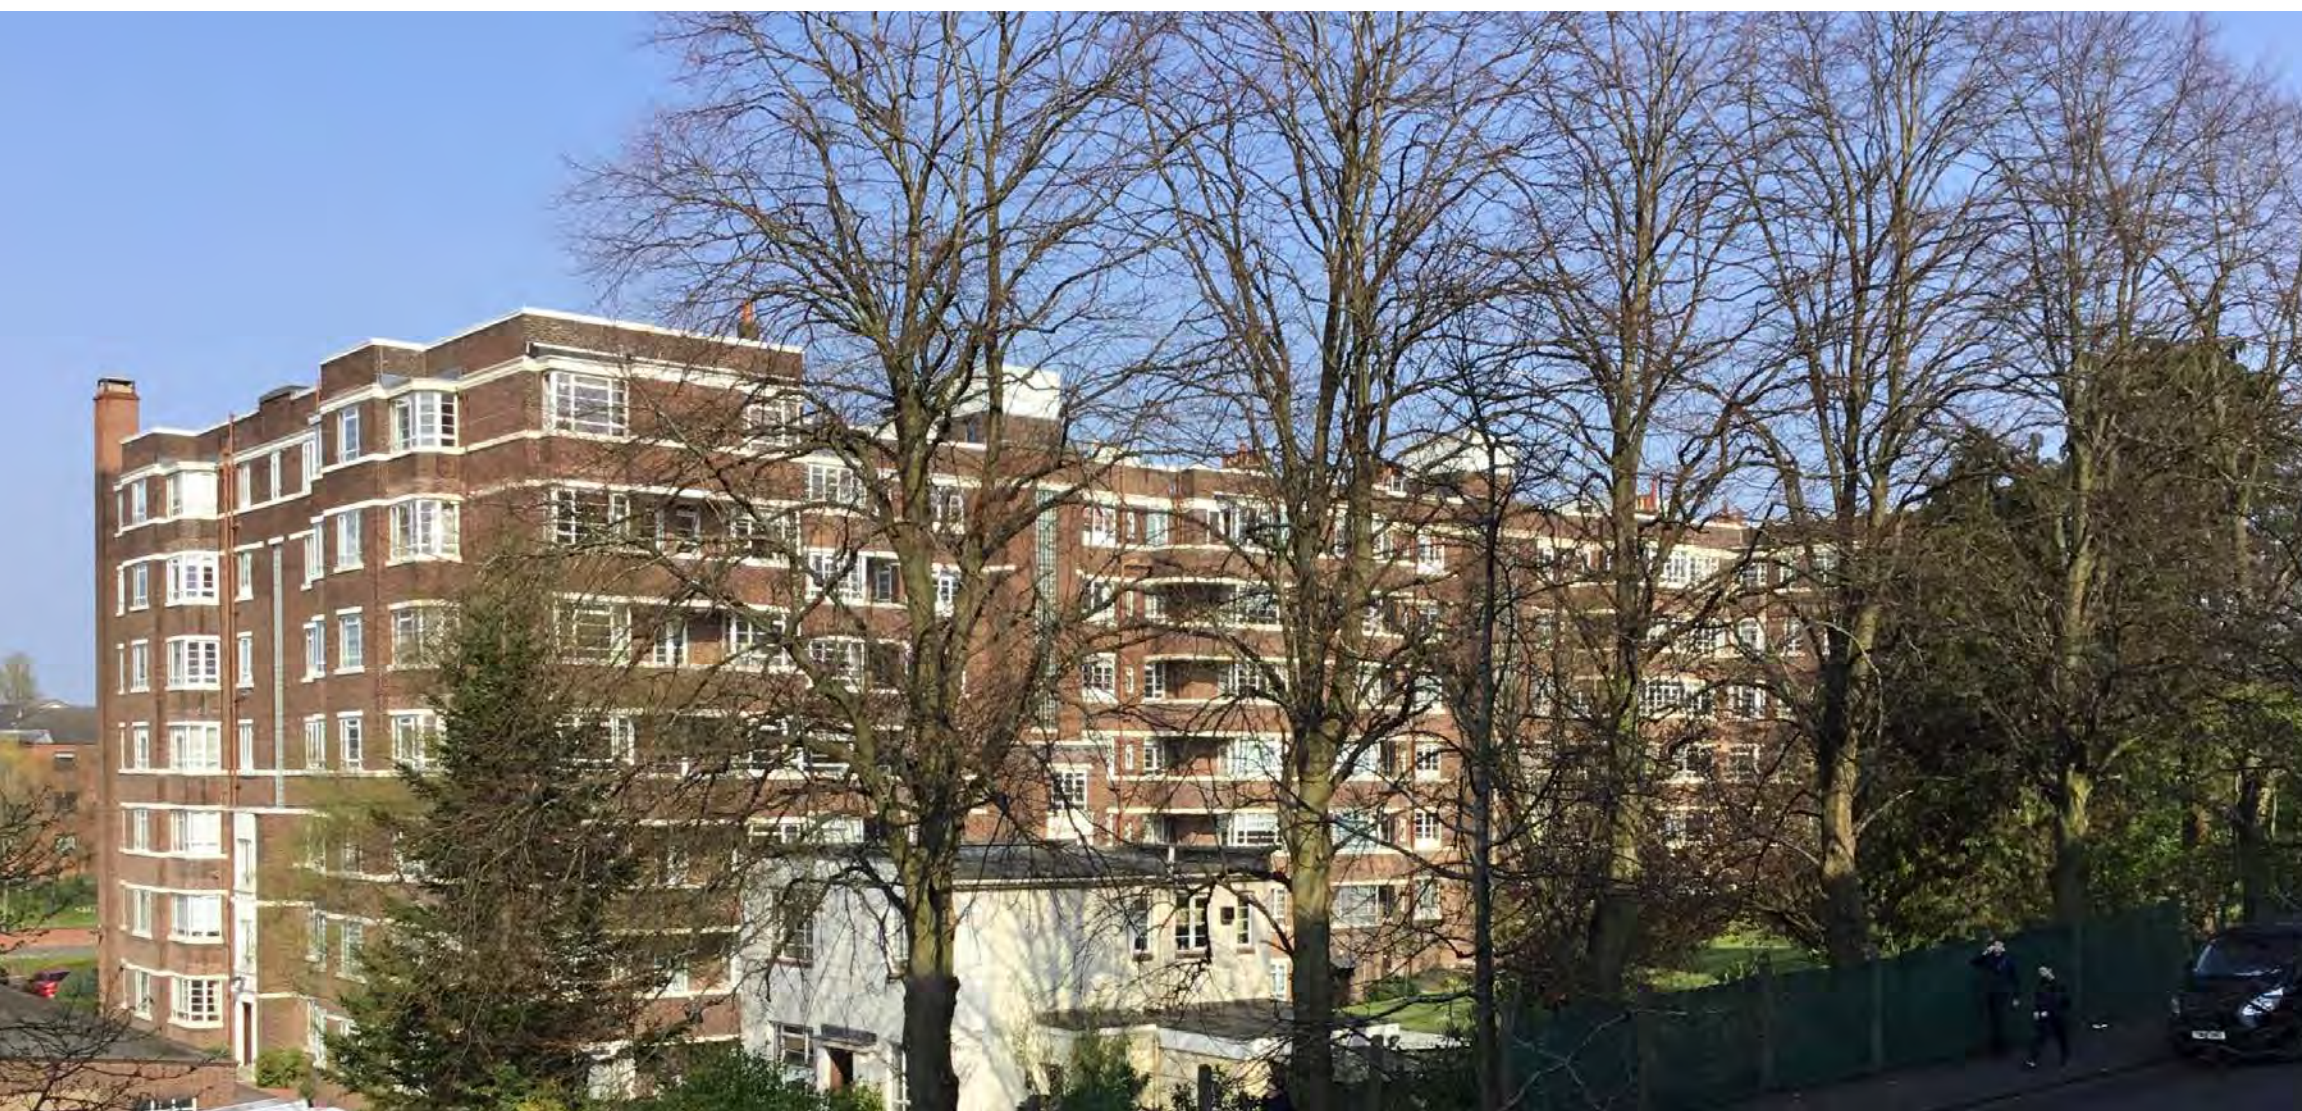
Clockwise from top left: the garage trusses are a fine example of engineering (© author); the garage roof is neatly covered in felt: there may be water ingress at the back of the north-facing parapet, which is not well finished (© author); the roof of the caretaker's house drains to the south only and is in need of repair (© author); the bases for the original coal boilers are still intact in the heating chamber (© author); the north-facing reinforced concrete wall in the underground heating chamber is in need of repair (© author).

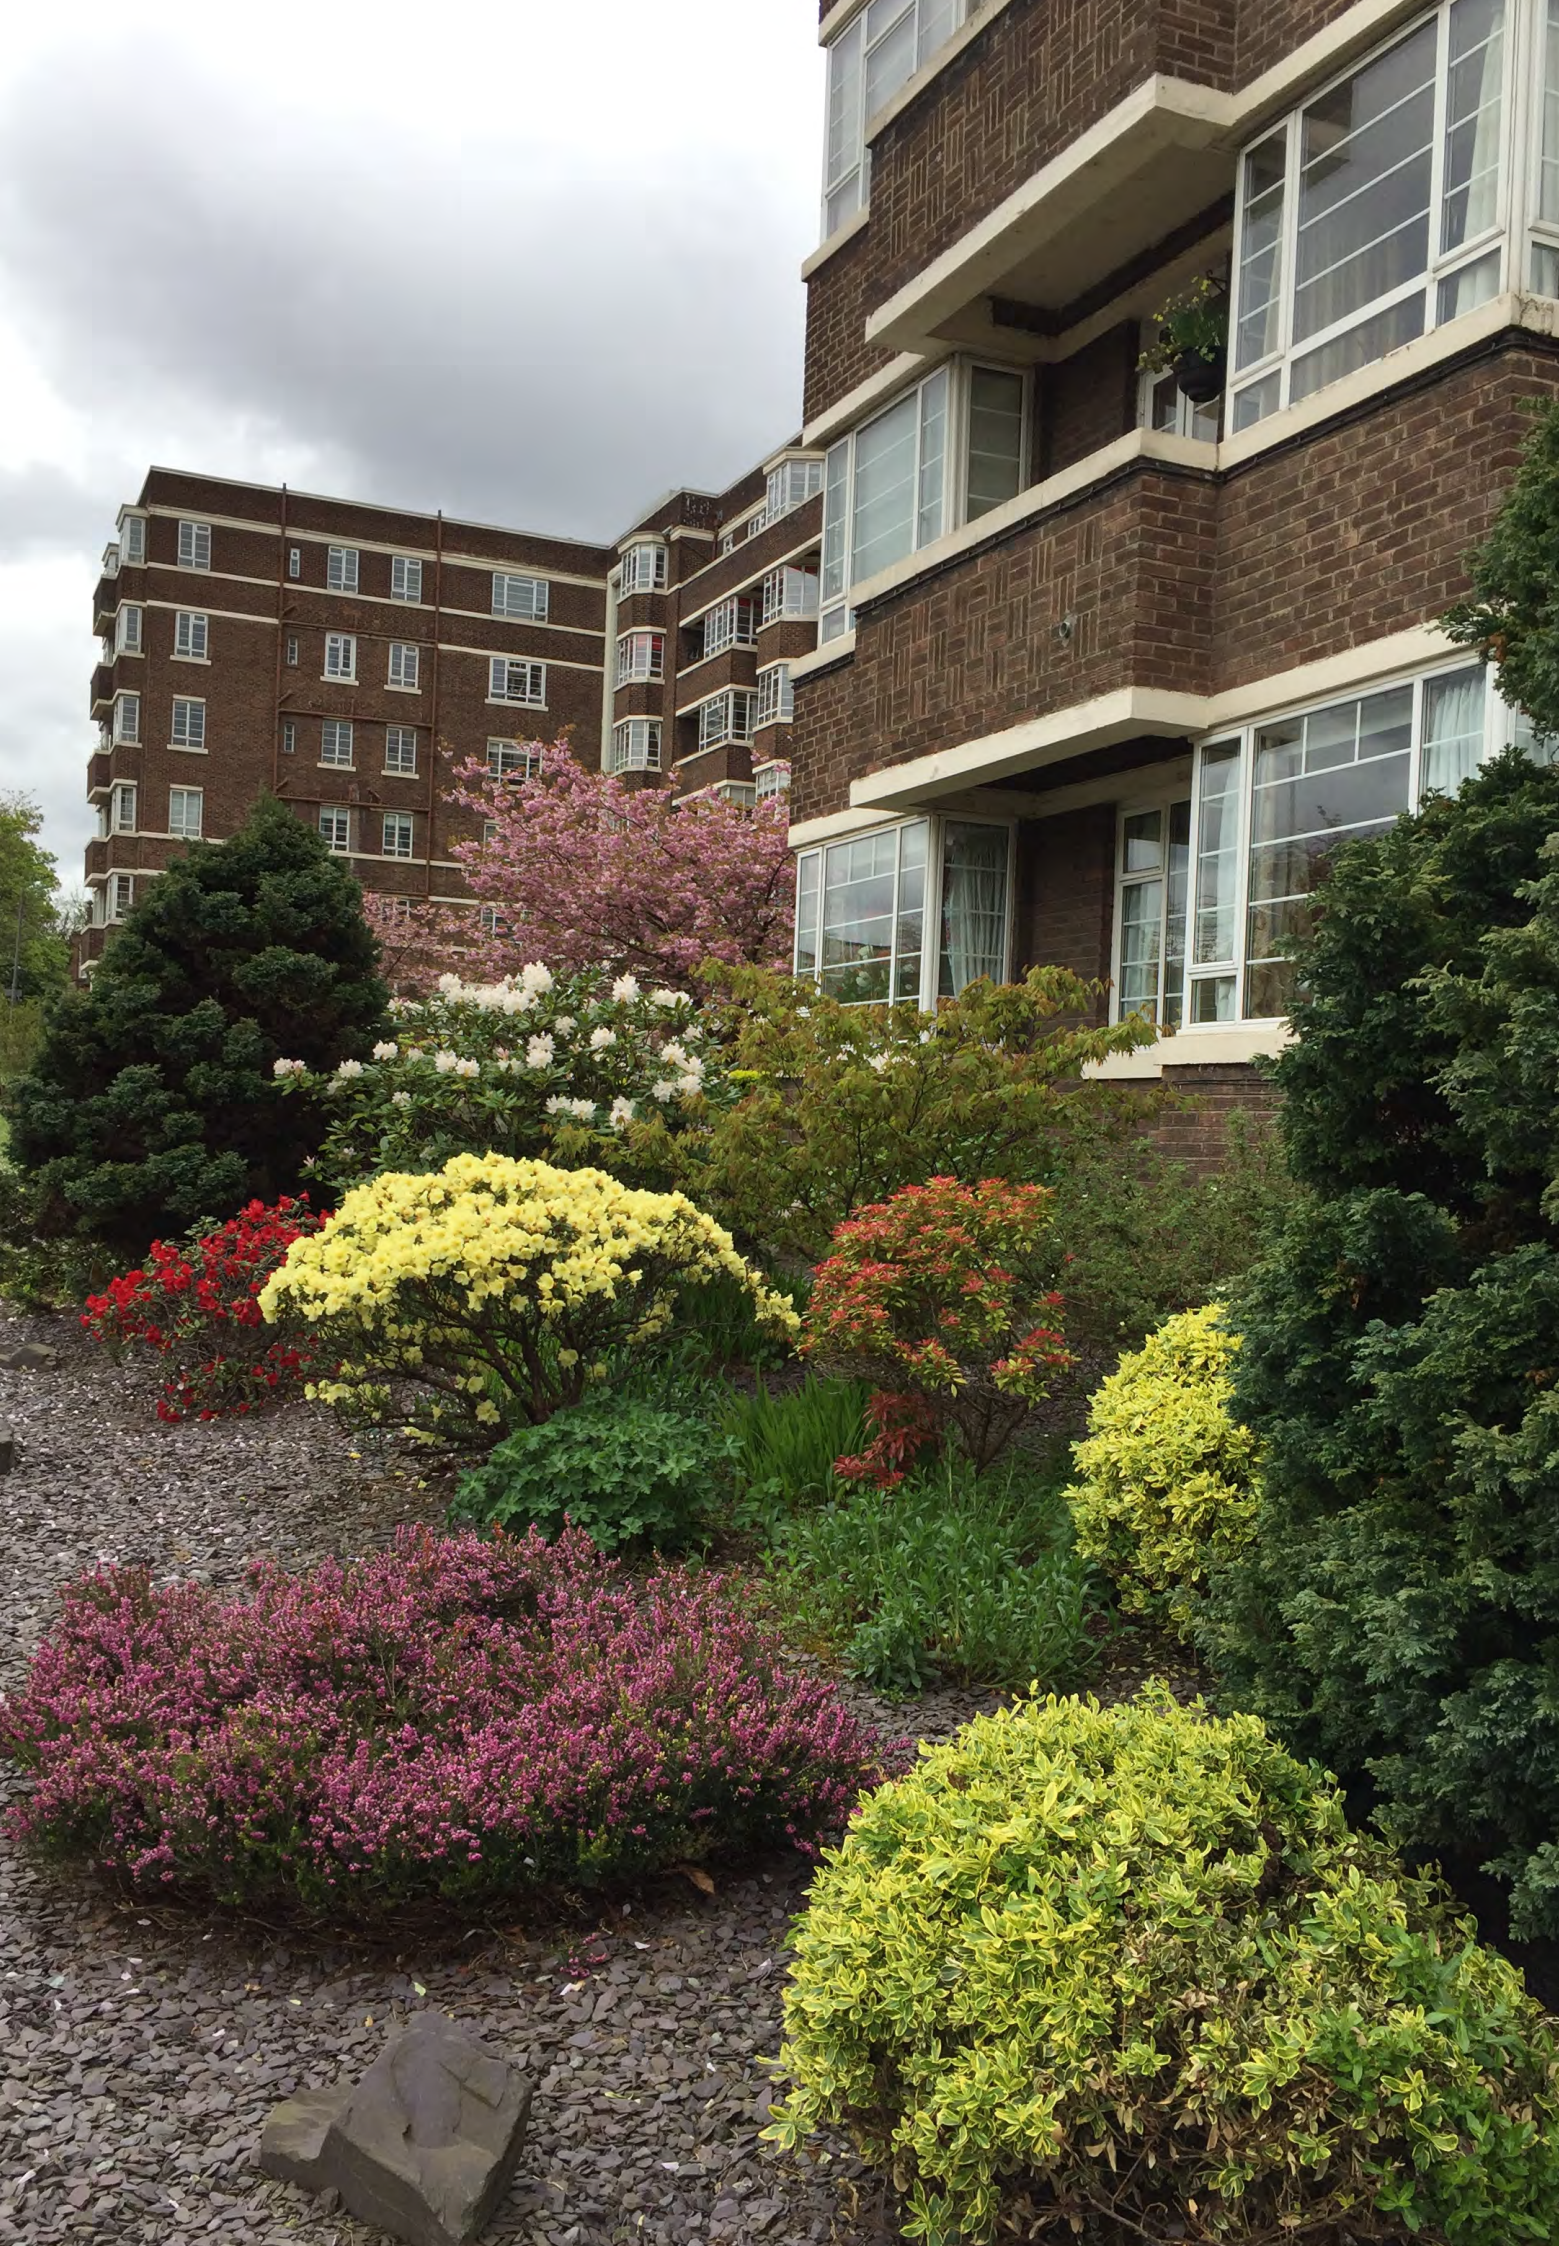
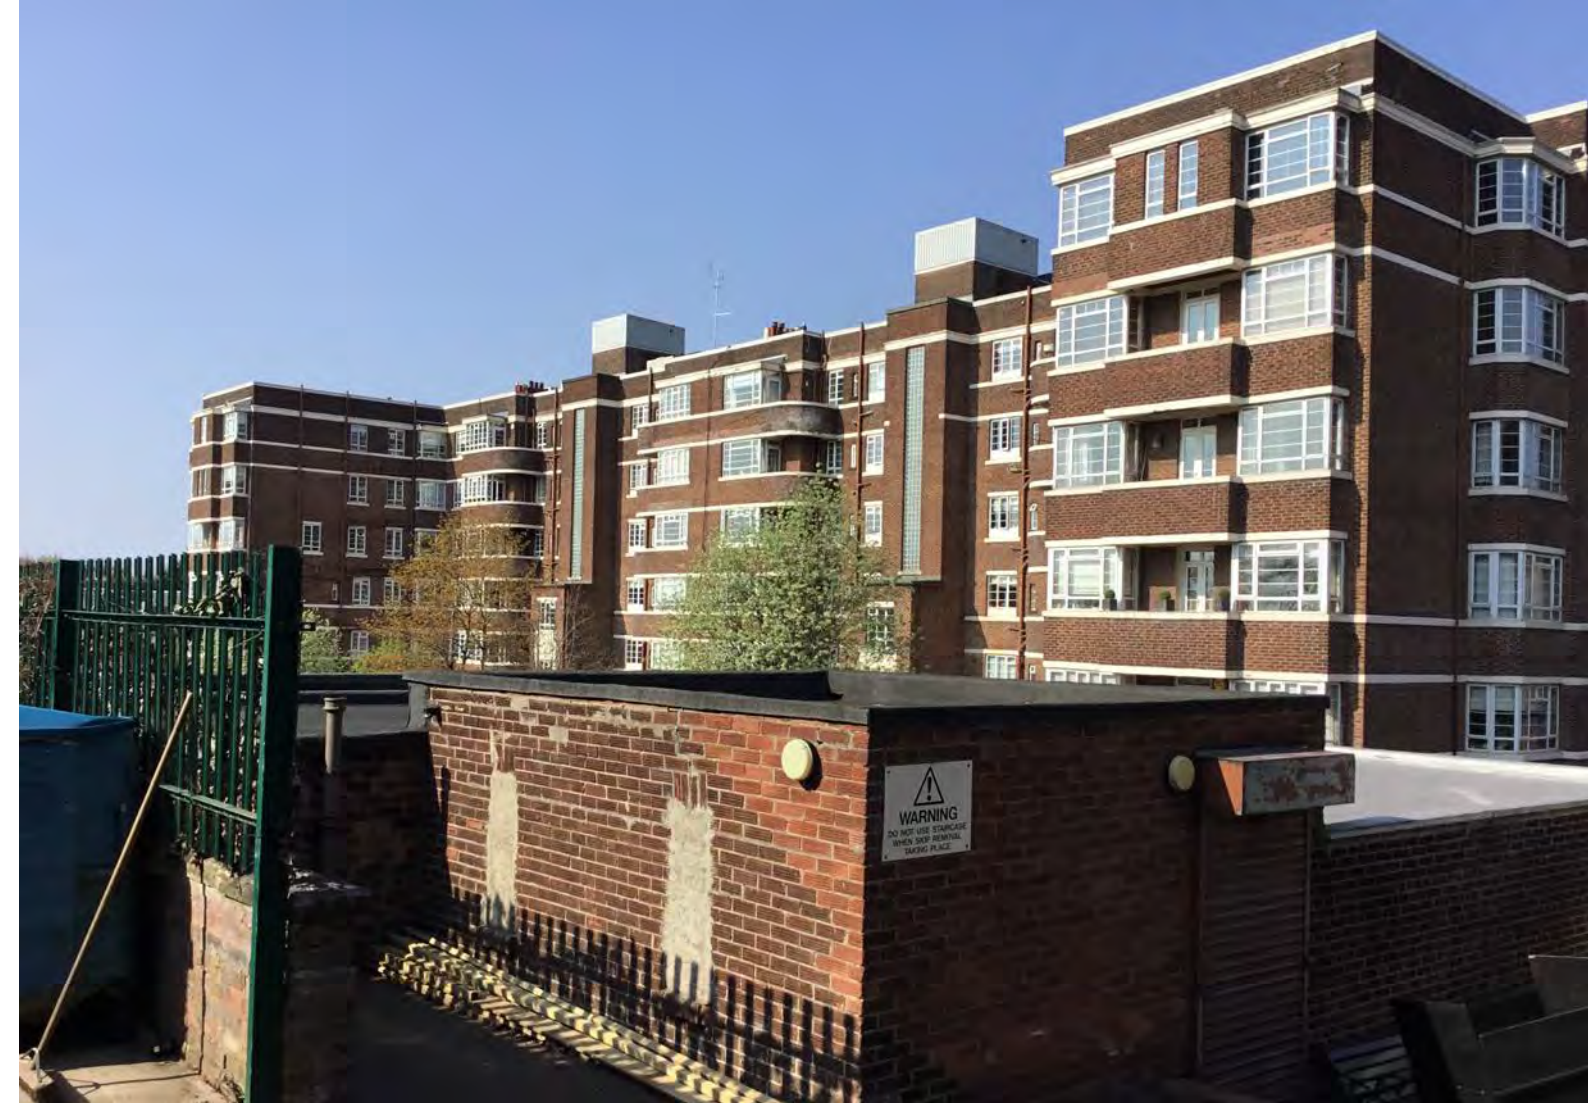
Clockwise from top left: the caretaker’s flat has been re-rendered on the west face only (© author); the lock-up roofs are finished in a range of different materials (© author); a few of the original lock-up doors survive (© author); the landscaping was designed to screen Kelvin Court from undeveloped land to the south (© author).
