KELVIN COURT, GREAT WESTERN ROAD,
GLASGOW
CONSERVATION NARRATIVE

April 2019

INSPECTIONS

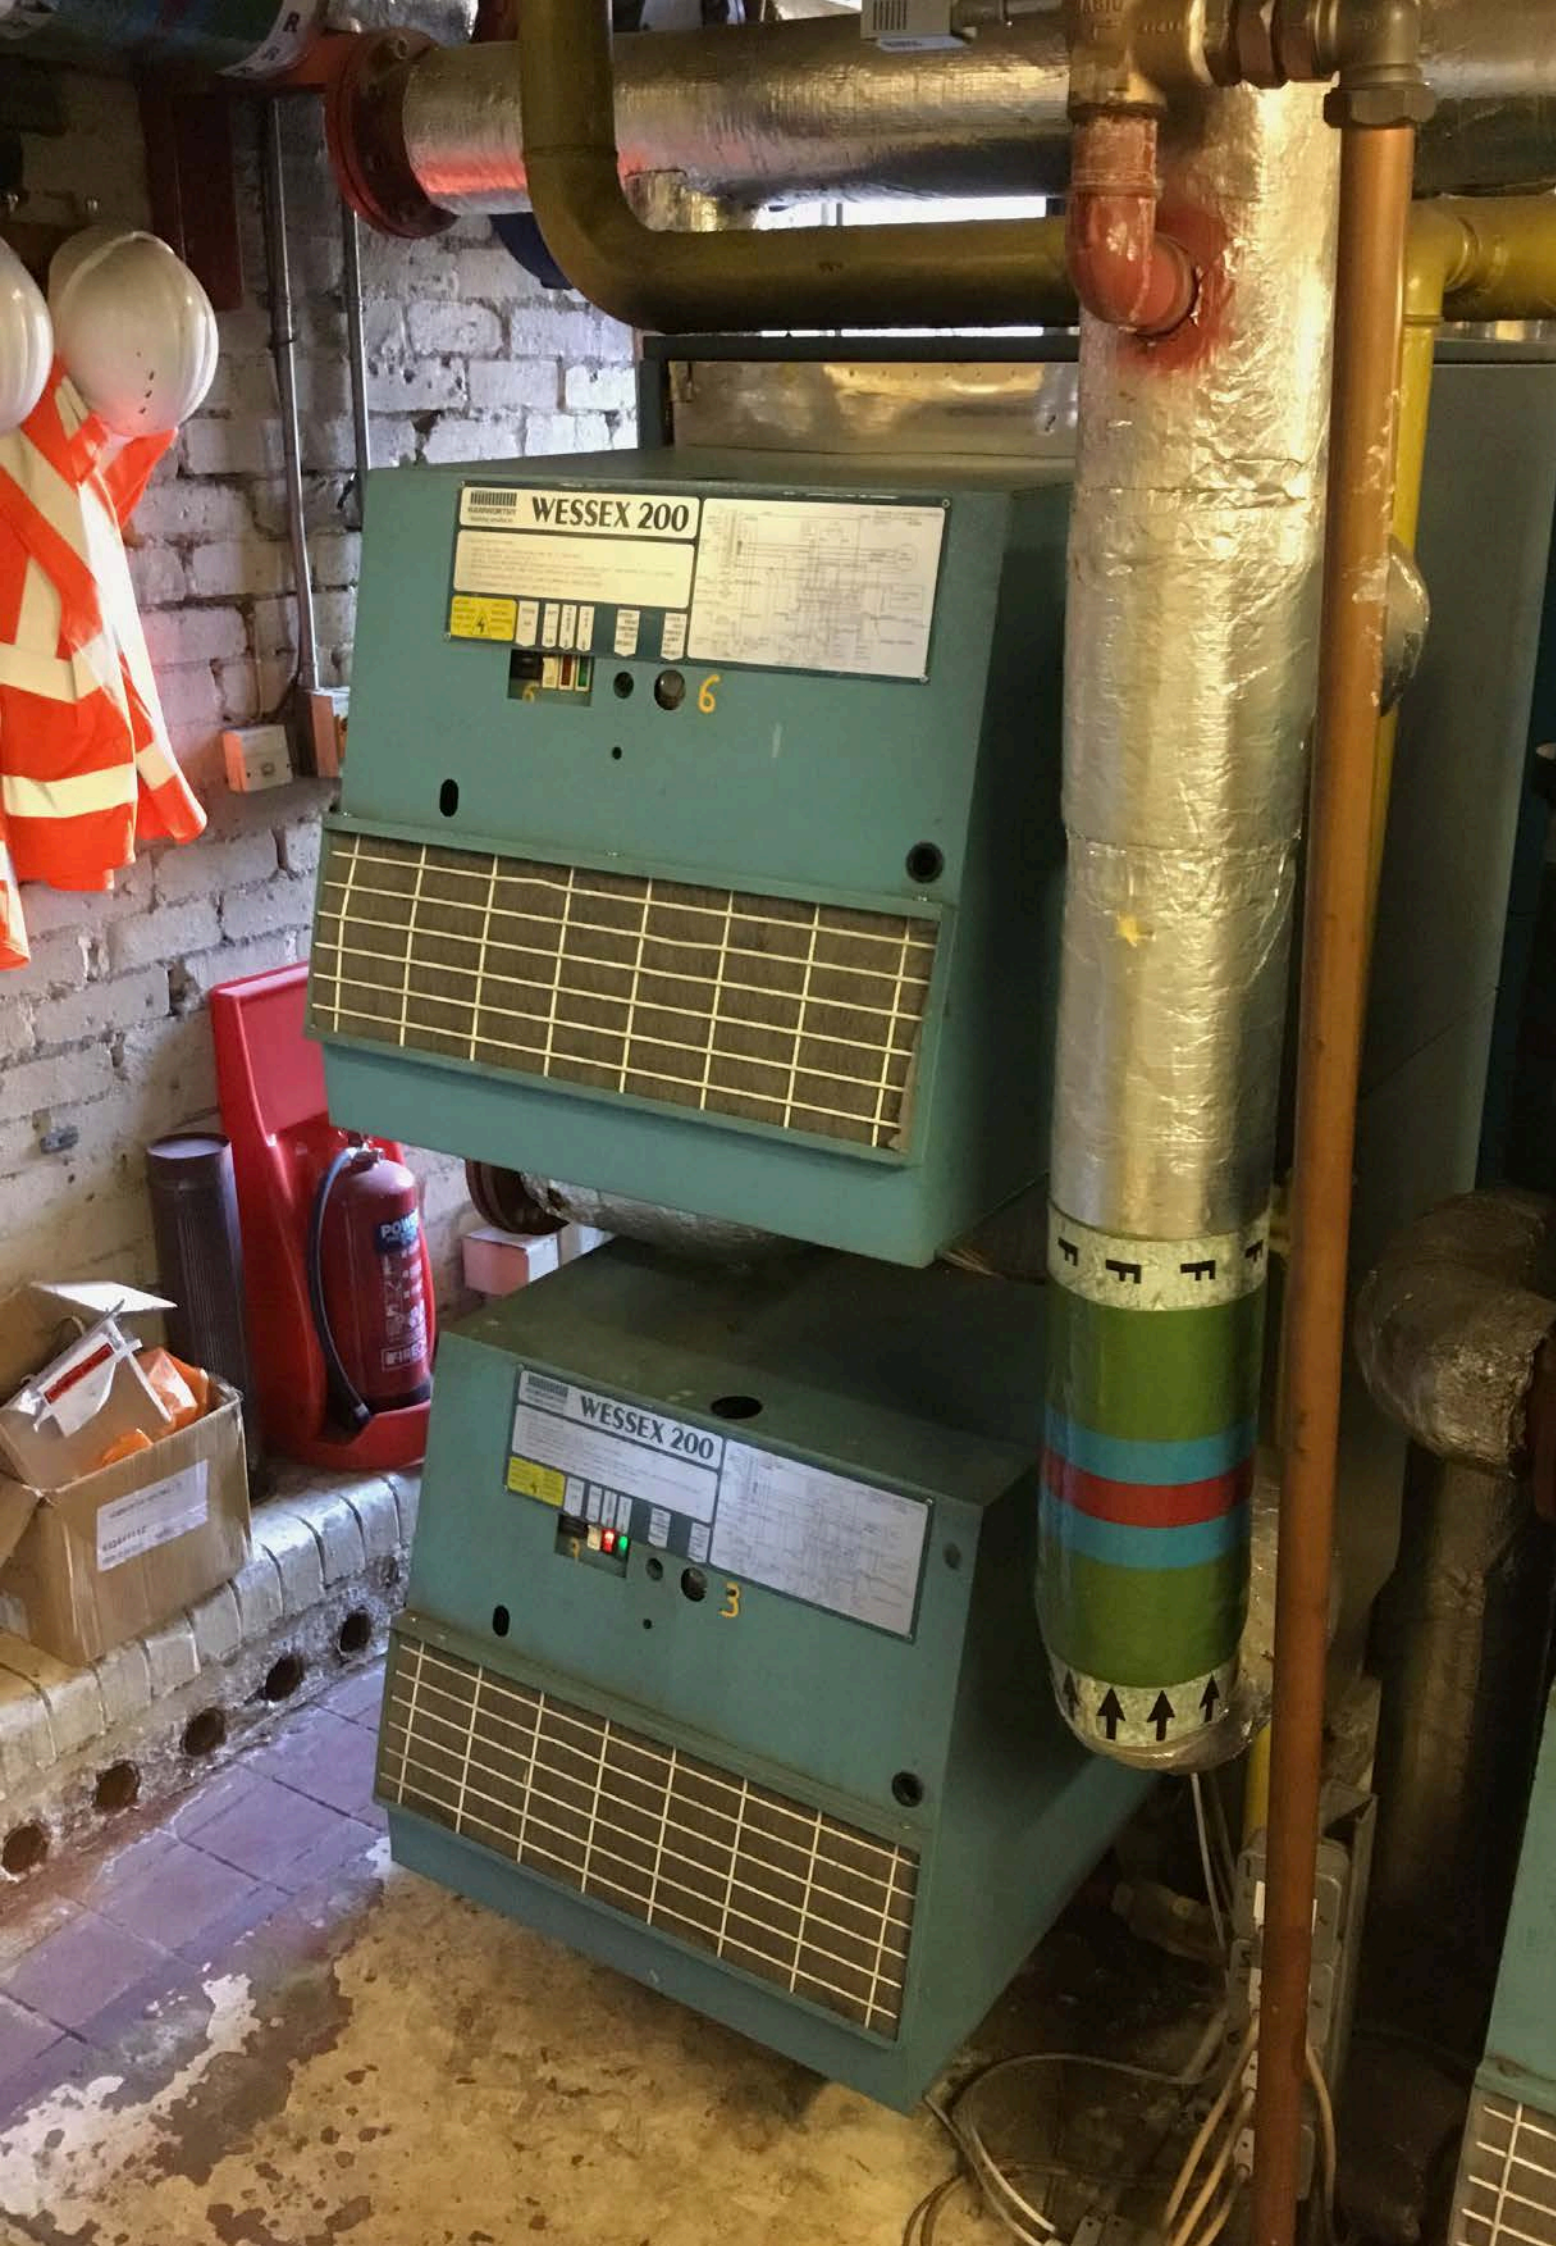
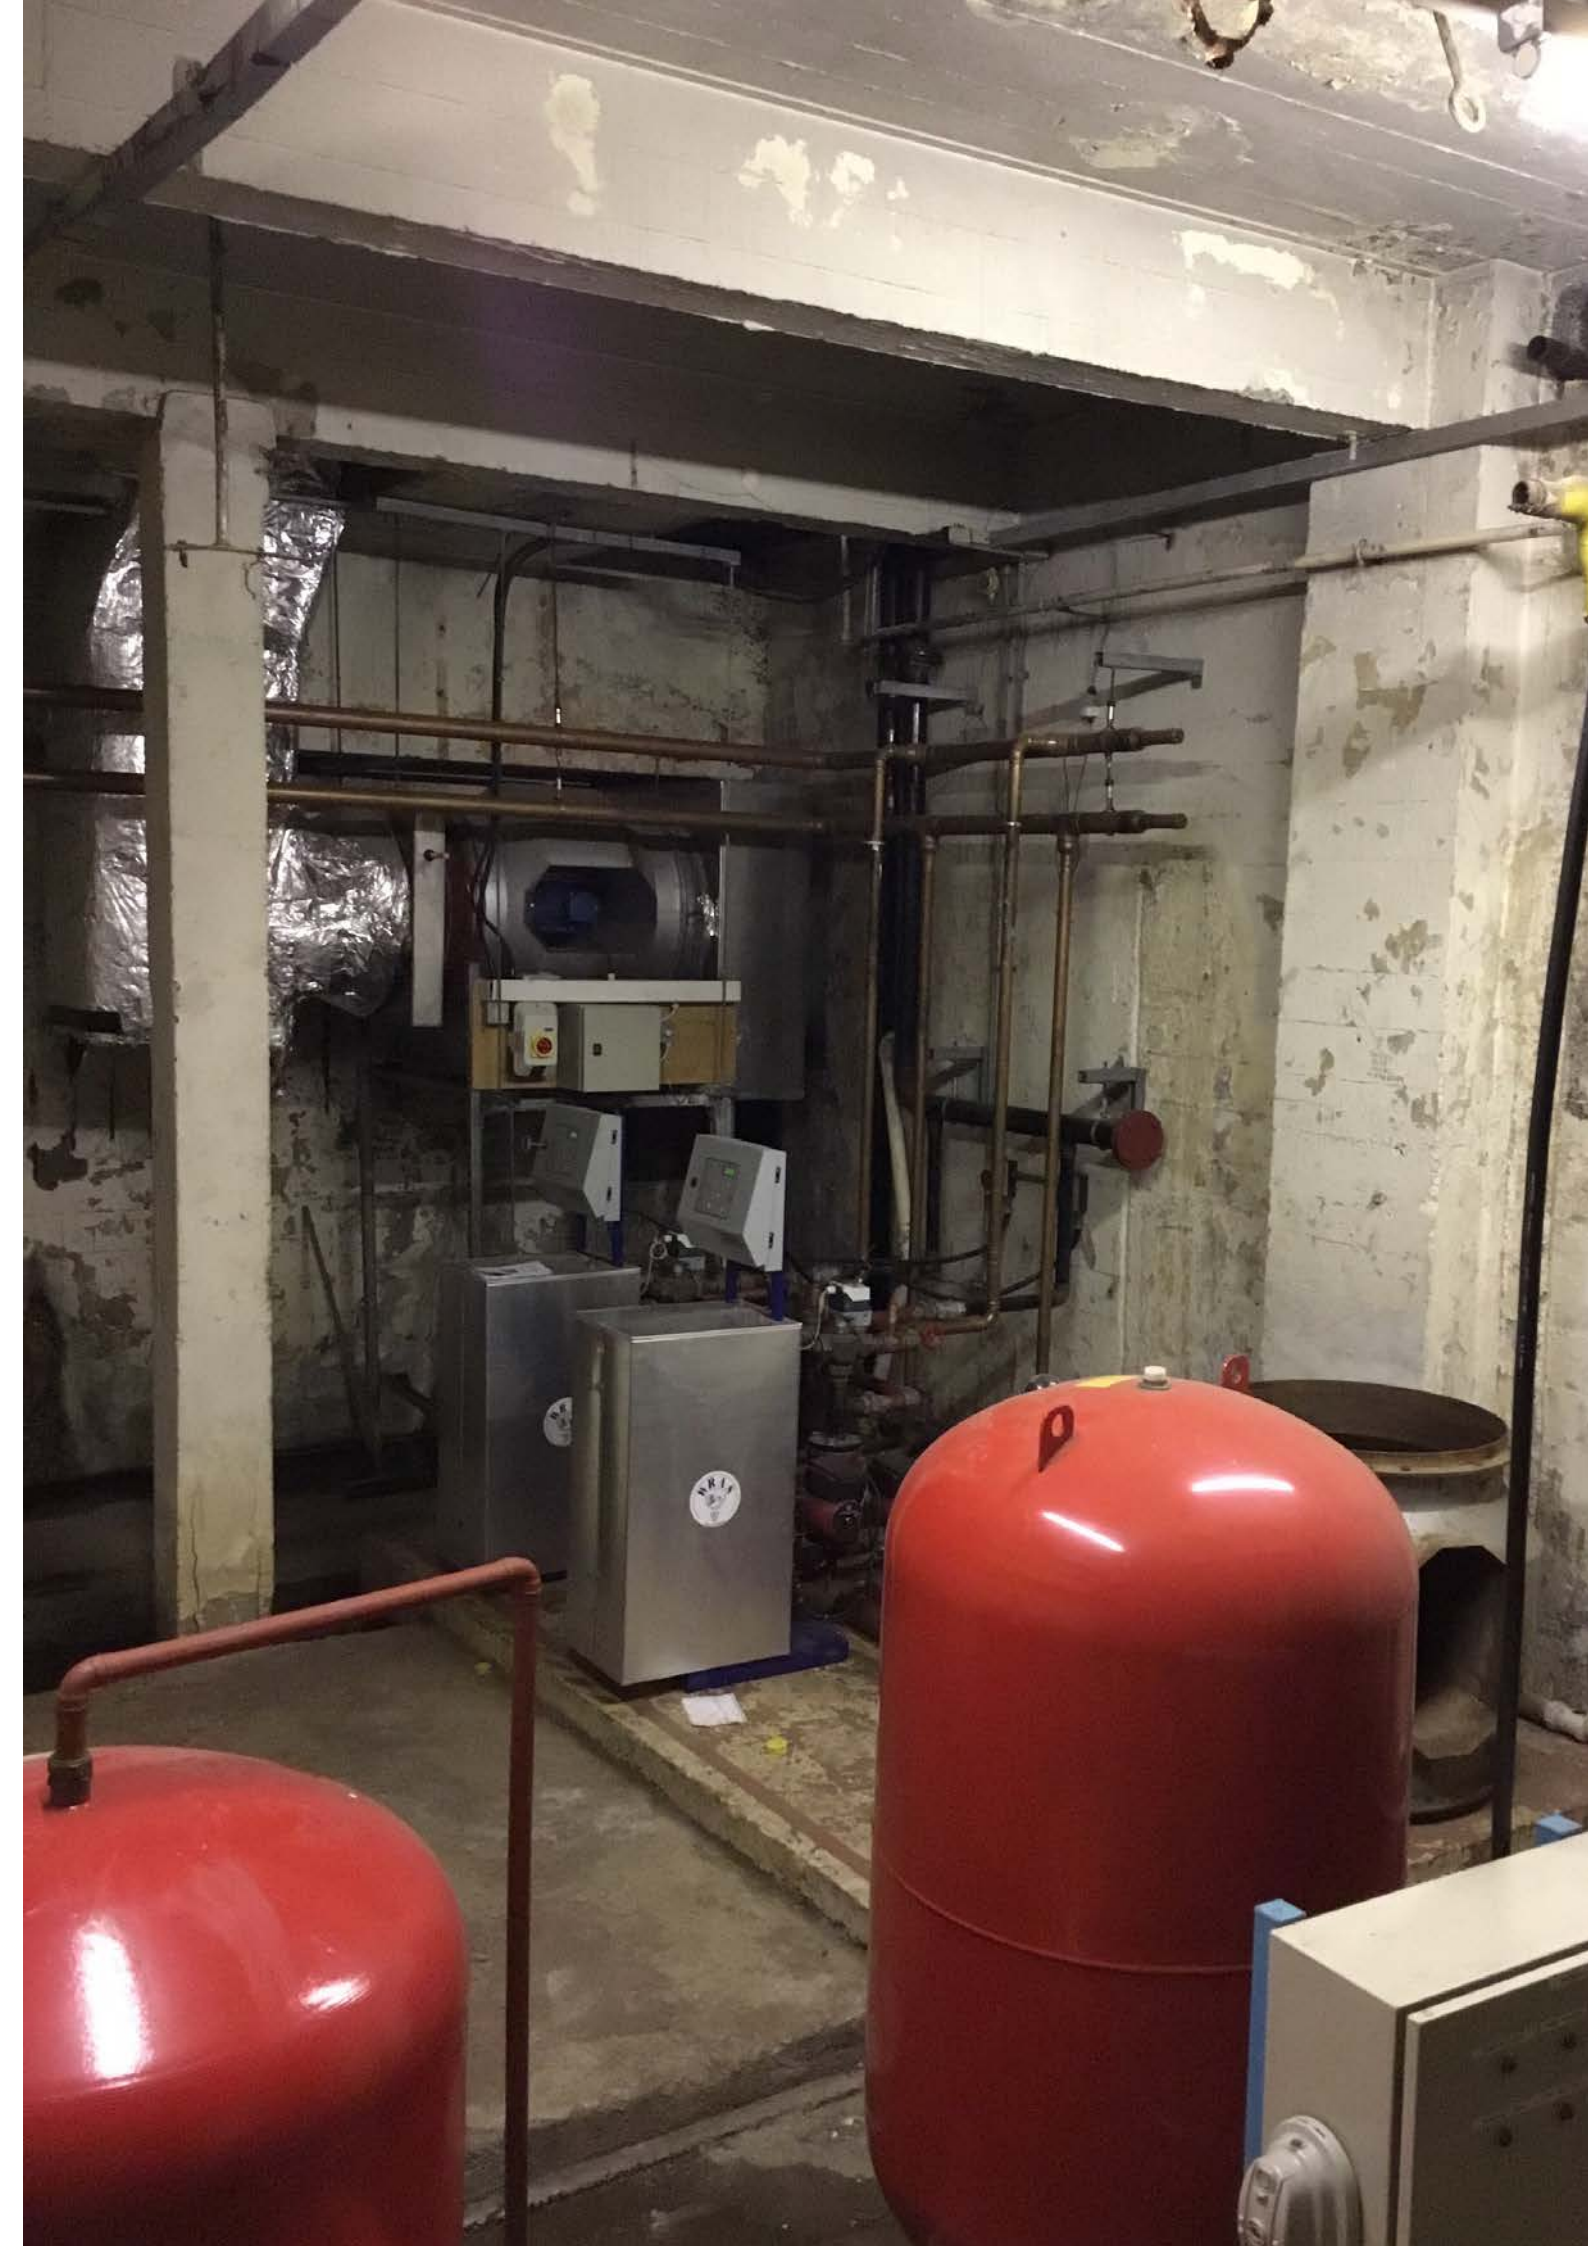
Clockwise from left: there are some attractive planted areas in the garden grounds (© Christine Martin); the old ash bin shelter is unloved and badly repaired (© author); heating gate valves are located in cellars and solums (© author); the heating pipework enters the two blocks in chambers next to the communal garage (© author).
