KELVIN COURT, GREAT WESTERN ROAD,
GLASGOW
CONSERVATION NARRATIVE

April 2019

INSPECTIONS

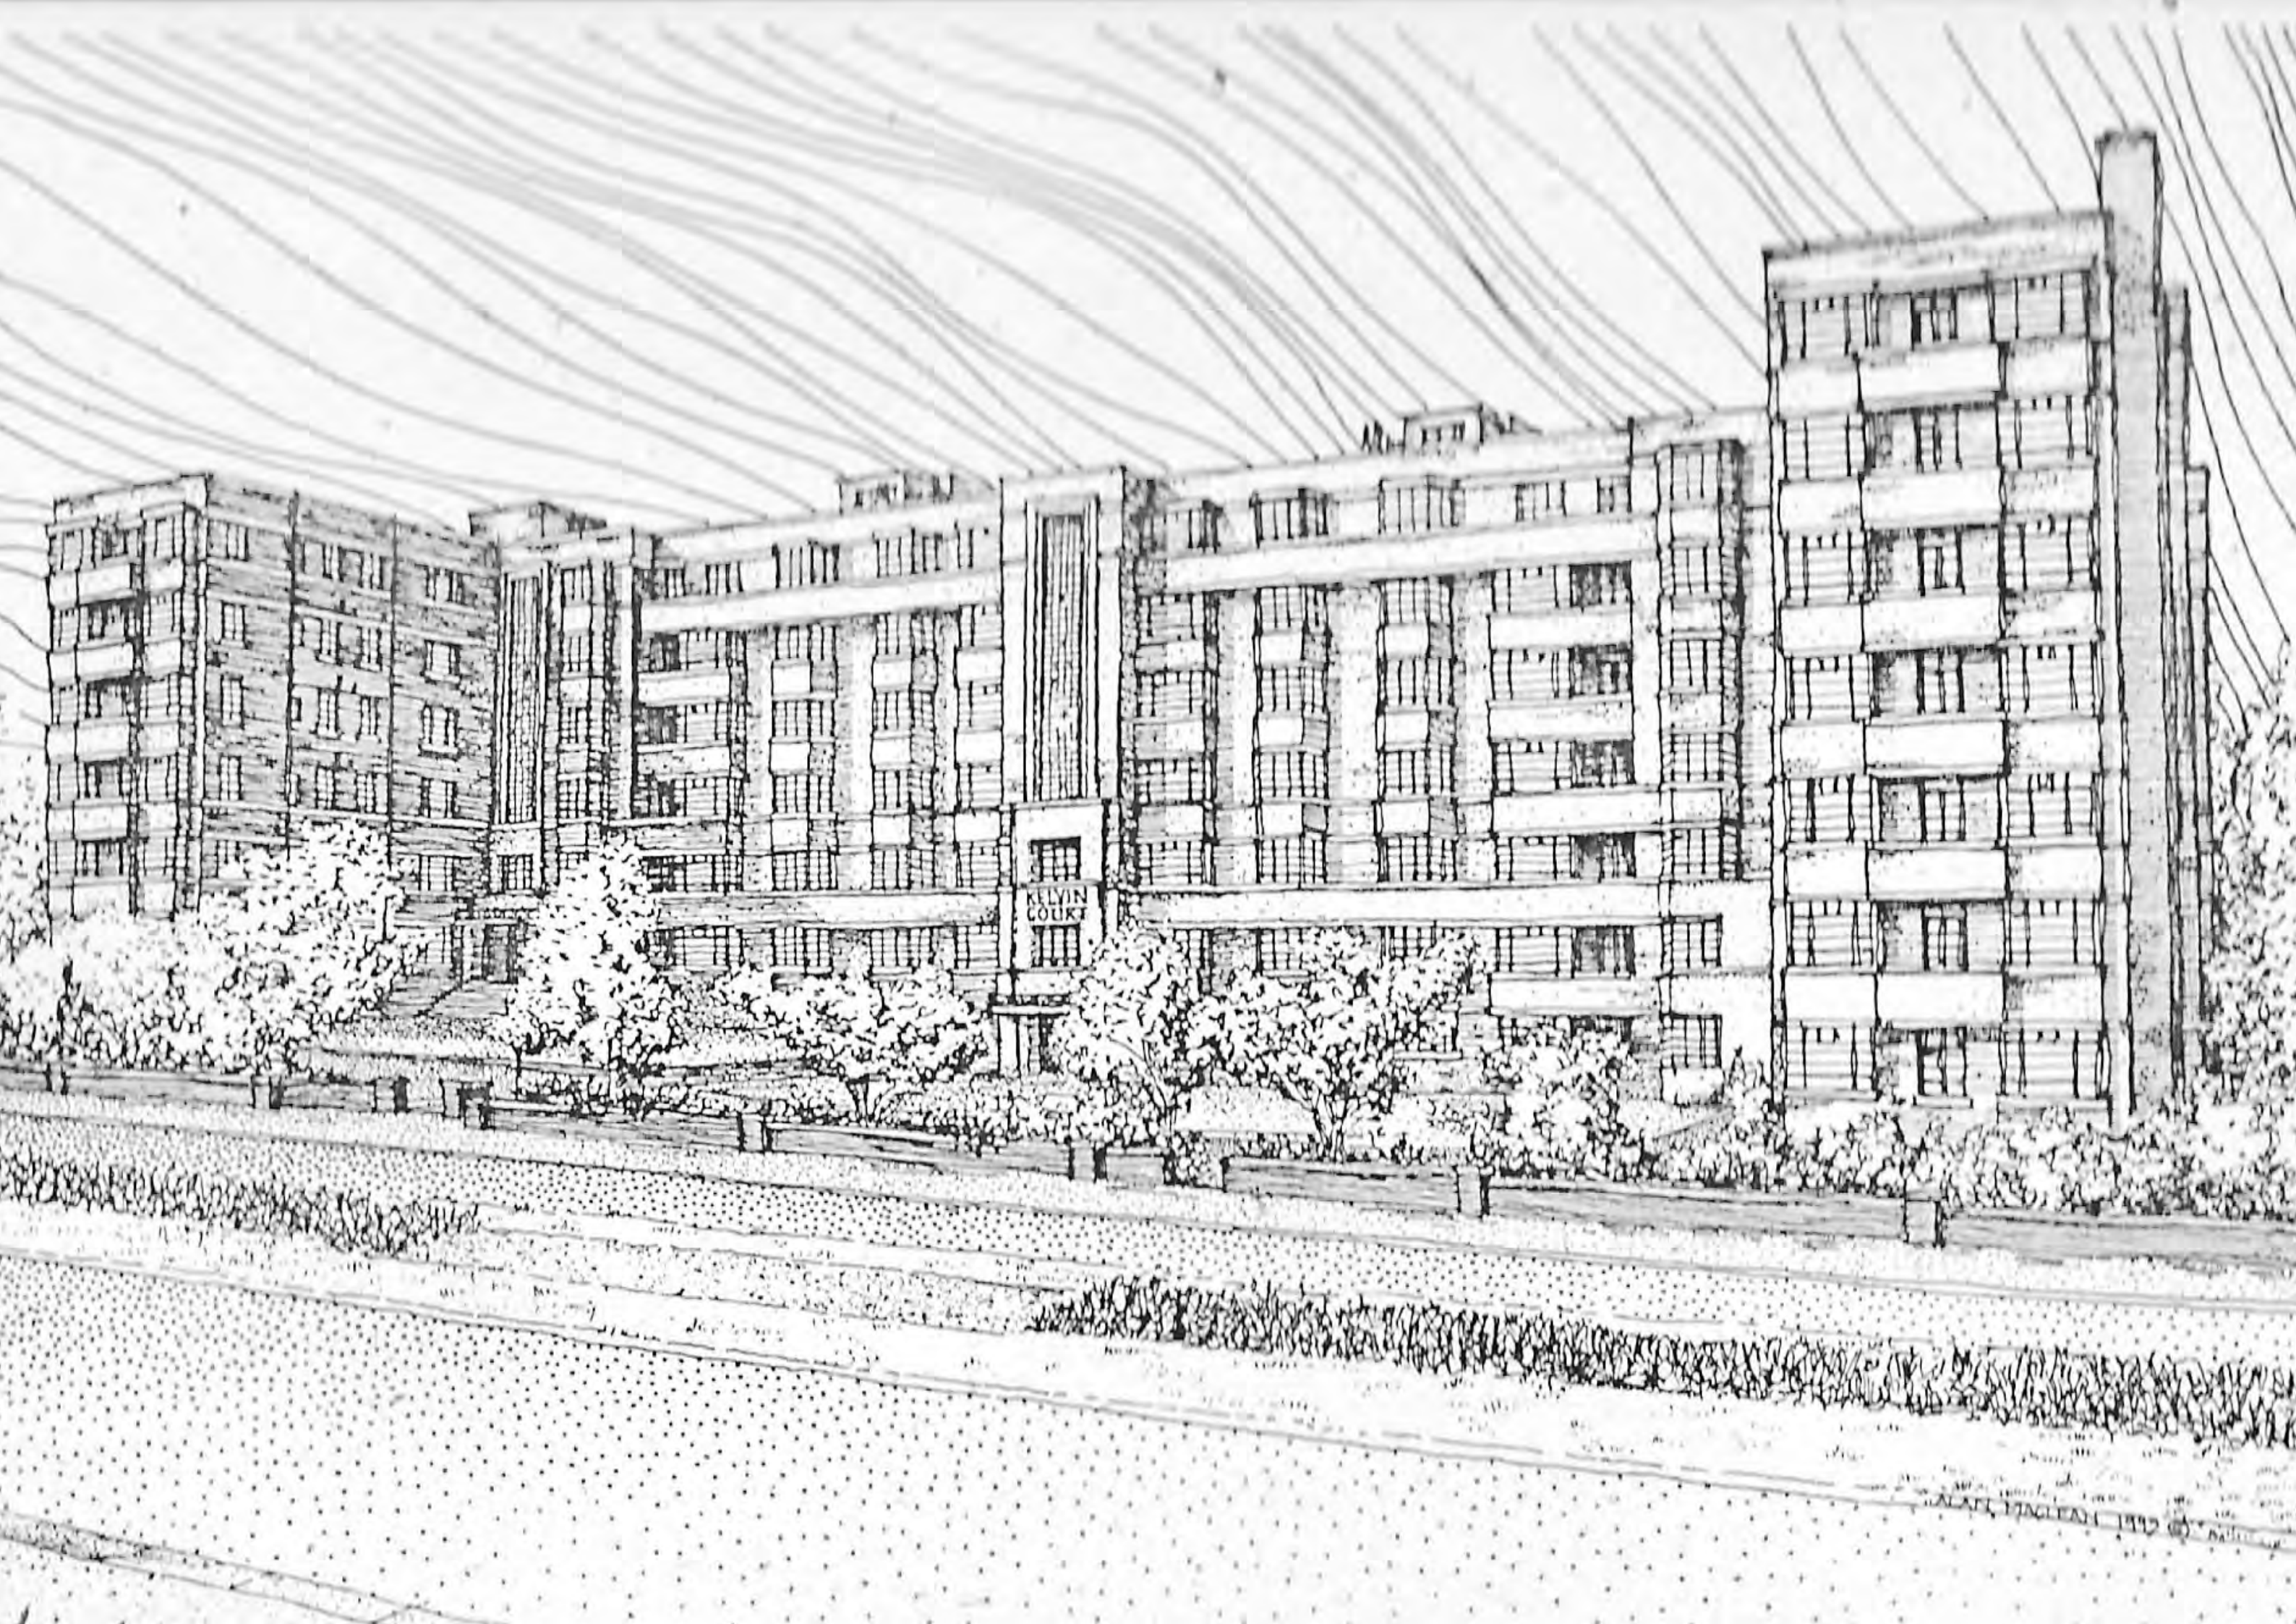
Clockwise from top left: the wonderful zig-zag pattern on the facing brick used (© author); even if these door handles are not original, they are a better fit for the period than knob handles (© author); old electrical boxes refer to lighting above the canopies and entry 'phones to the cellars (© author); there are a few doorbells left in service stairs (© author); the London Brick Company stamped its bricks (© author).
